Service News

Volume 1

JANUARY, 1951

Number 1

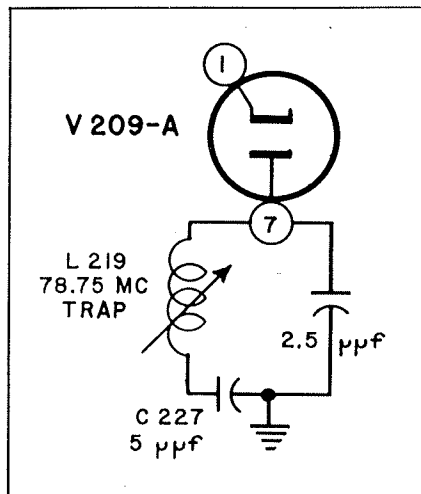
FIGURE T-1

Symptom: Channel 8 beat. Fine diagonal lines in picture, changing in frequency as fine tuning is varied. Condition occurs in channel 8 areas in those Telesets in which a channel 5 trap has been installed.

Probable Fault: The seventh harmonic (183.75) of the video if (26.25) combines with the video carrier of channel 8 (181.25) to produce a 2.5-mc beat.

Remedy: Connect a 2.5-mmF capacitor from pin 7 of the video detector (V209-A) to ground as shown in figure T-1.

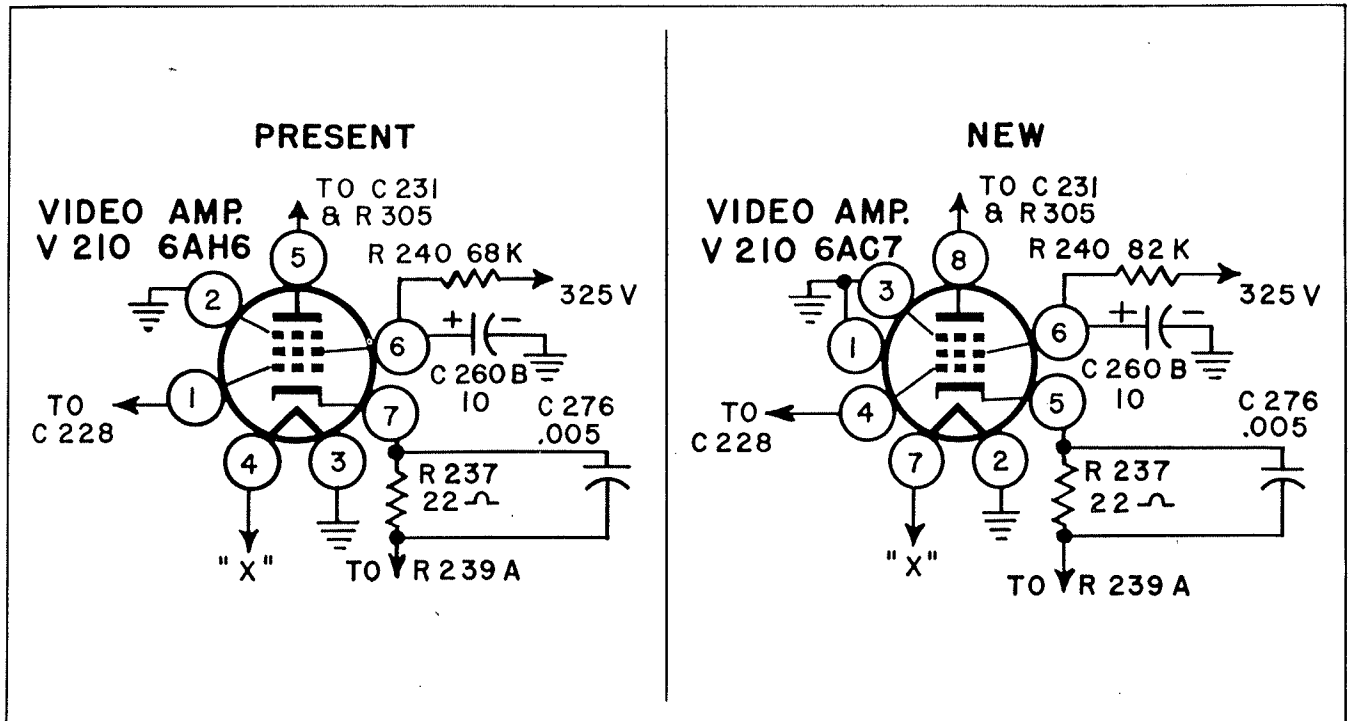
FIGURE P-1

Due to a shortage of 6AH6 electron tubes, it has been found necessary to make the following change.

1. Rewire V210 as shown in figure P-1.
2. Replace V210, 6AH6 with 6AC7.

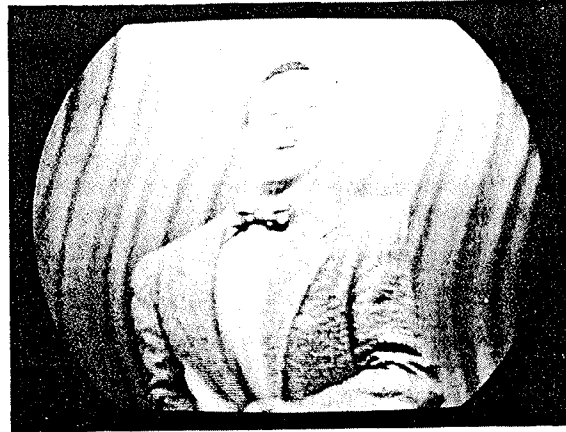
FIGURE H-1. "S" DISTORTION

Another effect of unstable sync, which occurs in all of the receivers mentioned, results in a horizontal movement of the picture which, in extreme cases, is an "S" shaped distortion of the picture, as shown in figure H-1. This condition has been confused with wobble or jitter, as described above, and the technician should study the picture carefully to make certain he has analyzed the trouble correctly.

This distortion is usually caused by heater to cathode leakage in the 6J6 r-f amplifier in the Inputuner. The tube should be checked and replaced, if necessary, before proceeding to examine the horizontal sync circuits.

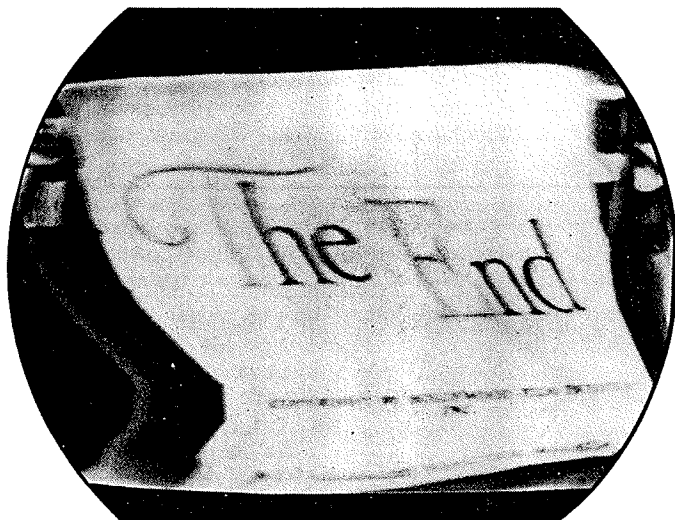
This condition is also referred to as "hook" and "whip" and occurs in RA-109A, RA-112A, RA-113 and RA-117A Telesets. It results in horizontal pulling of a portion of the picture, generally about one inch wide. This pulling is caused by the video signal entering the sync circuits. It can be corrected by changing the value of the by-passed cathode resistor, in the narrow-band sync stage, from 270 ohms to 470 ohms. The symbol number of this resistor is R359 in the RA-109A, and R315 in RA-112A, RA-113 and RA-117A Telesets. This change has been incorporated in all chassis starting with the serial numbers shown below:

Figure A-1. Horizontal pull.

If the difficulty persists, short R284 in the sync detector output. Since this

will reduce noise immunity, it is not advisable in noisy areas.

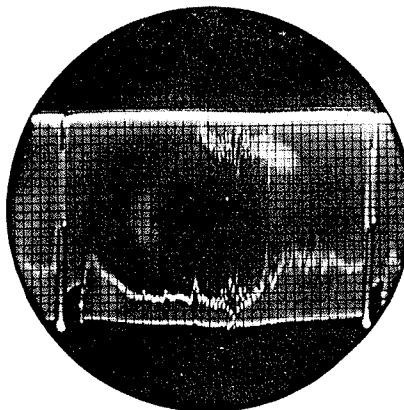
Figure A-2. Output of first sync clipper showing video in sync.

4. Set the contrast and brightness controls to obtain a normal picture and adjust the a-g-c control until the picture brightens up. This will usually cause video to appear at the plate of the first sync amplifier, as shown in figure A-2.
5. Vary the adjustments at the top

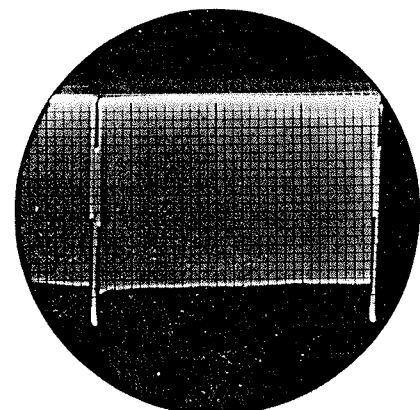
Figure A-3. Output of first sync clipper with narrow-band transformer properly adjusted.

and bottom of the narrow-band sync transformer until the video in the sync is eliminated, as observed on the oscillograph. When this adjustment has been made properly, the oscillograph pattern should appear as shown in figure A-3.

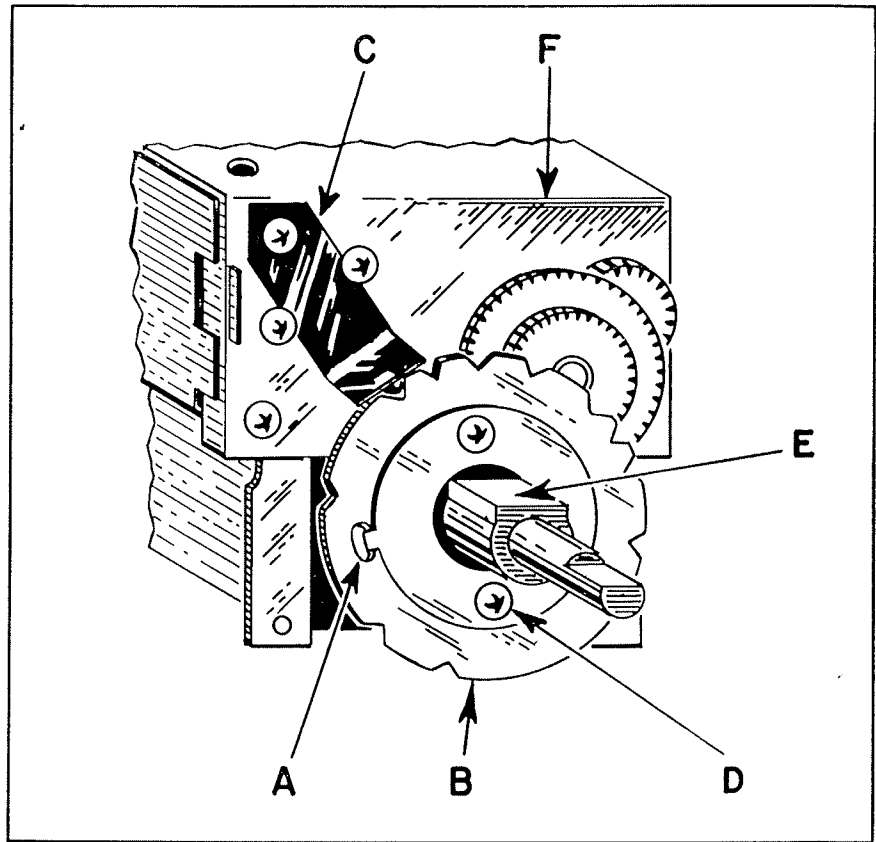
Figure S-1. RA-117A Selectuner.

If it is impossible to obtain proper calibration on all stations using the above procedure, the oscillator tracking adjustment may be off or the gear train in the tuner may have been damaged. A quick check of the calibration may be made by tuning to channel 13. If the gear train is properly engaged and the calibration is approximately correct, the flat (E) on

4. If the position of the detent is incorrect, loosen the two Phillips screws (D) on the front of the clutch disc one-half turn; while holding the detent disc in position.

5. Rotate the detent disc until the detent spring is centered in the proper detent.
6. Rotate the clutch disc until the stop is centered in the slot, when the tuning indicator shows proper tuning.
7. Tighten the two Phillips screws and make a final check of the dial calibration on all stations.

If the gear train in the Selectuner has been damaged, the unit should be returned to your distributor for exchange.

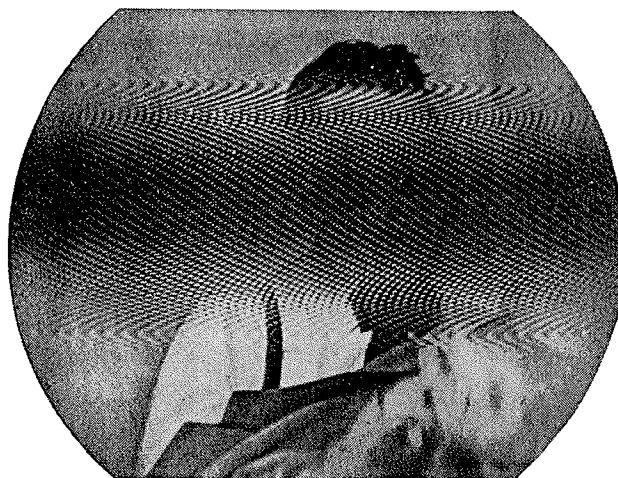
Figure D-1. Diathermy Interference.

Antenna traps for the elimination of diathermy interference will be available from your Du Mont distributor in the near future. Notification of the availability of these traps will appear in the SERVICE NEWS.

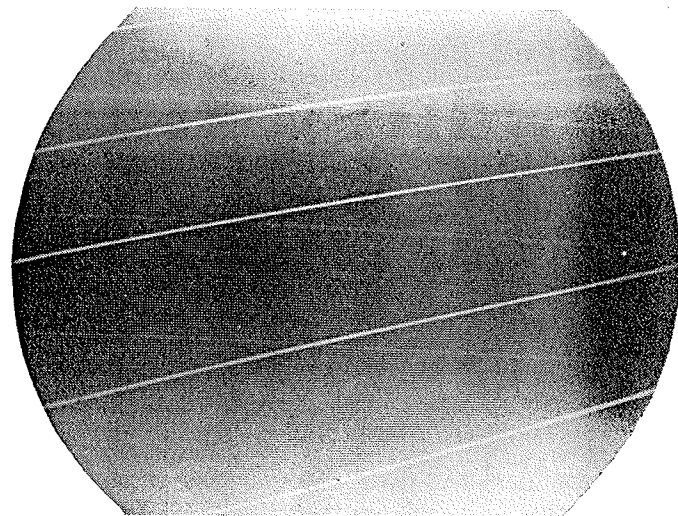
Symptom: No picture. Raster varies

in brightness from top to bottom forming a wide dark band as shown in Figure T-1. When Selector Switch is placed in the FM position, raster remains on screen but is not in sync. In some cases the picture will appear and disappear rapidly when switch is in Tele position.

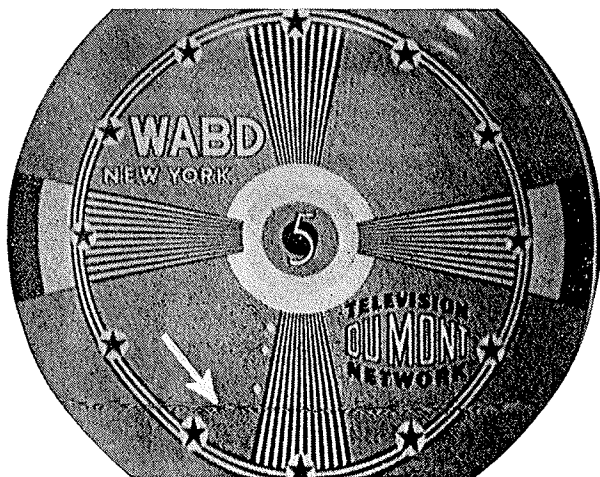
Mr. Rascoe adds that there may be as many as 30 or 40 bulbs located close enough to a receiver to cause interference. Having nearby neighbors pull their main power switches, while observing the picture, is a simple way to determine whether the offending bulbs are located in the customer's home or in a neighbor's.

Figure I-1. Test pattern showing interference caused by incandescent lamp.

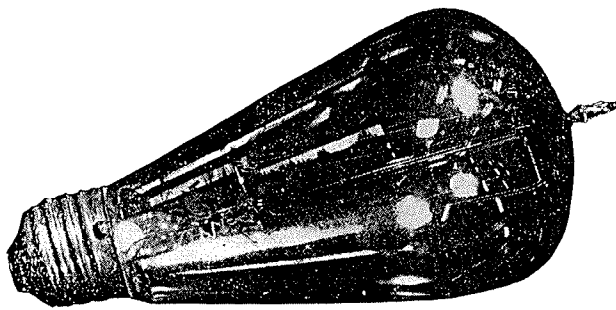
Figure I-2. Old type B bulb, one of the types which produces the interference shown in Figure I-1.
