# Service News

A PUBLICATION OF THE TELESET SERVICE CONTROL DEPARTMENT OF ALLEN B. DU MONT LABORATORIES, INC., EAST PATERSON, N. J.

AUGUST, 1951

## PICTURE ANALYSIS No. 1

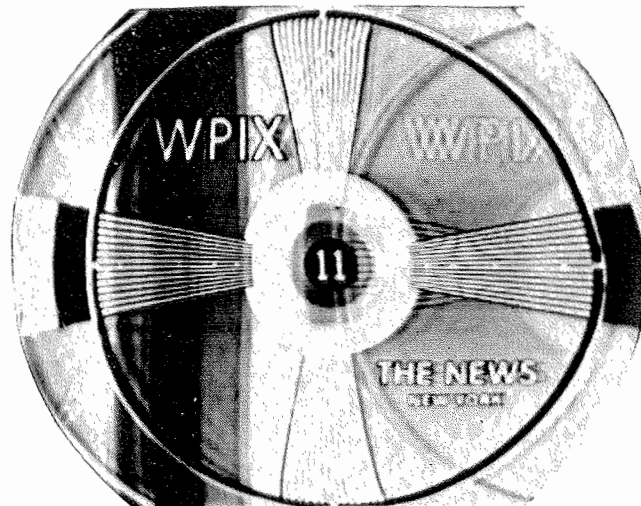
Figure E-1 illustrates a picture defect which the technician will occasionally encounter. The vertical black bar in the picture is caused by a reflected signal or ghost.

Fig. E-1. Test pattern showing vertical black bar caused by long path ghost.

In addition to the vertical bar there is a strong ghost in the picture. This ghost is the result of a reflected signal which is arriving over a much longer path than the direct signal, as evidenced by the fact that it is displaced almost half the width of the picture. This displacement is great enough to cause the blanking and sync pulses of the reflected signal to fall within the visible area of the screen.

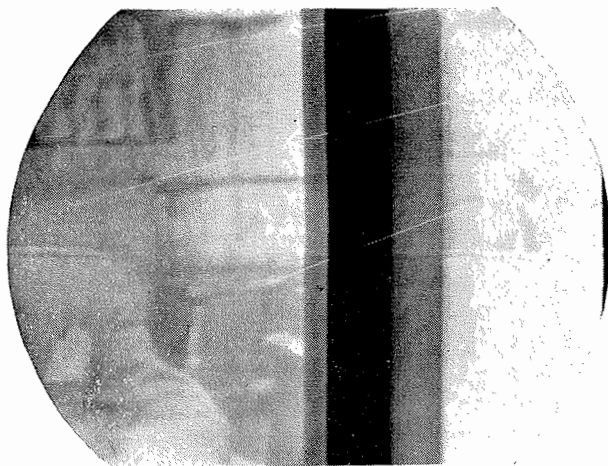
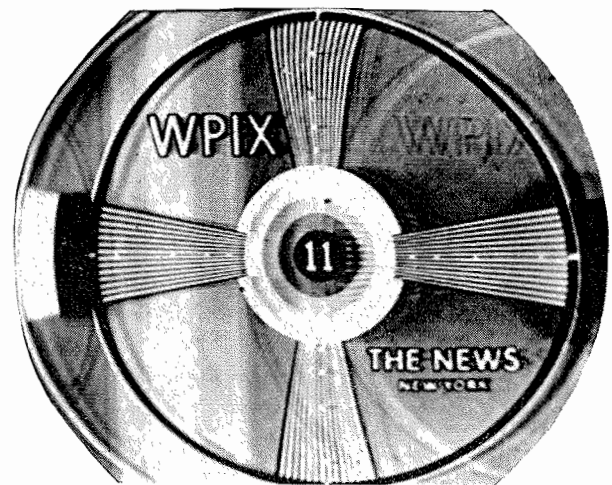
Figure E-4 illustrates the same condition shown in Figure E-1 except that the reflection is reversed in polarity and the black band is instead a white band. In either case the usual procedure for eliminating ghosts should be applied.

▲ Figure E-4. Test pattern with reverse ghost.

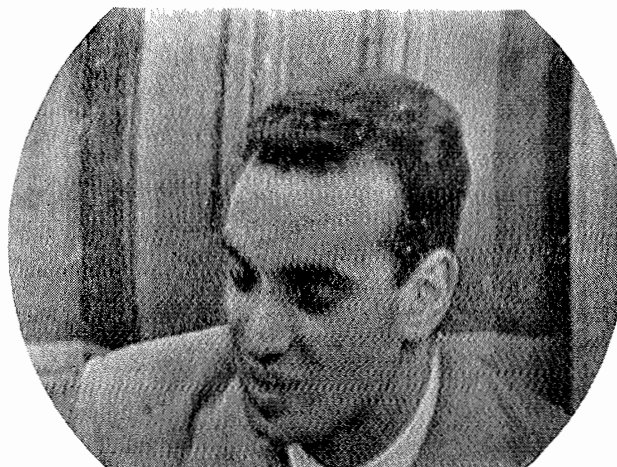
Figure 1 illustrates the effects on the picture of interference from an f-m broadcasting station. This type of interference occurs when an f-m signal beats with the video carrier of the t-v signal to which the Teleset is tuned. The herringbone pattern which appears in the picture varies with the modulation of the f-m station. If the f-m station is tuned in on an f-m receiver, at the same time that the interference in the picture is being observed, a definite relation between changes in the f-m sound and the interference, will be noticed.

Figure 1. Frequency Modulation Interference

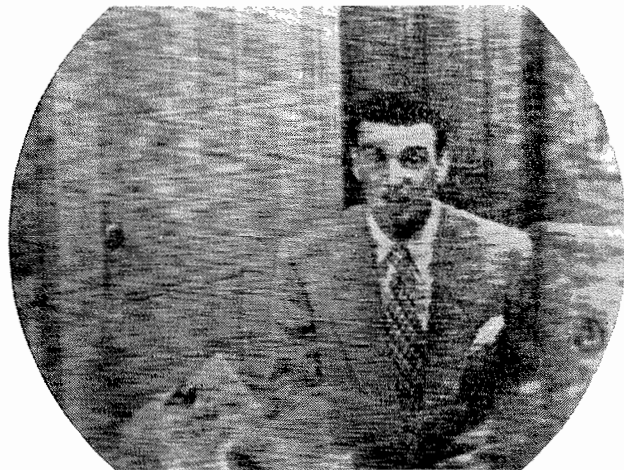
Figure 5. F-M Interference, Frequency of Beat Approximately 50 KC.

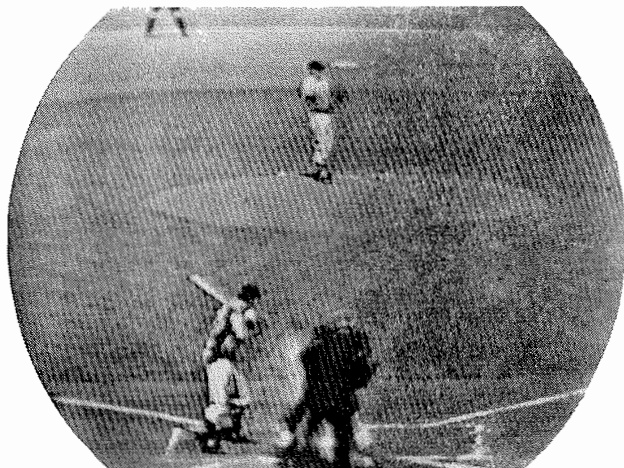
Figure 6.—Interference Produced by Amplitude Modulated or Unmodulated r-f Signal.

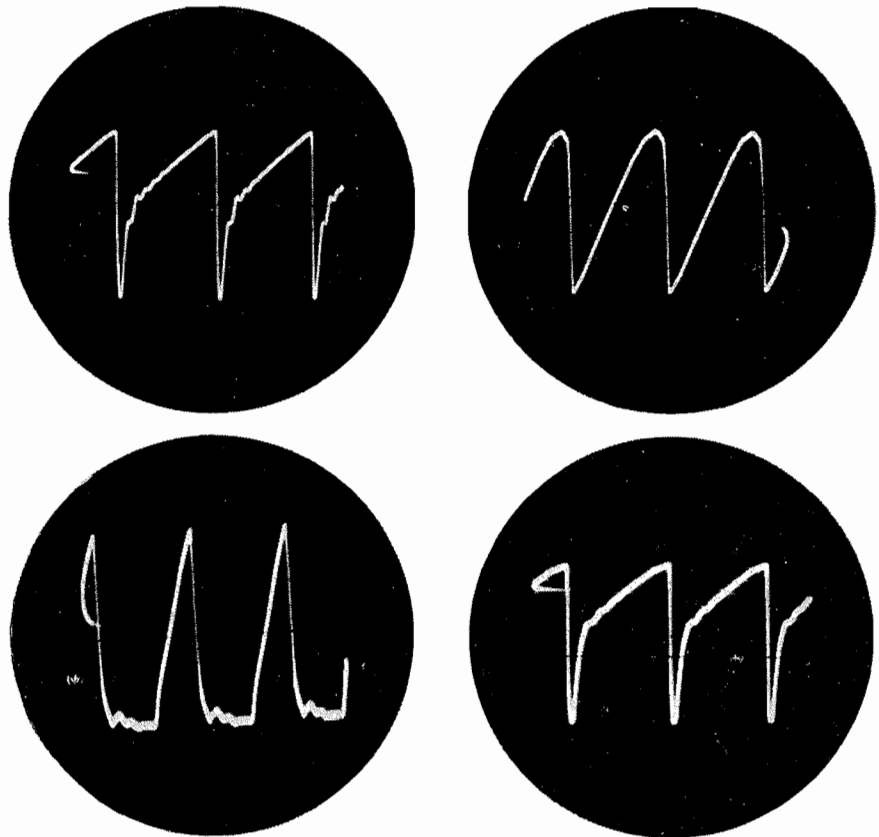
Figure A-9. A, Upper left—Waveform at grid of horizontal sweep amplifier showing effect of an open linearity-coil bypass capacitor. B, Upper right—Waveform at same point showing effect of a shorted drive control potentiometer. C, Lower left—Same waveform showing effect of a change in the time constant of the differentiating network. D, Lower right—Normal waveform at grid of the horizontal sweep amplifier of an RA-109A Teleset.

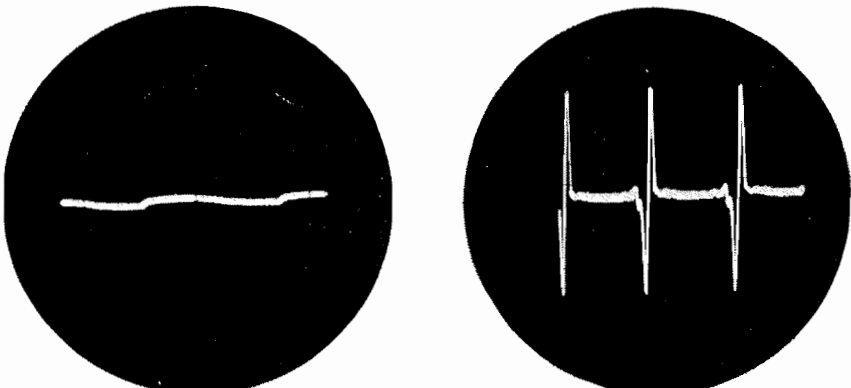
Figure H-8. Left, normal waveform on the -50 volt line. Right, horizontal signal on the -50 volt line indicating a filter failure.

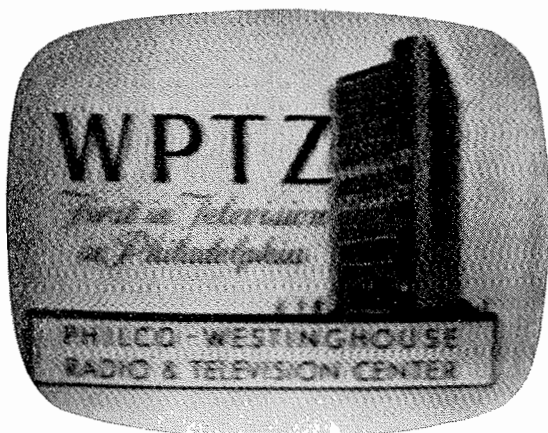
Figure A-2. 1.5 f-m beat interference produced by the adjacent-channel sound carrier.

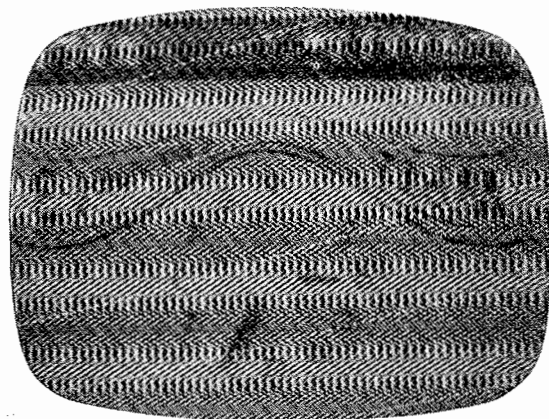
Figure A-3. Interference produced by adjacent-channel sound carrier during constant tone transmission.

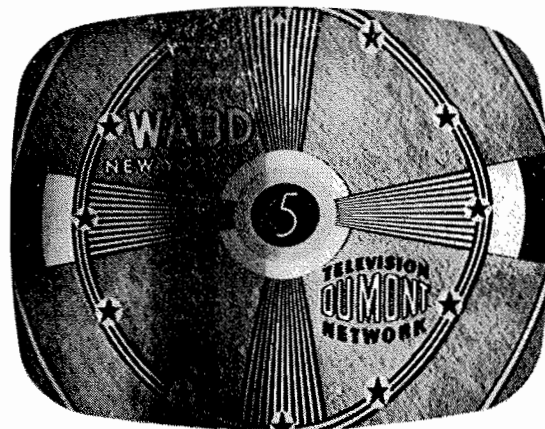
Figure A-6. Interference produced by the adjacent-channel video carrier.

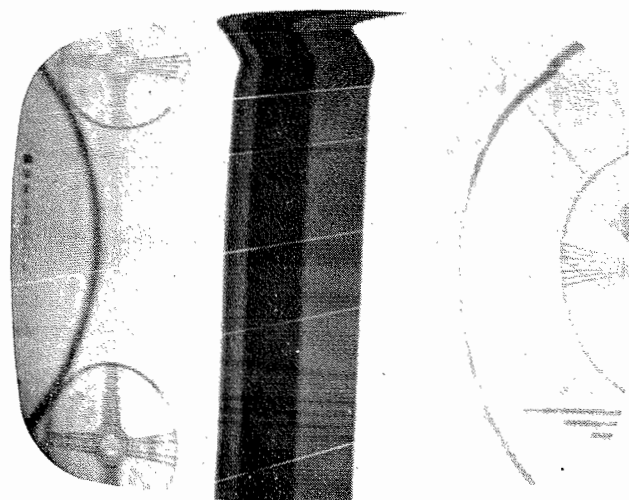
Figure A-8. Picture on CRT when the noise immunity network is not functioning properly.

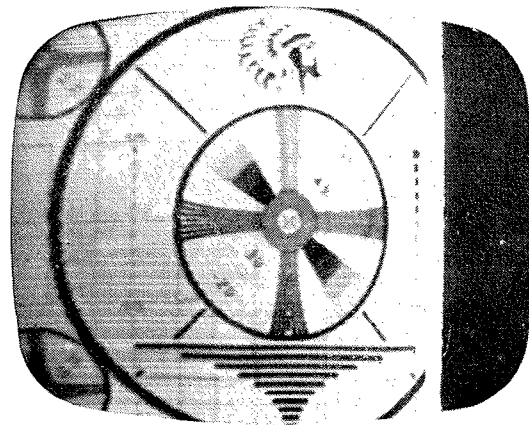
**Figure T-2.** Picture of a CRT showing heavy foldover at the right side of the screen. The steaking lines in the picture indicate that the horizontal sweep amplifier tube is defective and requires replacement.
