DUMONT

SERVICE NOTES

DU MONT TELESETS

ALLEN B. DU MONT LABORATORIES, INC.

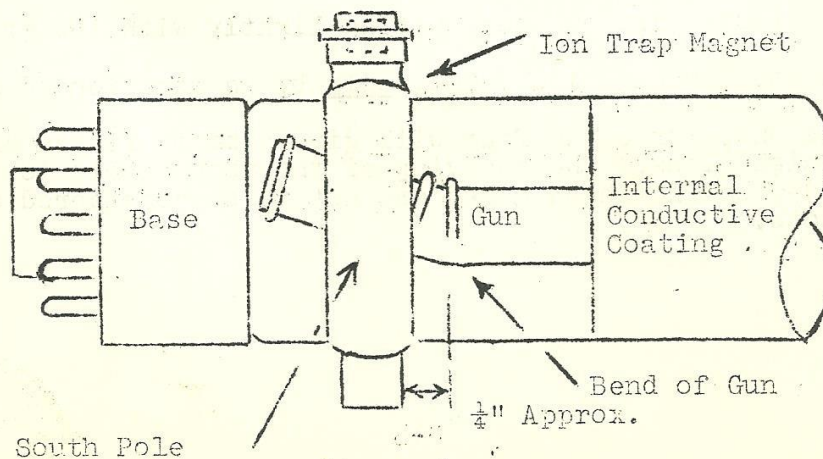
Figure 1

With the base end of the gun pointing up as shown, slide the magnet over the neck. The north pole should be to the left adjacent to pin #12 and the south pole to the right adjacent to pin #6. The magnet should be placed about $\frac{1}{4}$ " in back of the bend in the gun for the first adjustment.

Rotate the ion trap magnet about an eighth of a turn each way and slide it back and forth along the neck stopping at the point of maximum brightness. Keep reducing the brightness as the system is brought into line to avoid damage to the tube. After alignment at low brightness, make a final adjustment with the brightness control set to where the raster just starts to "bloom". At this point the raster begins to expand in size rapidly.

If no raster appears and all other conditions are normal, it is possible that the magnet polarity is reversed. Rotate the magnet through half a turn around the neck. Then make adjustments as before; if there is still no raster, try another magnet before looking for other sources of trouble.
