**SERVICE NOTES**

**DU MONT TELESETS**

**ALLEN B. DU MONT LABORATORIES, INC.**

### INSTALLATION SECTION

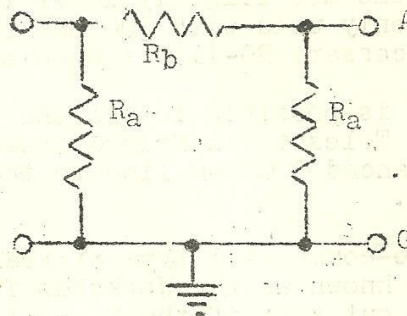
In certain areas where Telesets are installed, the signal level is too high to permit proper control of synchronization. One of the best methods in use to reduce signal strength to usable levels is the "Pi" type resistance attenuator.

For the convenience of servicemen, the following circuit diagram and table of values of a standard attenuator is published.

<u>db Attenuation Desired</u>	<u>R<sub>a</sub> (ohms)</u>	<u>R<sub>b</sub> (ohms)</u>
5	257	43.8
10	139	102.5
15	103	196
20	88	356
25	80.5	637
30	76.7	1140
35	74.6	2020
40	73.4	4600
45	72.8	6400
50	72.5	11380

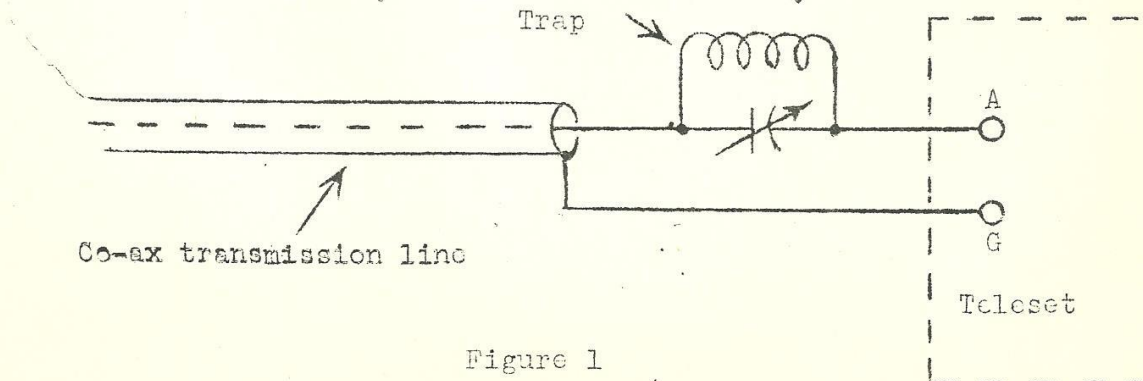
Figure 1

FM interference may also be caused by fundamental overloading of the RF and mixer stages by a strong FM station. This results in generation of harmonics of the FM station frequency. The second harmonic is the most annoying as it usually falls into and causes interference with, one of the higher TV channels.

The basic principle behind the elimination of FM interference of either type is to attenuate the FM signal at its fundamental frequency. This may be accomplished by the use of a trap in the antenna input to the receiver. A simple parallel resonant trap which is available from the Teleset Service Control Department may be inserted in series with the transmission line to accomplish the desired results.

This trap is designed to tune over the FM band (88-108 mc) and, therefore, attenuate the signal. This trap has been used in many locations and has been found to work satisfactorily. The normal method of installation is shown in Figure 1.

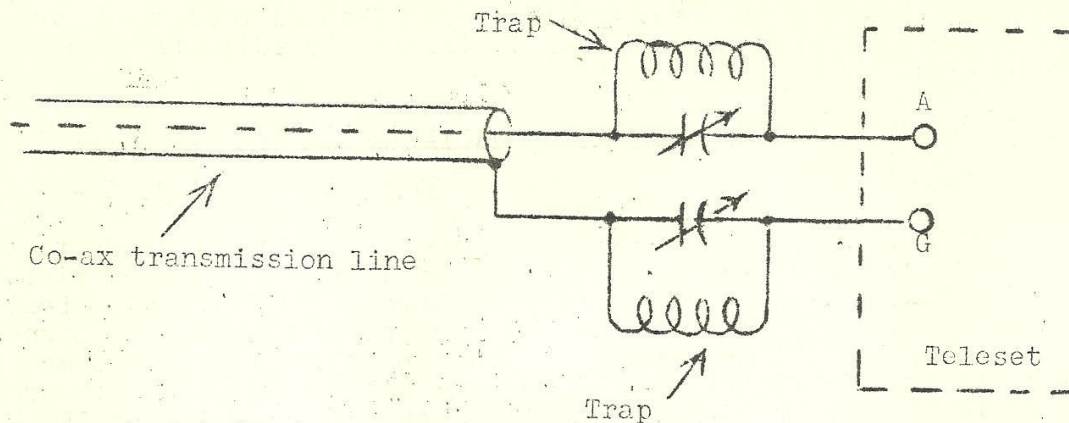
Figure 2

In some very extreme cases of interference, especially where the Teleset is located close to the FM station, it is necessary to insert one trap in the shield of the coax as well as one in the hot side of the line. This is shown in Figure 2.

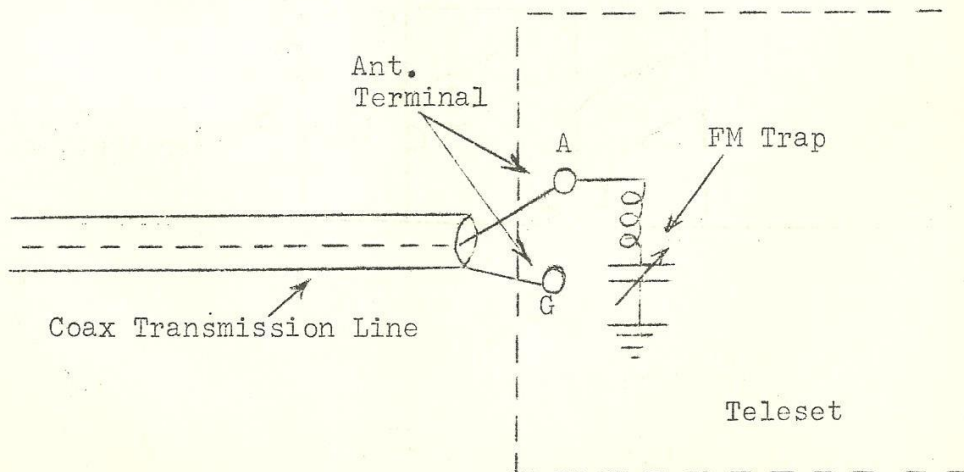
FM Series Trap - Straight Bracket Type

The parallel resonant trap has been found to be very inconvenient to install in the 72 ohm coax type of antenna lead used on Du Mont Telesets. A more convenient and equally effective method for eliminating FM interference in many locations is the insertion of a series resonant trap shunted across the transmission line at the antenna terminal of the receiver. This series trap is designed to tune over the FM band (88-108 mc) and can be easily adjusted for resonance at the frequency of the interfering station.

Used on RA-103C - RA-103D - RA-104A - RA-110A

Because of the convenience in mounting the series trap, the parallel FM trap will no longer be available. For installation instruction, see the following sketches.

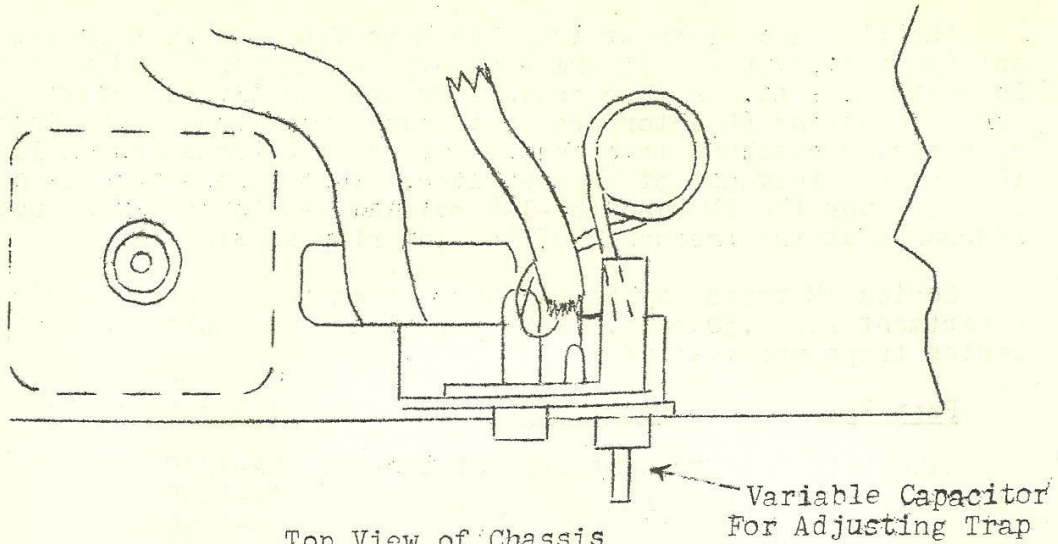
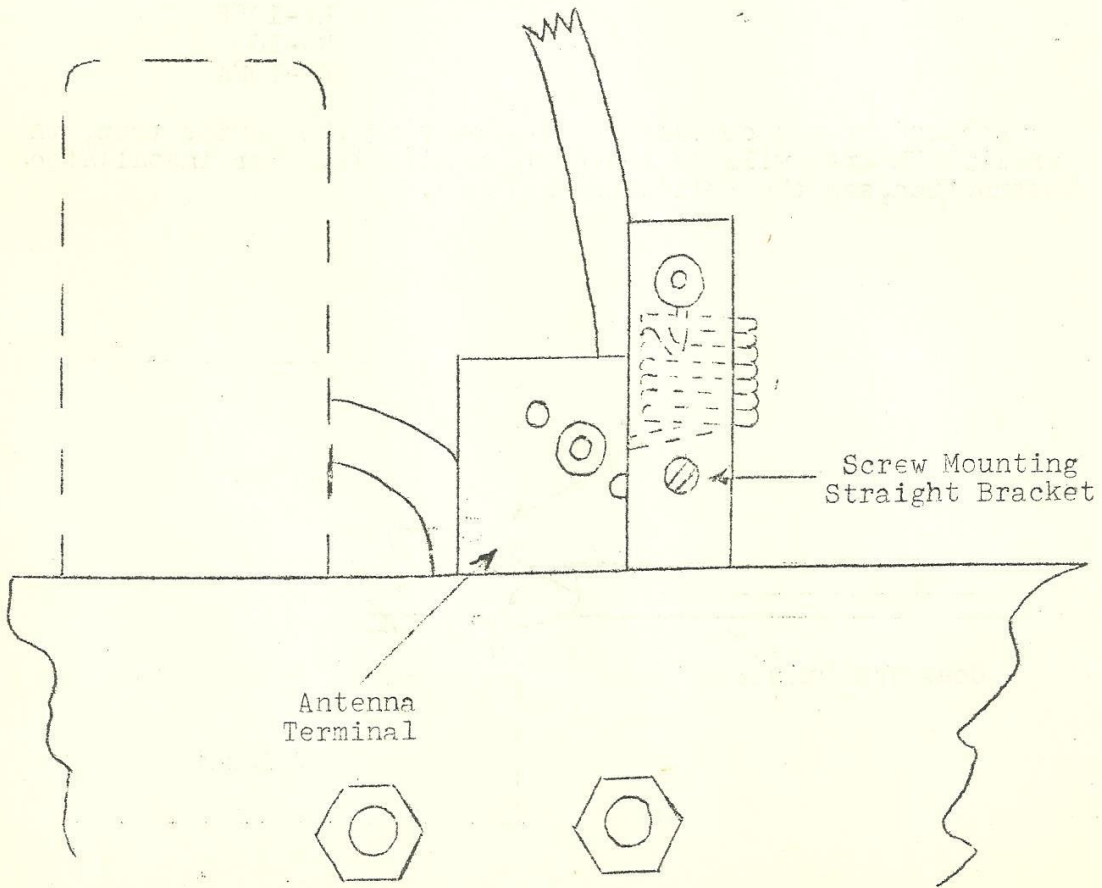
Top View of Chassis

Rear View of Chassis

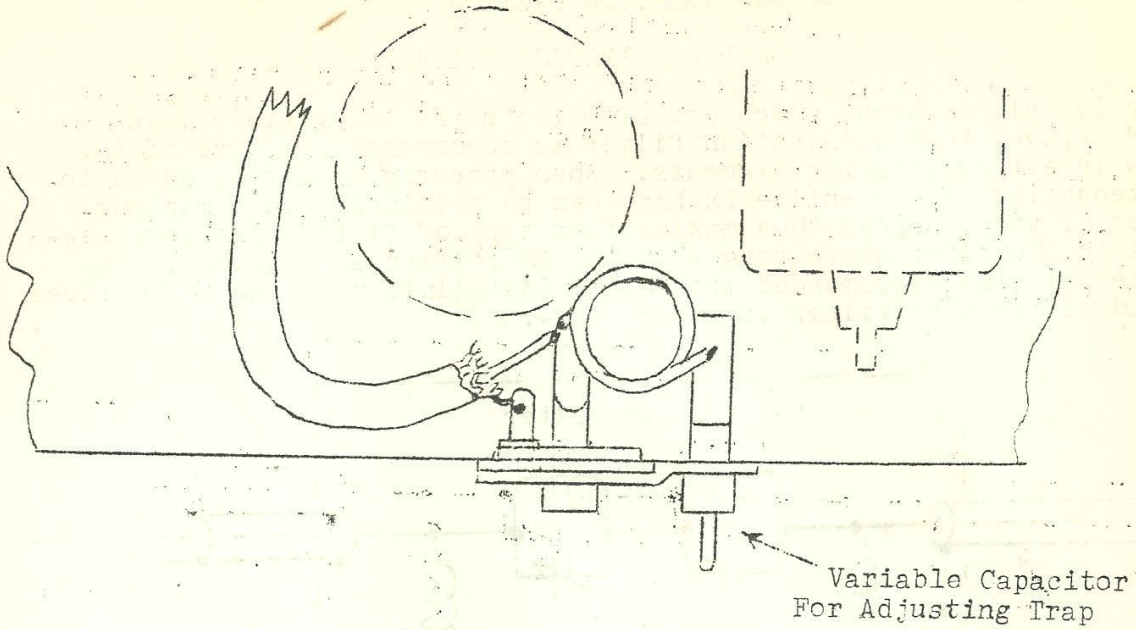
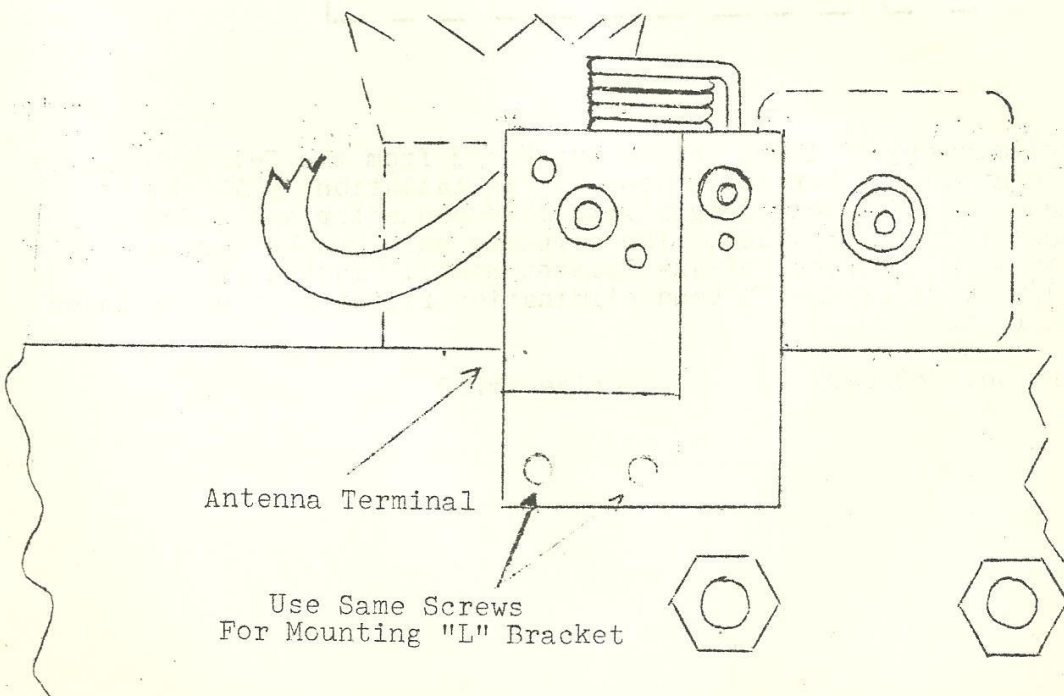
FM Series Trap - "L" Bracket Type  
Used on RA-105A - RA-105B - RA-106 - RA-108A

Top View of Chassis

Rear View of Chassis

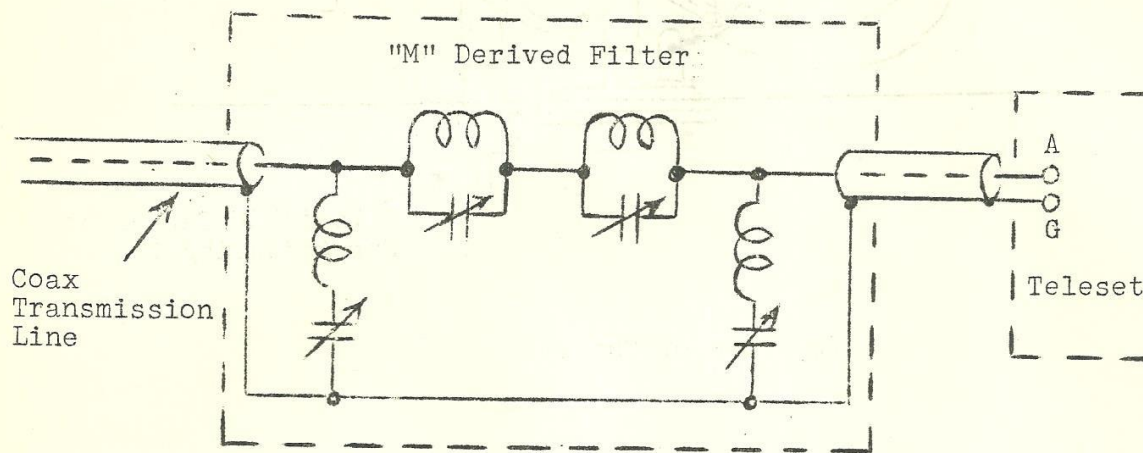
For low signal areas which are affected by FM interference, an "M" derived band elimination filter is recommended because of the low insertion loss requirements. When properly adjusted, adequate attenuation of the entire FM band can be obtained with a minimum loss of video signal thus making this type of filter also very useful in locations where more than one FM station is causing interference. The recommended method for installation of the "M" derived band elimination filter is shown below.

FM band elimination filters may be purchased from the Teleset Service Control Department. For convenience in installation, a 72 ohm coax output lead of sufficient length with male connector and a female input connector are provided. The complete unit can be easily mounted on the back panel of any Teleset model. Instructions for proper adjustment of the FM band elimination filter will be included with each filter.

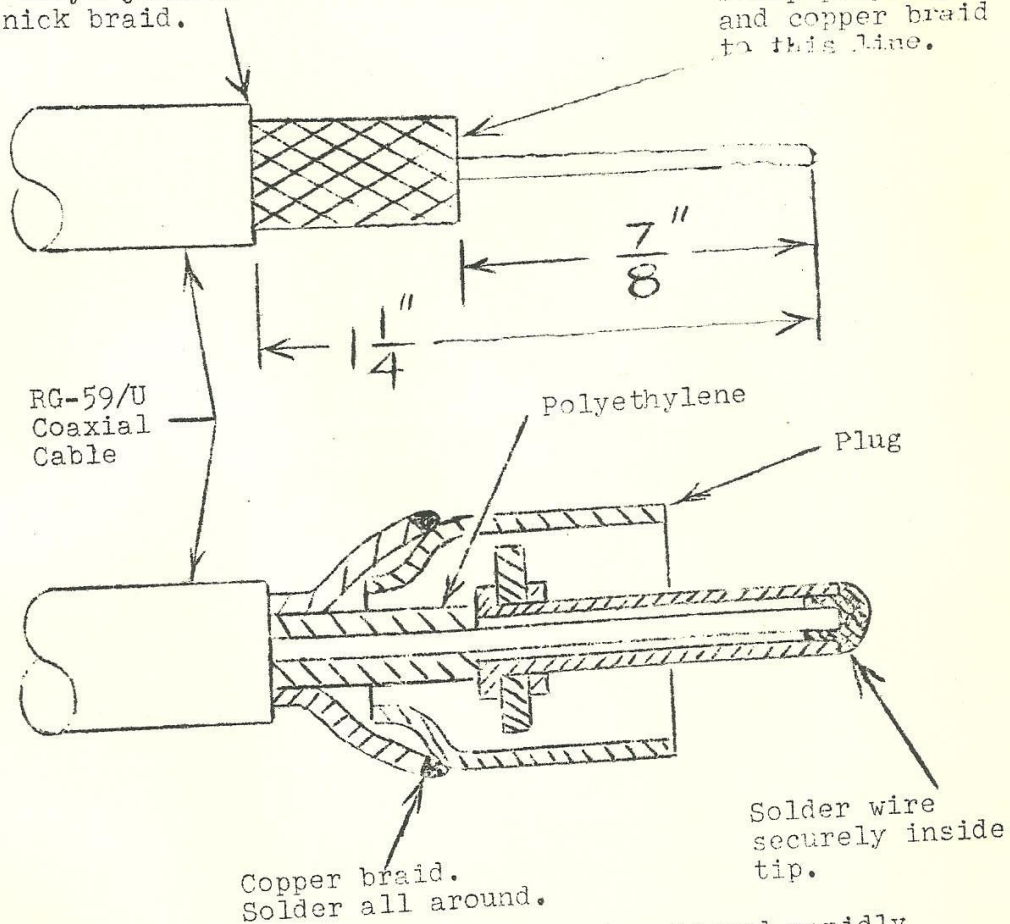
Observations made over a long period of time indicate that many servicemen either do not know how or do not take the time to solder the antenna plug to the coaxial cable lead-in properly. If care is exercised to solder the antenna plug carefully according to the instruction tag included with each Teleset, many call-backs may be eliminated. Extreme care should be taken to avoid application of excessive heat to the polyethylene insulation. This will damage the insulation and increase the possibility of leakage and short circuit from inner conductor to ground.

Remove vinyl jacket.  
Don't nick braid.

Strip polyethylene  
and copper braid  
to this line.

These connections must be soldered rapidly with hot iron to avoid damage to polyethylene insulation. Cable must be in line with body of antenna plug when soldering.
