SERVICE NOTES

DU MONT TELESETS

ALLEN B. DU MONT LABORATORIES, INC.

RA-101

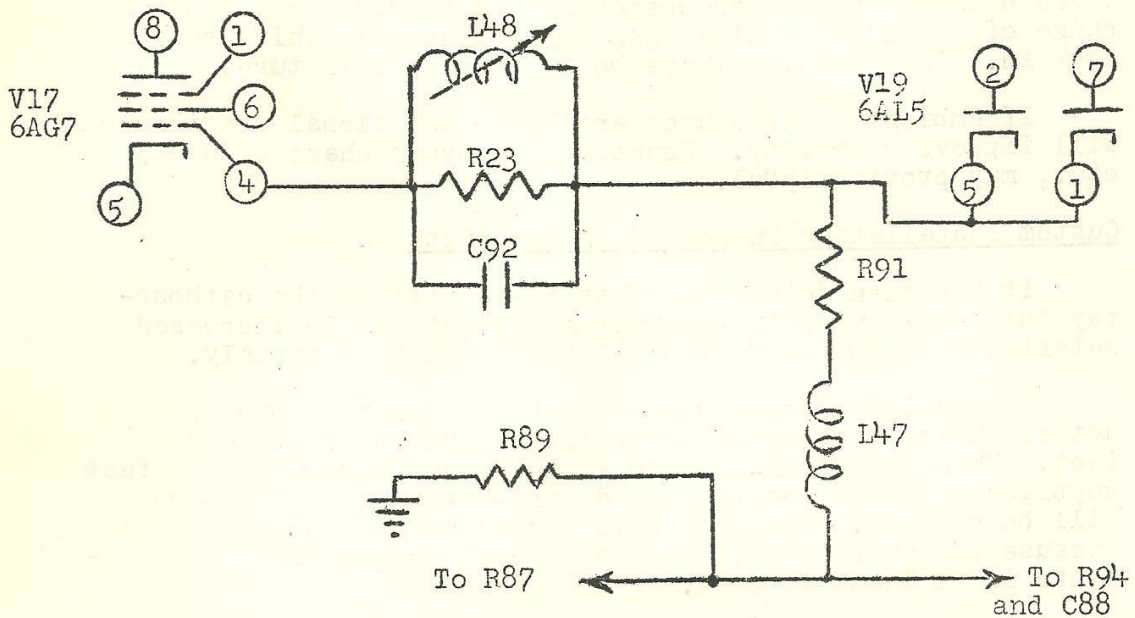
Addition of 4.5Mc (Grain) Trap

Under certain conditions, it is possible that a fine grain type of interference may be present on the RA-101 Telesets.

To reduce this type of interference, it will be necessary to add a special trap tuned to 4.5 Mc and referred to as a "grain" trap.

This 4.5Mc is the "beat" frequency that exists between the video carrier and sound carrier.

The instructions for adding this trap follow:

<u>Change</u>	<u>Symbol</u>	<u>Du Mont Part No.</u>	<u>Description</u>
Added	C92	3-1395 or 3-1419	Capacitor, fixed: Ceramic 47 mmfd; $\pm 5\%$; 350V
Added	L47	21A-4903-1	Coil, video peaking, μh ; $\pm 5\%$
Added	L48	21A-13098-101	Coil, assembly 4.5 mc trap
Added	R23	RC21BF103K	Resistor; fixed; composition; 10,000 ohms; $\pm 10\%$; 1/2W.
