SERVICE NOTES

DU MONT TELESETS

RA-103D-104A-110A

RA-103D, RA-104A, RA-110A SECTION

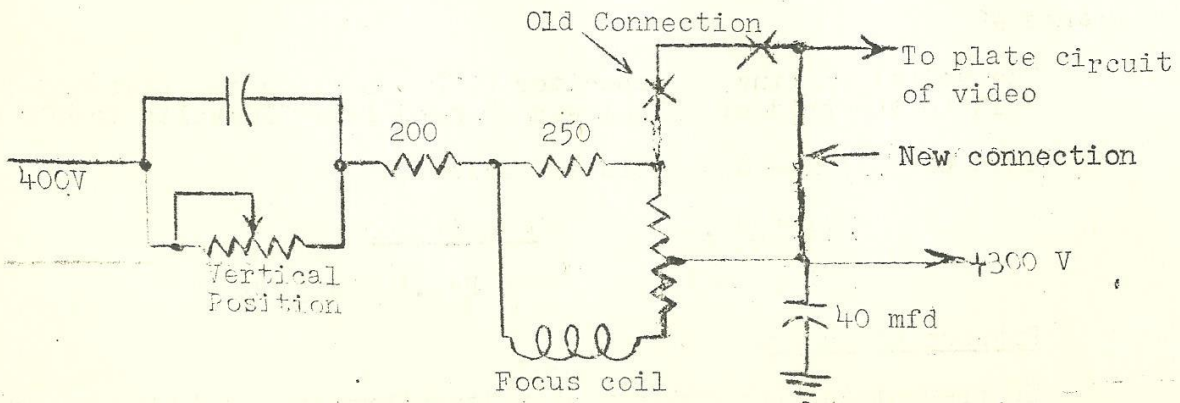
Figure 1

1. In the early models, the plate circuit of V205, the video amplifier, was connected to the junction of R286B and the focus control. With this wiring arrangement, the only time the B+ line going to the video amplifier was completely by-passed by C264B, was when the focus control was at its extreme clockwise position.

In order that this line be adequately by-passed at all times, the B+ line to the video amplifier is now connected to the arm of the focus control. This change is shown in Fig. 1.

This change reduces the B+ voltage of the video amplifier about 25 to 30 volts but does not noticeably affect the operation of this stage.

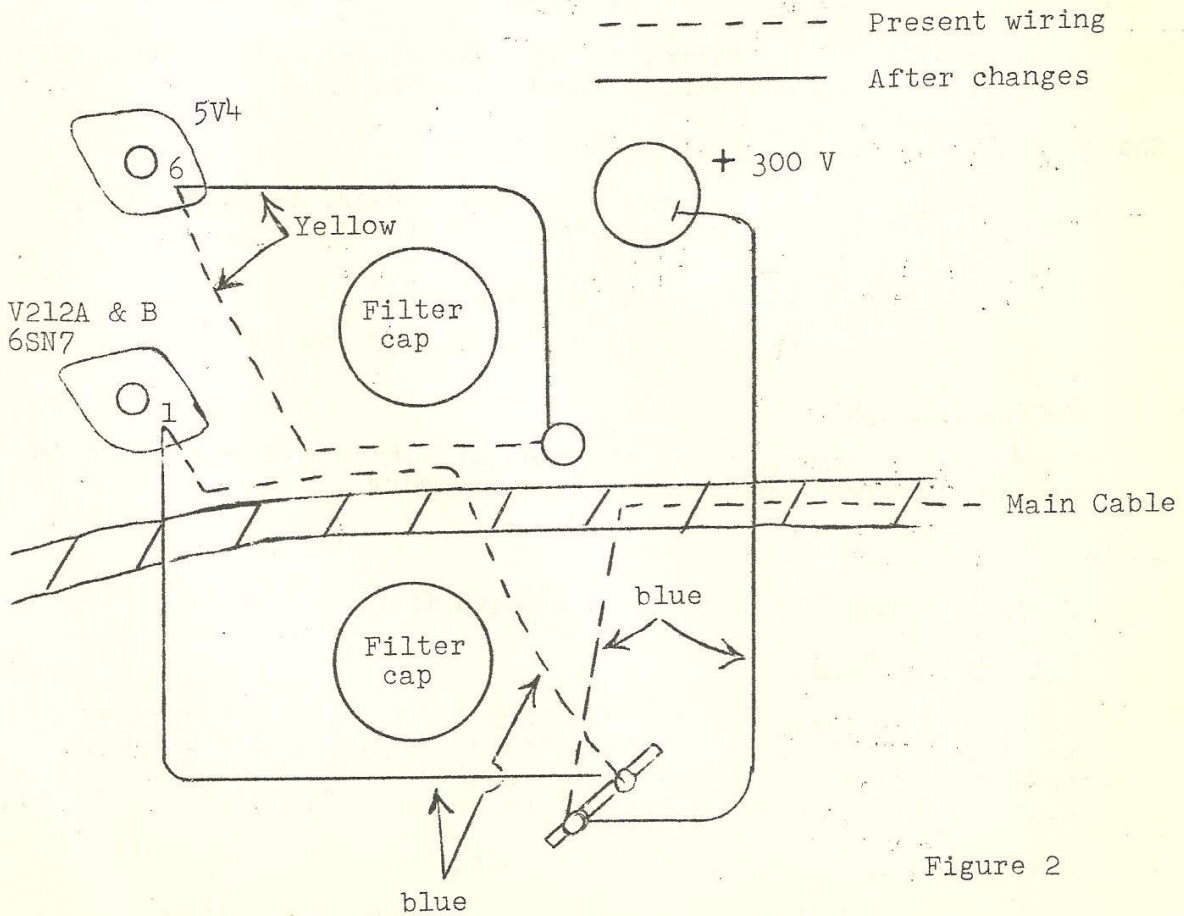
Figure 2

(a) The lead from the coupling capacitor (C306) to the grid of the sync clipper (V212A) should not be run under the main cable between the two large filter capacitors. Rather, it should go straight from the terminal board toward the rear of the chassis, and then after a 90° turn, it goes to the grid of V212A so that it passes under the main cable at right angles.

(b) The lead from the high side of the yoke now goes to pin 6 of the 5V4 by running parallel with the main cable through the space between the two large filter capacitors and then to the 5V4. This lead (colored yellow) should go toward the linearity coil after emerging from the grommet and then after a 90° turn to pin 6 of the 5V4.

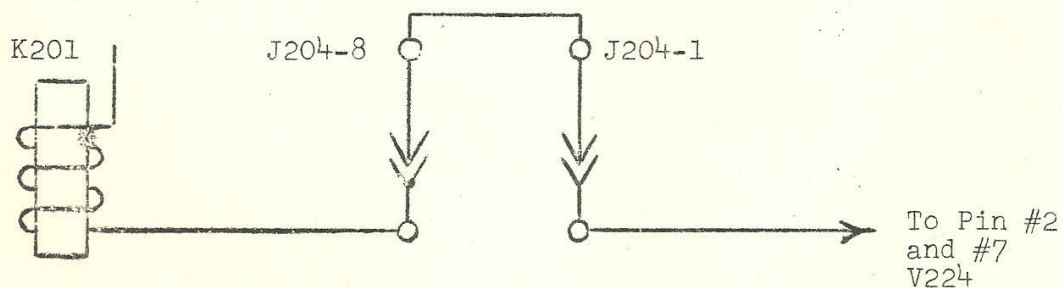
Add ground connection at junction of C300 and C296. "Break" connection from V224, pin #2 to K201 and insert the following:

Delete connection from junction of C300, C296 to J204-8 and the above circuit of J204-8 and J204-1.

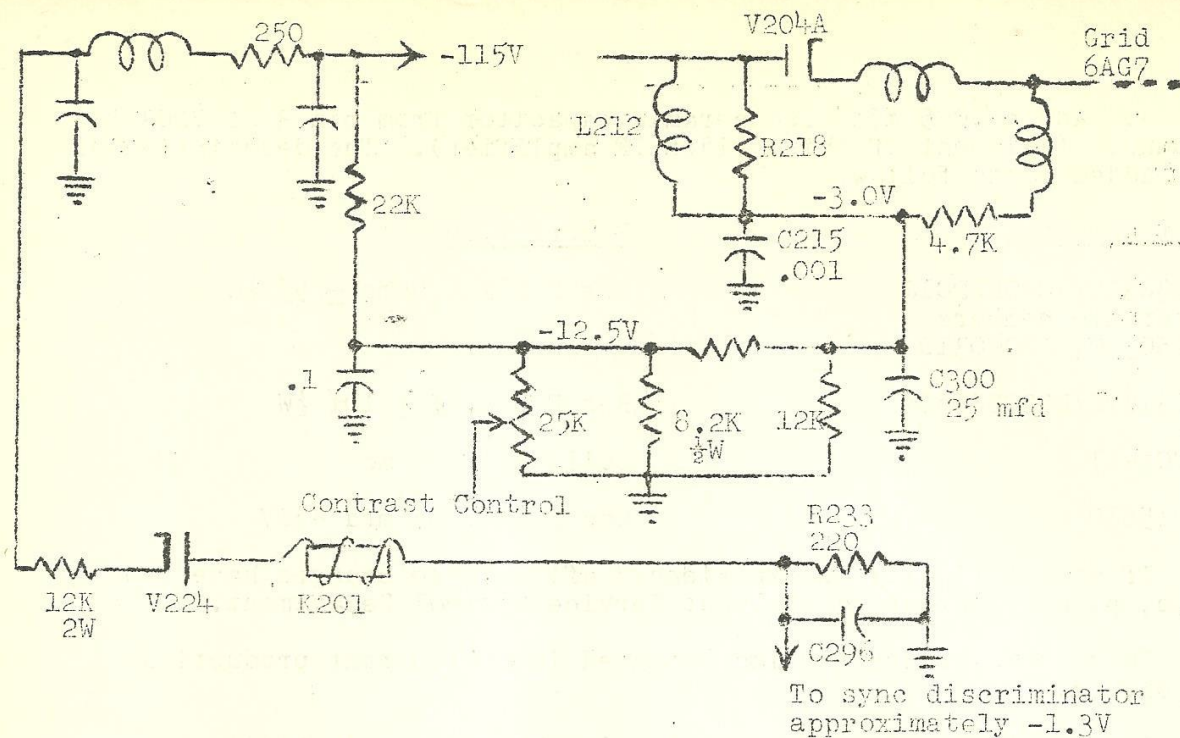
Figure 1

Present Bias Circuit

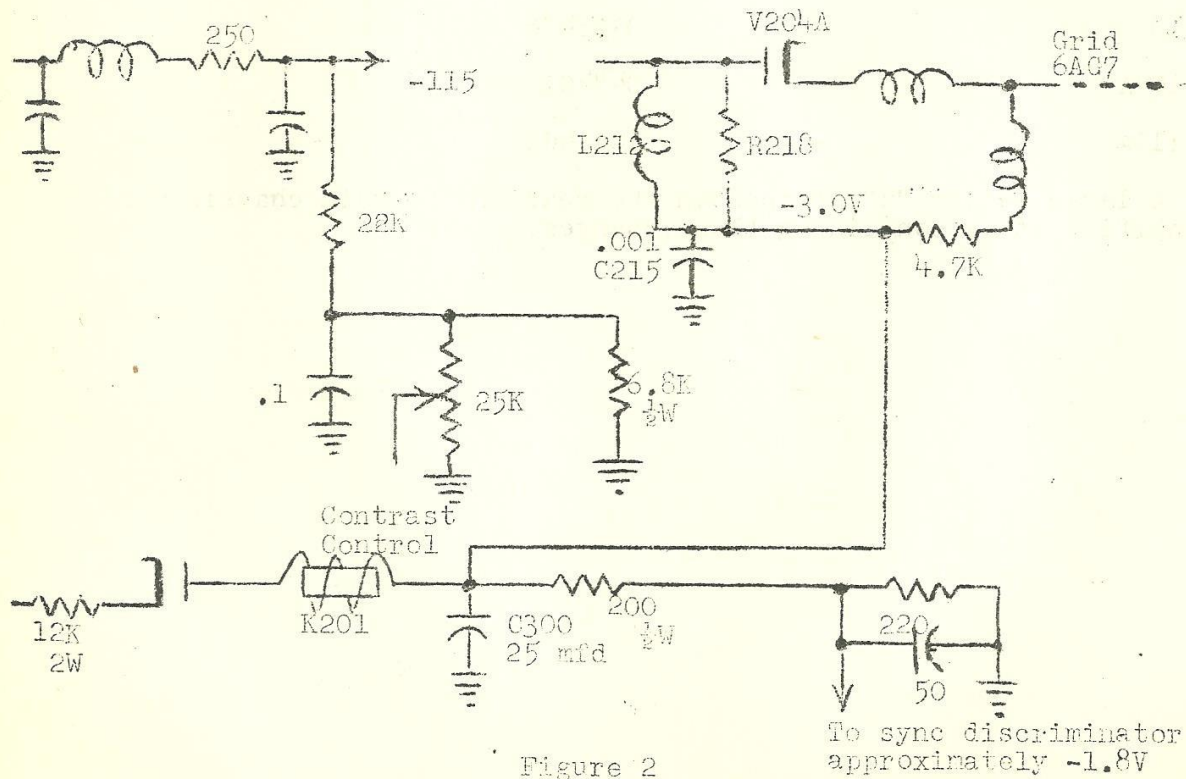
Figure 2

Proposed Bias Circuit

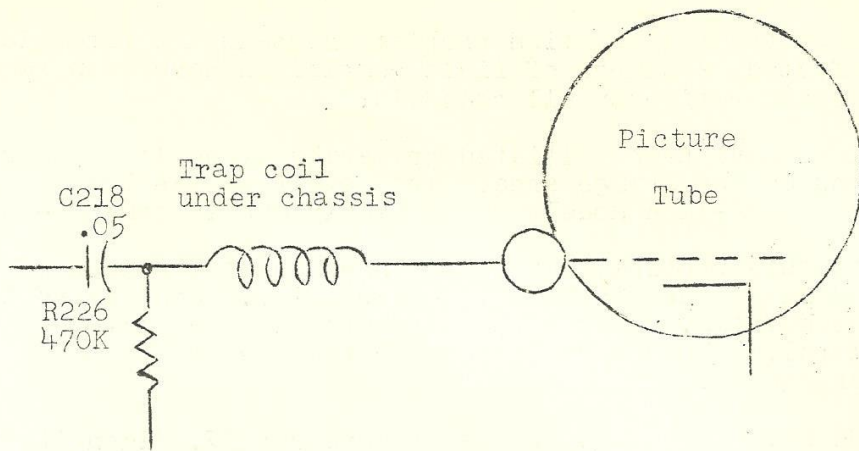
Figure 3
Location of Trap

This condition is caused to a major extent, by feedback of the third harmonic of the video IF, from the CRT grid lead back to the antenna and RF section of the tuner. Since the lead to the CRT grid is longer in the RA-104A and RA-110A models, it is obvious why regeneration has been greater in these sets.

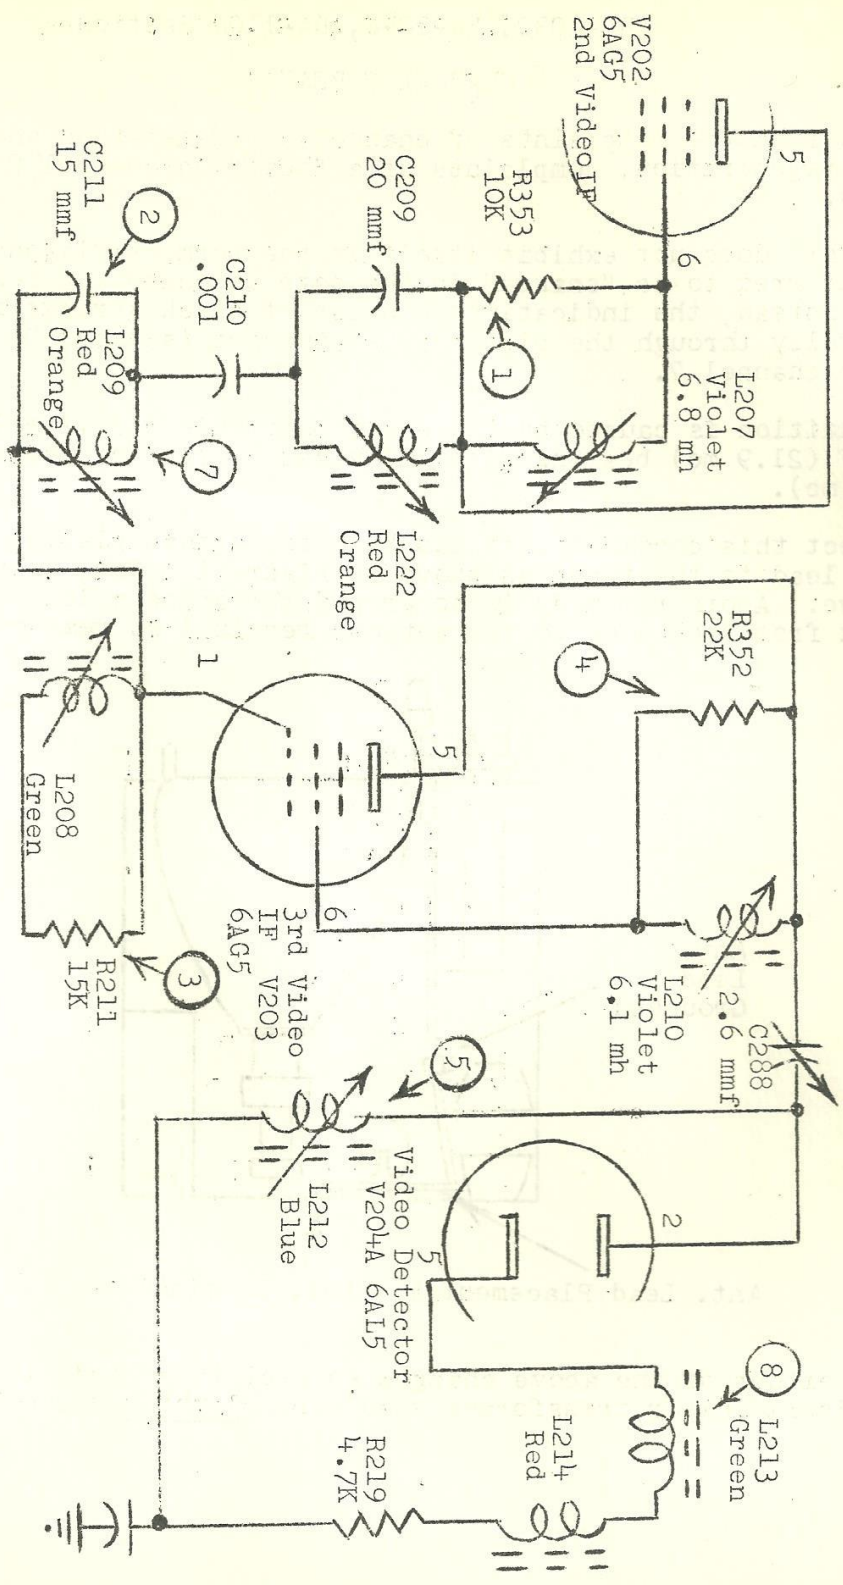
Figure 1. Simplified schematic showing changes necessary to reduce regeneration on all channels and improve picture quality. The only items affected are indicated by an encircled numeral. See page 13d for detailed instructions. There are no wiring changes, only additions and deletions of certain components and changes in value of certain other components.

In addition to reducing regeneration, these changes will also improve picture quality.

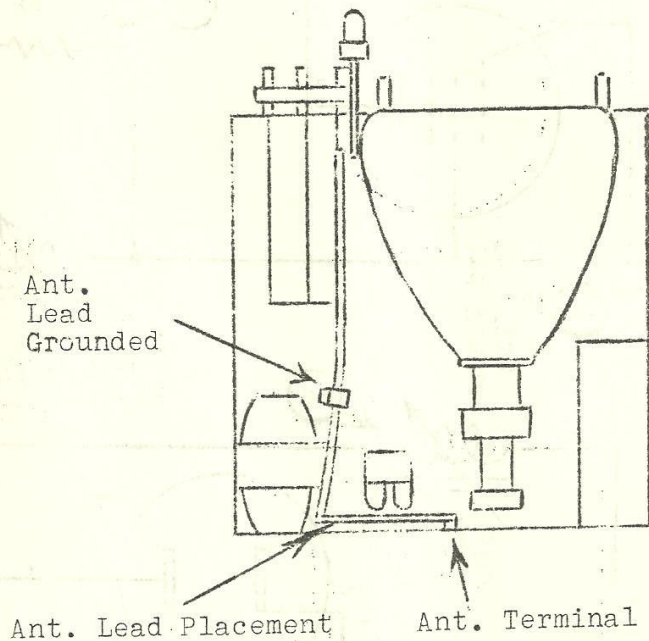
This condition is caused by the eighth harmonic (175.2 mc) of the sound IF (21.9 mc) beating with the video carrier of channel 7 (175.25 mc).

To correct this condition, it has been found that placing the antenna lead to the tuner as shown on Figure 1 below, is very effective. Another remedy is to ground the antenna lead one-half way back from the tuner to the antenna terminal on rear of chassis.

Should neither of the above changes correct this condition, the sound discriminator transformer should be slightly detuned.
