SERVICE NOTES

DU MONT TELESETS

RA-105A-106A

RA-105 -- RA-106 SECTION

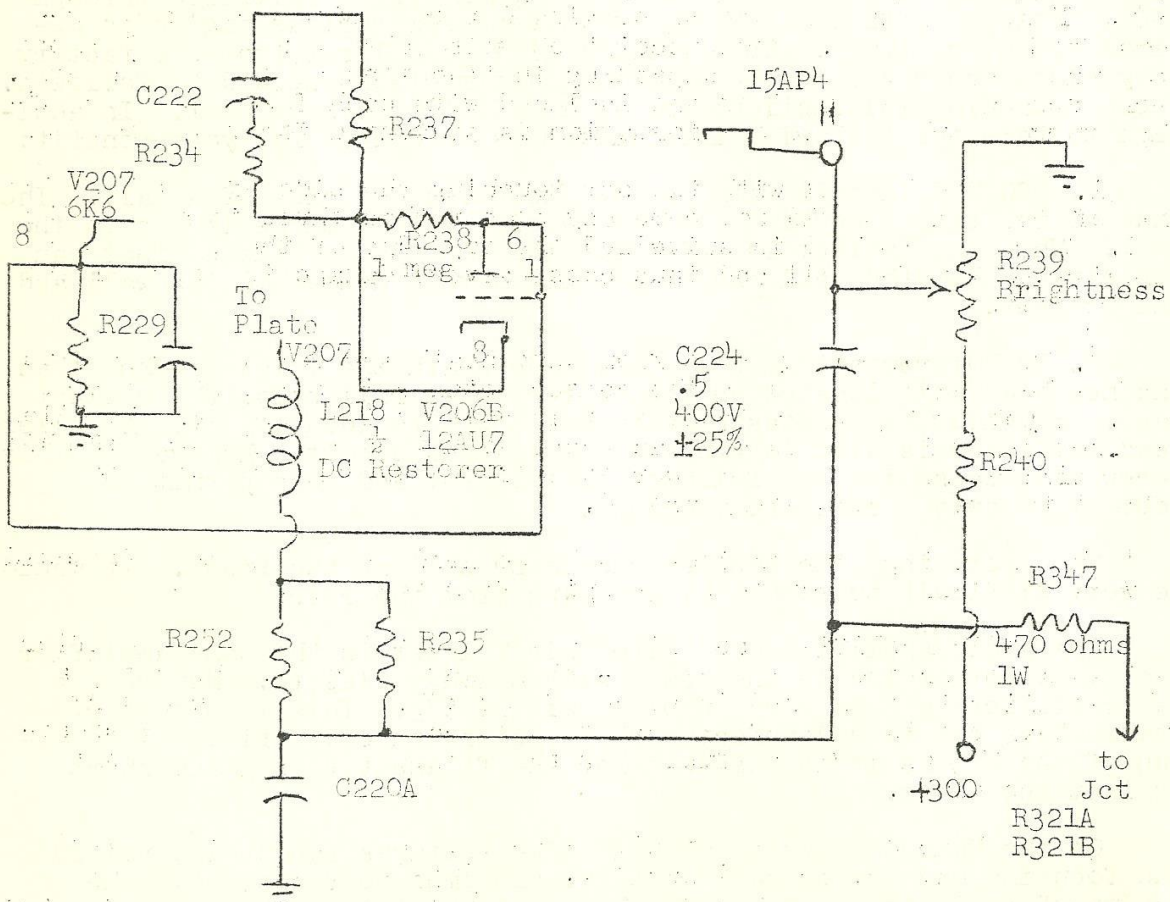
The schematic shown below illustrates changes made in the RA-105, RA-106 main chassis to reduce flicker. The flicker referred to results from periodic line voltage fluctuations such as are produced by reciprocating pumps and like devices. This change is sometimes referred to as an "anti-flicker circuit".

1. Pins #6 and #7 on V206-B the DC restorer tube are removed from ground.
2. Pins #6 and #7 on V206-B are connected together and a lead is run from pin #6 of V206-B to pin #8 of V207, thus returning the DC restorer to the cathode of the third video amplifier instead of ground.
3. Capacitor C224 is changed from .1 200V \pm 25% to .5 400V \pm 25%. The part number of the new capacitor is 03014260.
4. Capacitor C224 is connected between pin #11 of the CRT and the junction of R235 and C220A.
5. Resistor R347 470 ohms 1 W 10% (part #02034730 alternate part #02044730) is connected in series between R232 and R321.

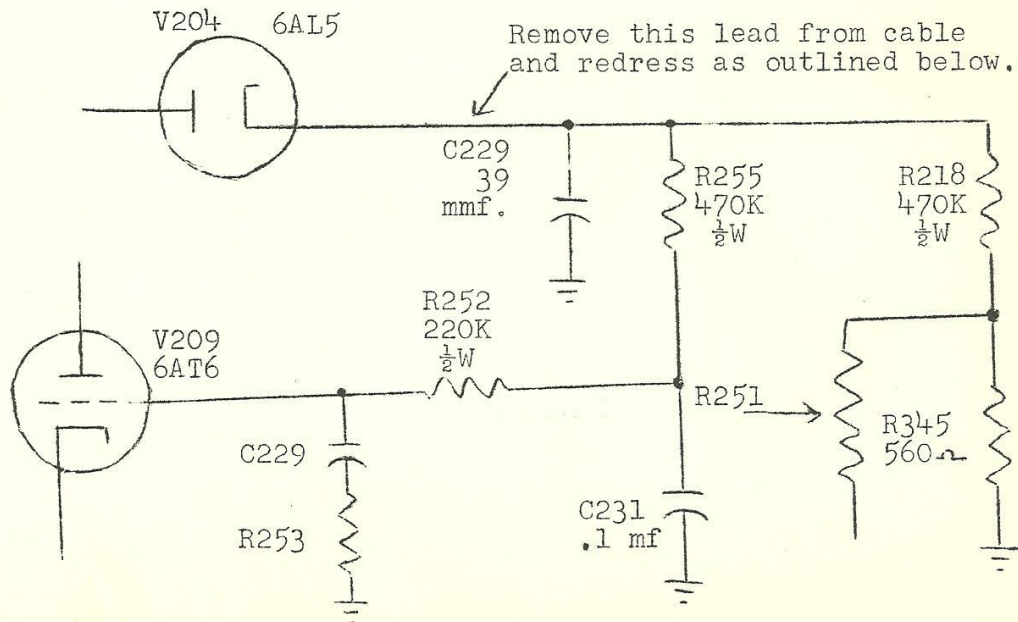
Very humid weather normally encountered in the summer months has been the cause of considerable difficulty with the AGC circuit as used in the early RA-105 Telesets. The condition that is normally encountered was a fading of both picture and sound. When the serviceman checks the set he usually finds that all components are normal and is at a loss to determine the reason for the faulty operation of the receiver. Where this trouble is encountered it is recommended that the following changes in the AGC circuit be made. These changes have been included in production on all of the sets made after March, 1949. The purpose of these changes is to reduce the impedance of the grid circuit of the 6AT6 AGC stage and thus improve the stability of this circuit. The list of changes follow:

R218 was changed from a 1.2 meg. resistor to 470K, $\frac{1}{2}$ W, part number 02032090. It was disconnected from the junction of R252, R255 and C296 and connected to the junction of R345 and R251.

R252 has been changed from a 1.2 meg. resistor to 220K, $\frac{1}{2}$ W, part number 02032050.

R255 and C231 are no longer used.

R345 is changed from a 390 ohm resistor to a 560 ohm $\frac{1}{2}$ watt resistor, part number 02031740.

A 470K, $\frac{1}{2}$ watt resistor, part number 02032090 between pin #5 of V204 and the junction of R252 and C231 was added.

A 39 mmfd. 500 volt ceramic capacitor, part number 03017030 from pin #5 of V204 to ground was added.

C231 was changed from a .005 mfd. capacitor to a .1 mfd. 200 volt capacitor, part number 03013910.

In addition to the above changes the blue lead that runs through the cable from pin #5 of the 6AL5 (V204) to V209 (AGC circuit) should be removed from the cable. This lead should be run as short as possible. A simple method of dressing this is to go through a hole in the RF shield (this shield is the one on which the traps are mounted) to the 6AT6 circuit.

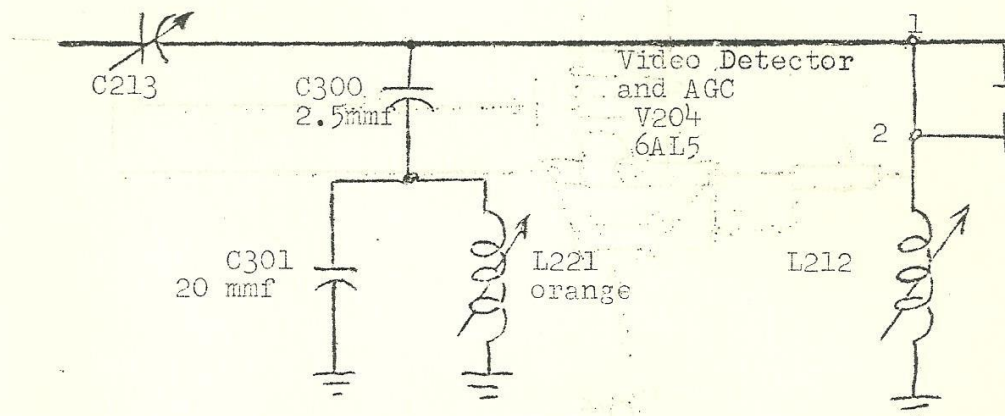
Figure 1

In certain areas where television signals are received on two adjacent channels (such as half way between two cities having television stations) adjacent channel video interference has been observed on RA-105 and RA-106 Telesets. When tuned to the lower frequency channel of two such adjacent channels, interference is usually seen as horizontal sync running back and forth through the desired signal.

This may be corrected in the field by the addition of a series-parallel resonant trap in the third video IF amplifier as illustrated in Fig. 1. (Note: the latest RA-105 and RA-106 Telesets include this trap).

This trap will be tuned to 20.4 mc. This 20.4 mc is obtained when the local oscillator beats with the video carrier of the channel above the desired channel. Consider a location where both channel #5 and channel #6 can be received. With the Teleset tuned to channel #5, 76-82 mc, the local oscillator is tuned to 77.25 mc (video carrier of channel #5) plus 26.4 mc or 103.65 mc. The local oscillator signal also beats with the video carrier of channel #6 (83.25 mc) and produces a frequency equal to the difference between 103.65 mc and 83.25 mc which is 20.4 mc.

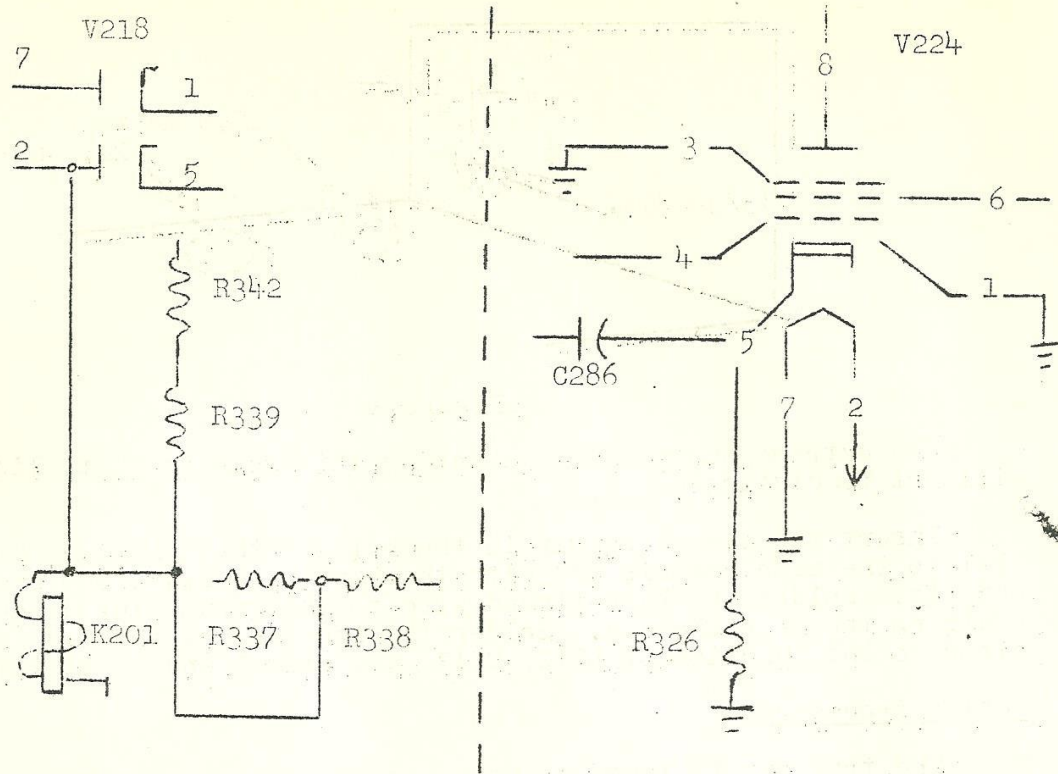
The following changes were made to eliminate the horizontal displacement or "hook" in the top of the picture.

1. R327, 150 ohms connected from R326 to ground is deleted and R326 is connected to ground.
2. C289, the 25 mfd 25V capacitor connected from the junction of V224 and R326 to ground is deleted.
3. The connection from pin 2 of V218 to ground is removed.
4. Pin 2 of V218 is connected to the junction of K201, R339, R338, and R337.
5. Pin 3 of V224 is connected to pin 1 of V224.
6. R299 is disconnected from pin 2 of V218 and reconnected to pin 1 of V219, which is at ground potential.

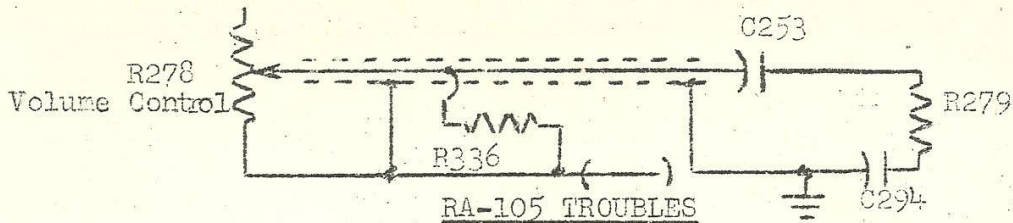
(The error is in the volume control circuit, where R336 is shown shorted out and the "hot" wire of the shielded lead is shown grounded. The sketch shows the correct connections).

The schematic of the Main Chassis (dated Nov. 15, 1948) should be corrected as shown in the following sketch:
