ALLEN B. DU MONT LABORATORIES, INC.

TELESET SERVICE BULLETIN

October 14, 1949

RE-ORGANIZATION OF SERVICE NOTES

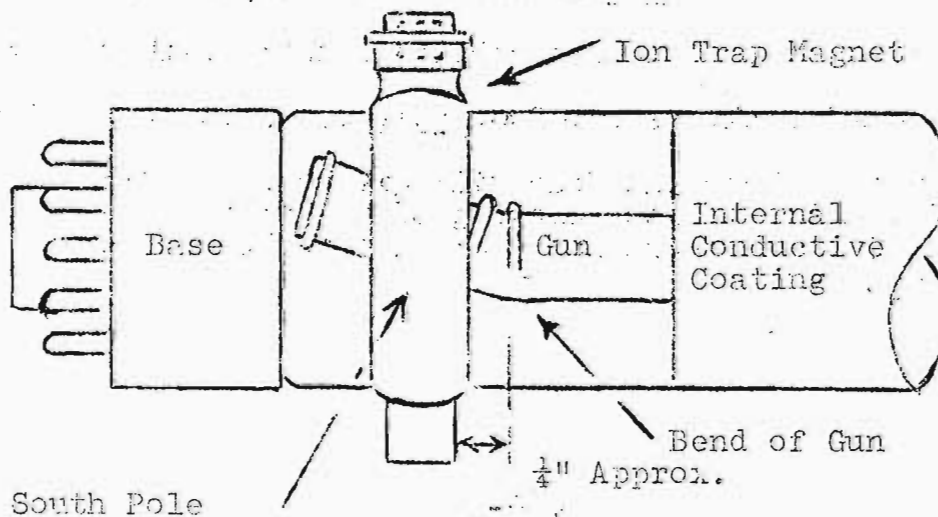
Figure 1

Make all initial ion trap adjustments at the lowest setting of the brightness control possible. The correct position for the ion trap magnet is shown in figure 1.

With the base end of the gun pointing up as shown, slide the magnet over the neck. The north pole should be to the left adjacent to pin #12 and the south pole to the right adjacent to pin #6. The magnet should be placed about $\frac{1}{4}$ " in back of the bend in the gun for the first adjustment.

Rotate the ion trap magnet about an eighth of a turn each way and slide it back and forth along the neck stopping at the point of maximum brightness. Keep reducing the brightness as the system is brought into line to avoid damage to the tube. After alignment at low brightness, make a final adjustment with the brightness control set to where the raster just starts to "bloom". At this point the raster begins to expand in size rapidly.

If no raster appears and all other conditions are normal, it is possible that the magnet polarity is reversed. Rotate the magnet through half a turn around the neck. Then make adjustments as before; if there is still no raster, try another magnet before looking for other sources of trouble.

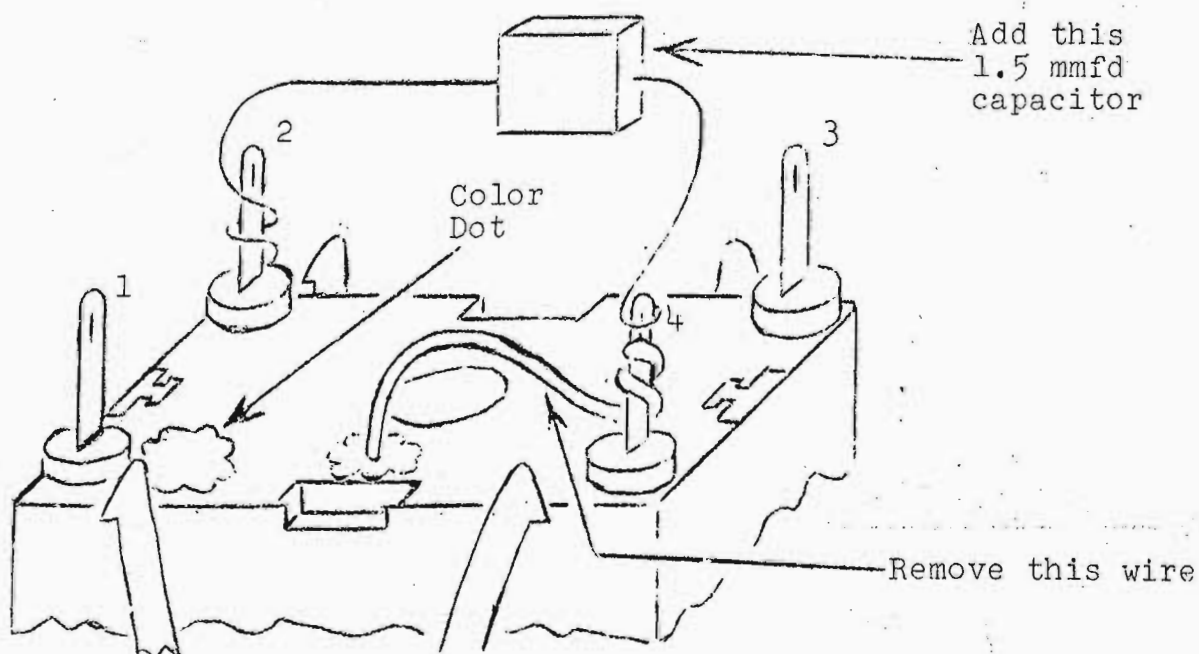
DEFECTIVE VIDEO IF TRANSFORMERS

Some complaints of breakdown of the ceramic coupling condenser in the video IF transformers have been received. The condition encountered was an arc-over between the end of the silvered ceramic tube and the bare wire that fits in it. These transformers are used in the RA-109A, RA-111A, RA-112A and RA-113 Telesets. The condition was corrected by the use of a synthetic coated wire. It is not necessary to replace the entire transformer to correct this defect. Instead, the bare wire should be removed from the ceramic tube and a 1.5 mmfd 400 volt type GA-3 Stackpole capacitor, or equivalent, should be connected between terminals 2 and 4 (grid to plate) of the transformer. After making this change, a slight amount of rephasing of the grid and plate coils of the respective transformers will usually be necessary.

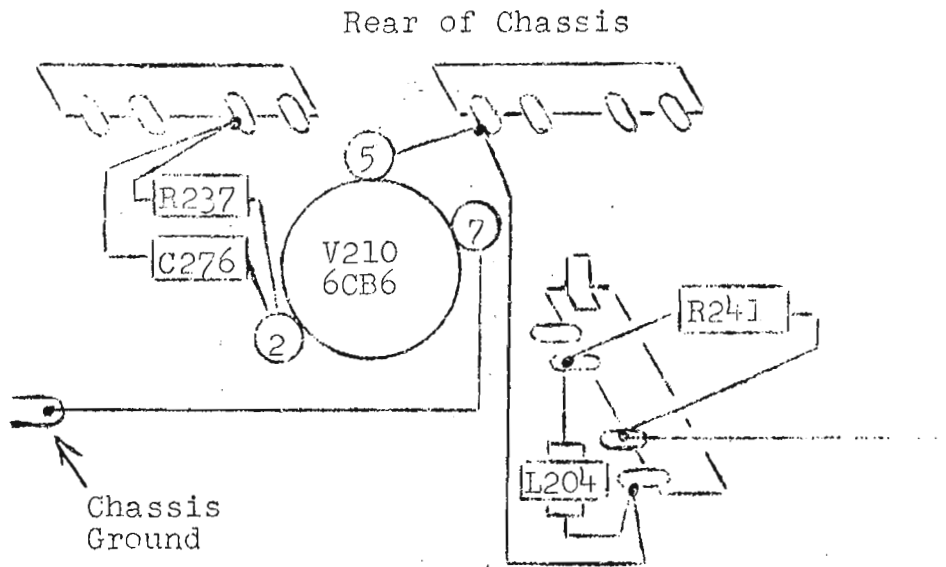
This wire is removed from 305 volts and reconnected to 200 volts.

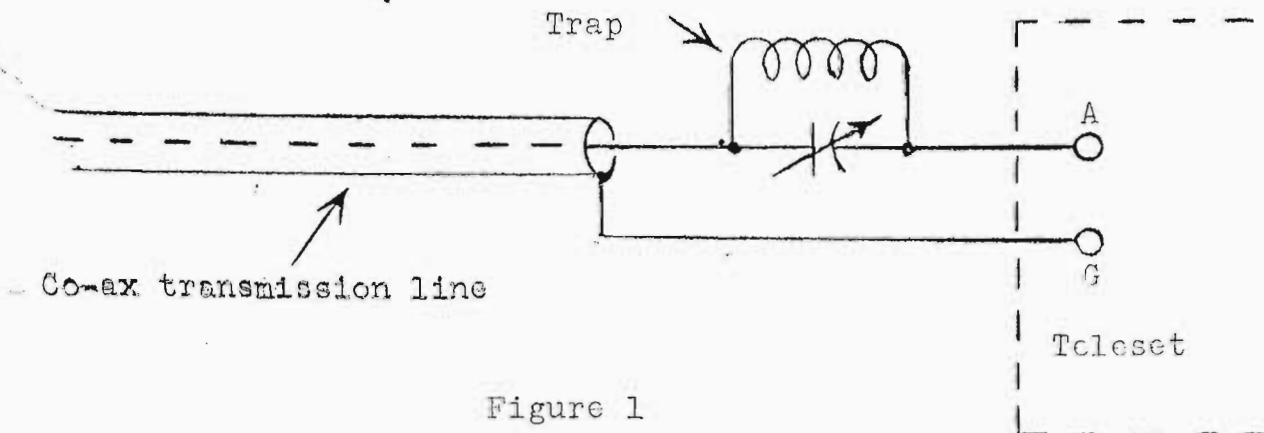
Figure 1

The basic principle behind the elimination of FM interference of either type is to attenuate the FM signal at its fundamental frequency. This may be accomplished by the use of a trap in the antenna input to the receiver. A simple parallel resonant trap which is available from the Teleset Service Control Department may be inserted in series with the transmission line to accomplish the desired results.

This trap is designed to tune over the FM band (88-108 mc) and, therefore, attenuate the signal. This trap has been used in many locations and has been found to work satisfactorily. The normal method of installation is shown in Figure 1.

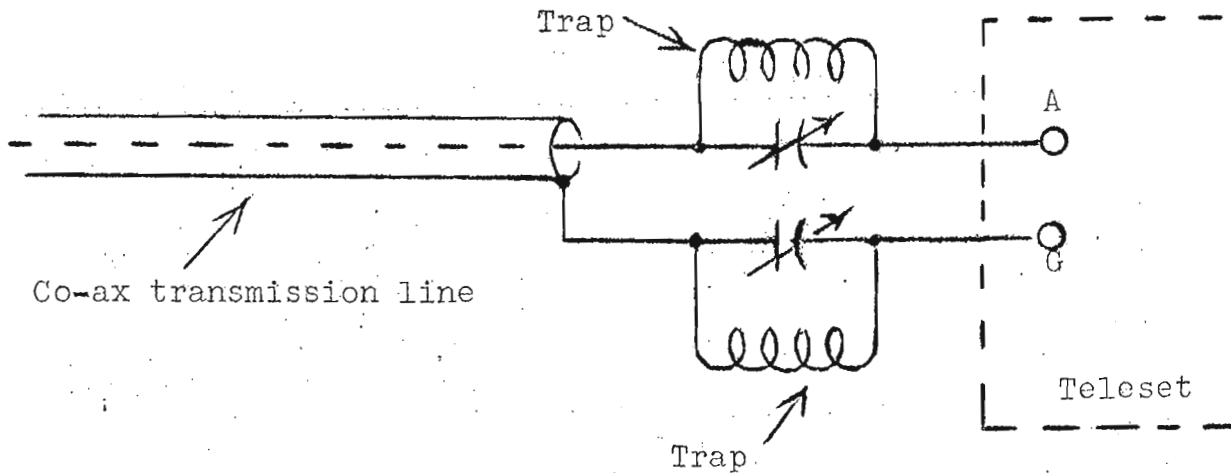
Figure 2

In some very extreme cases of interference, especially where the Teleset is located close to the FM station, it is necessary to insert one trap in the shield of the coax as well as one in the hot side of the line. This is shown in Figure 2.

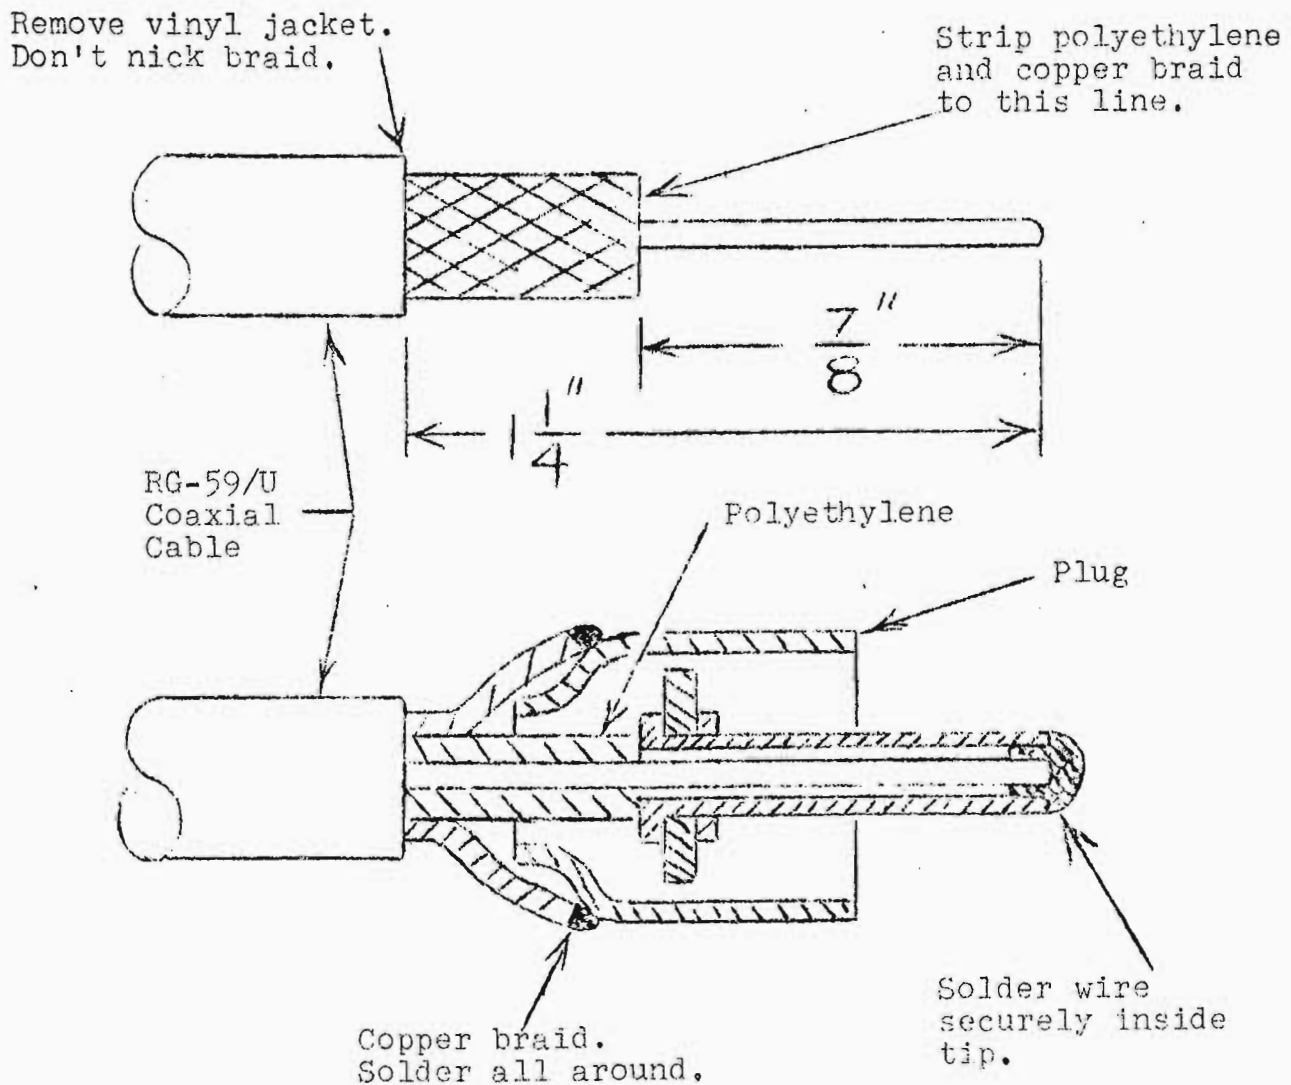
Observations made over a long period of time indicate that many servicemen either do not know how or do not take the time to solder the antenna plug to the coaxial cable lead-in properly. If care is exercised to solder the antenna plug carefully according to the instruction tag included with each Teleset, many call-backs may be eliminated. Extreme care should be taken to avoid application of excessive heat to the polyethylene insulation. This will damage the insulation and increase the possibility of leakage and short circuit from inner conductor to ground.

The proper procedure for soldering the antenna plug to the coaxial cable lead-in is shown below:

These connections must be soldered rapidly with hot iron to avoid damage to polyethylene insulation. Cable must be in line with body of antenna plug when soldering.

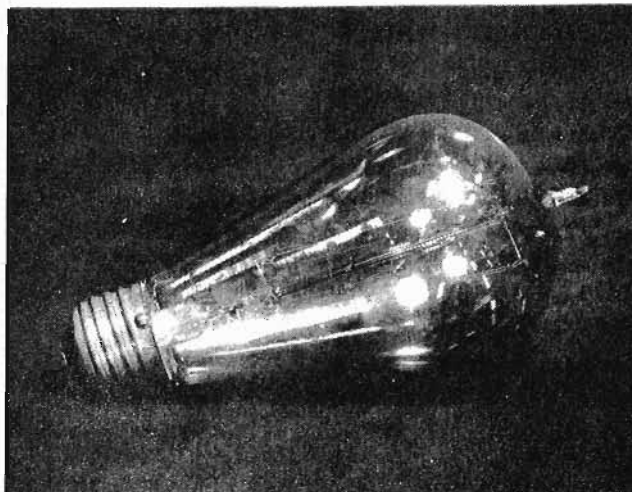
The light bulb shown in the illustration was found in the attic of the house in which the Teleset was installed. We do not know however, the distance over which the bulb can radiate.

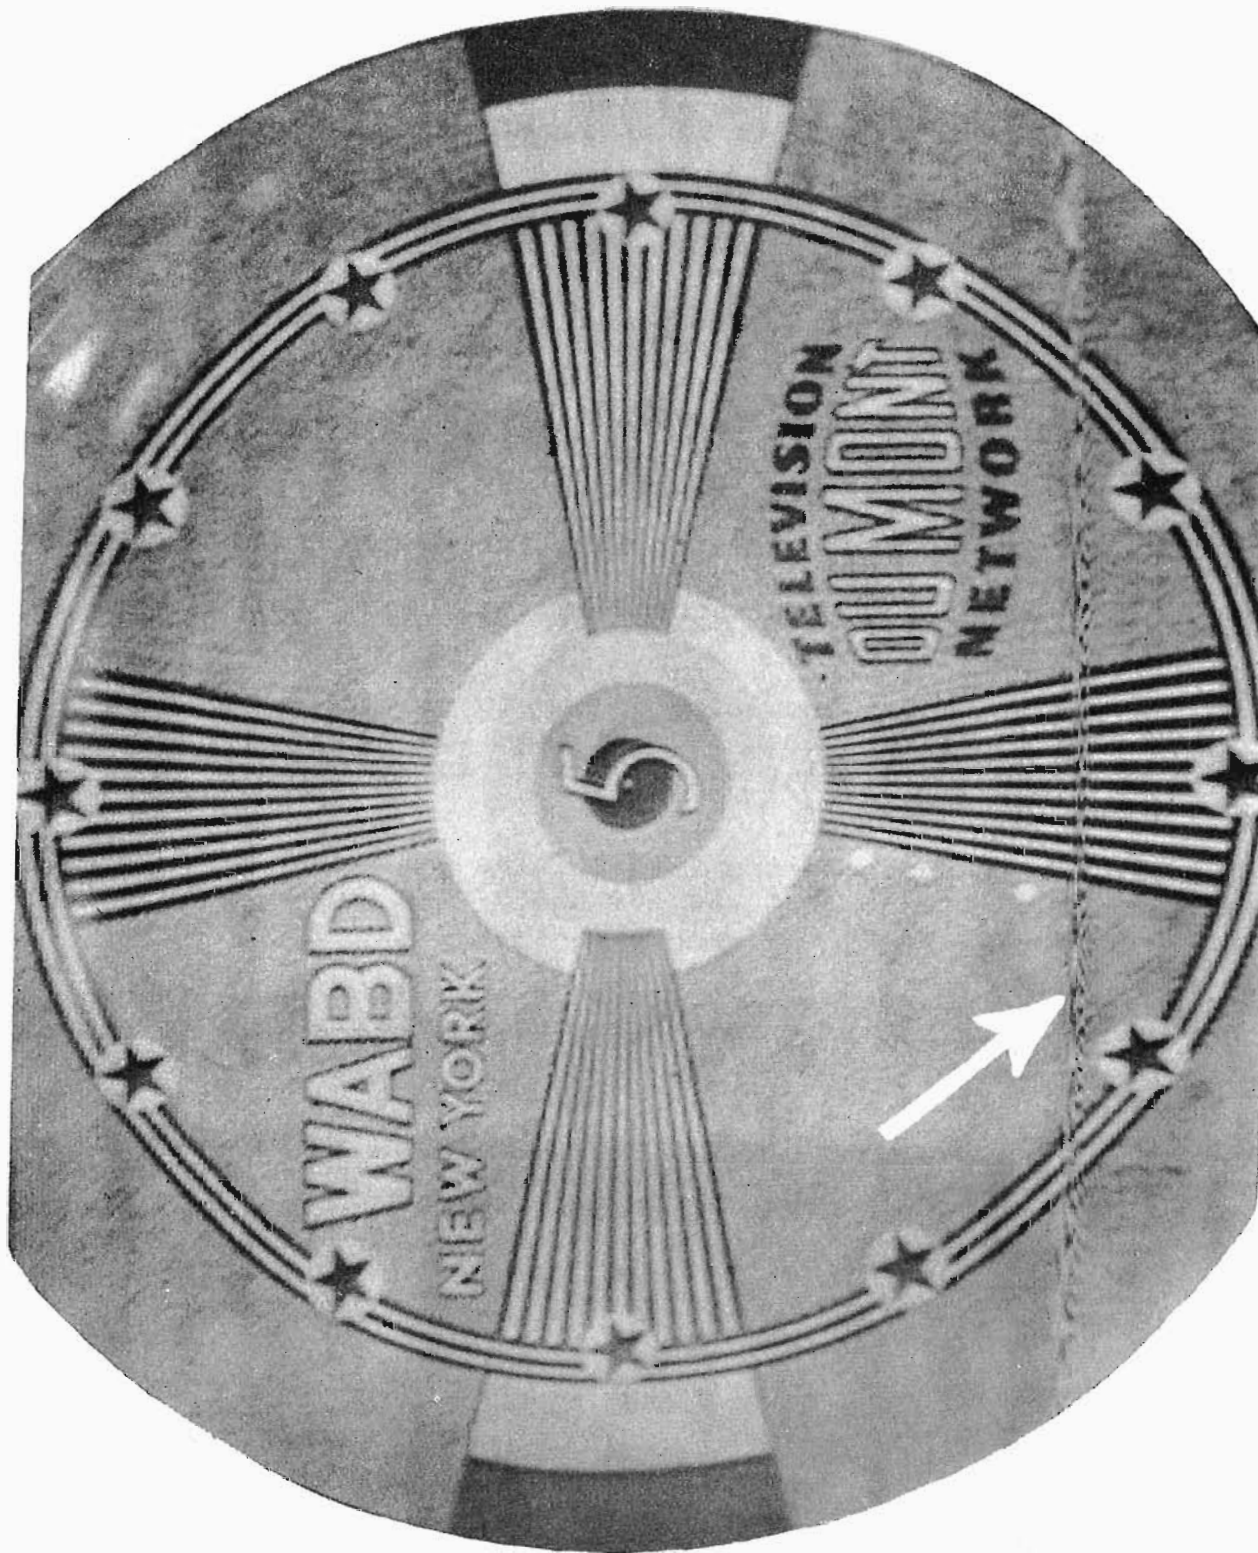
INTERFERENCE PATTERN CAUSED BY INCANDESCENT LAMP
