RA-102 SECTION

RA-103C SECTION

RA-103D, RA-104A, RA-110A SECTION

RA-105 -- RA-106 SECTION

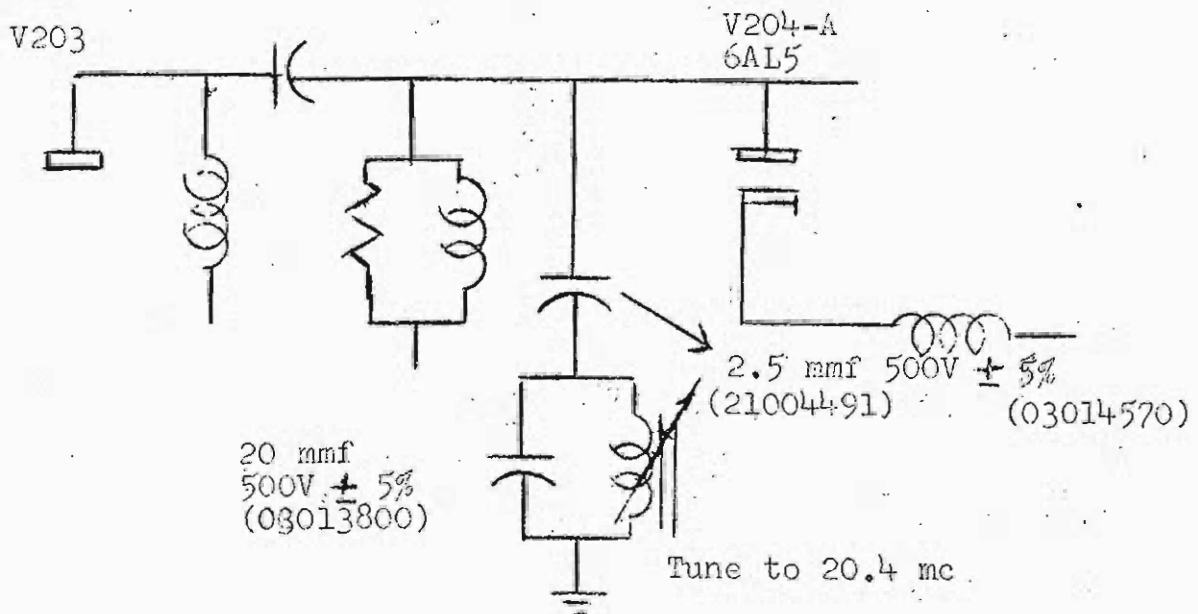
In certain areas where television signals are received on two adjacent channels (such as halfway between two cities having television stations), adjacent channel video interference has been observed on RA-103 Telesets. When tuned to the lower frequency channel of two such adjacent channels, interference is experienced from the video carrier in the higher frequency channel. This interference is usually seen as horizontal sync running back and forth through the desired signal.

This may be corrected in the field, by the addition of a series-parallel resonant trap in the third video IF amplifier as illustrated in the sketch below:

The parts required are one 2.5 uuf, part #03014570, one 20 uuf, part #03013800 and one inductor assembly, part #21004491. Connect the 2.5 uuf capacitor to the lug to which the end of the winding closest the lug is soldered, leaving $\frac{1}{2}$ " of wire between the body of the capacitor and the lug.

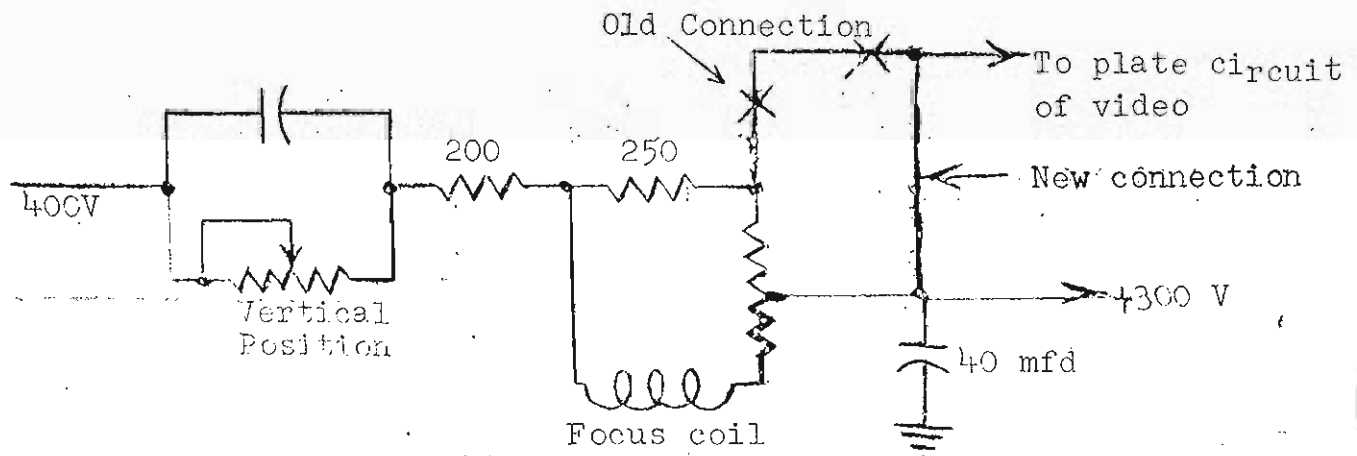
Figure 1

1. In the early models, the plate circuit of V205, the video amplifier, was connected to the junction of R286B and the focus control. With this wiring arrangement, the only time the B+ line going to the video amplifier was completely by-passed by C264B, was when the focus control was at its extreme clockwise position.

In order that this line be adequately by-passed at all times, the B+ line to the video amplifier is now connected to the arm of the focus control. This change is shown in Fig. 1.

This change reduces the B+ voltage of the video amplifier about 25 to 30 volts but does not noticeably affect the operation of this stage.

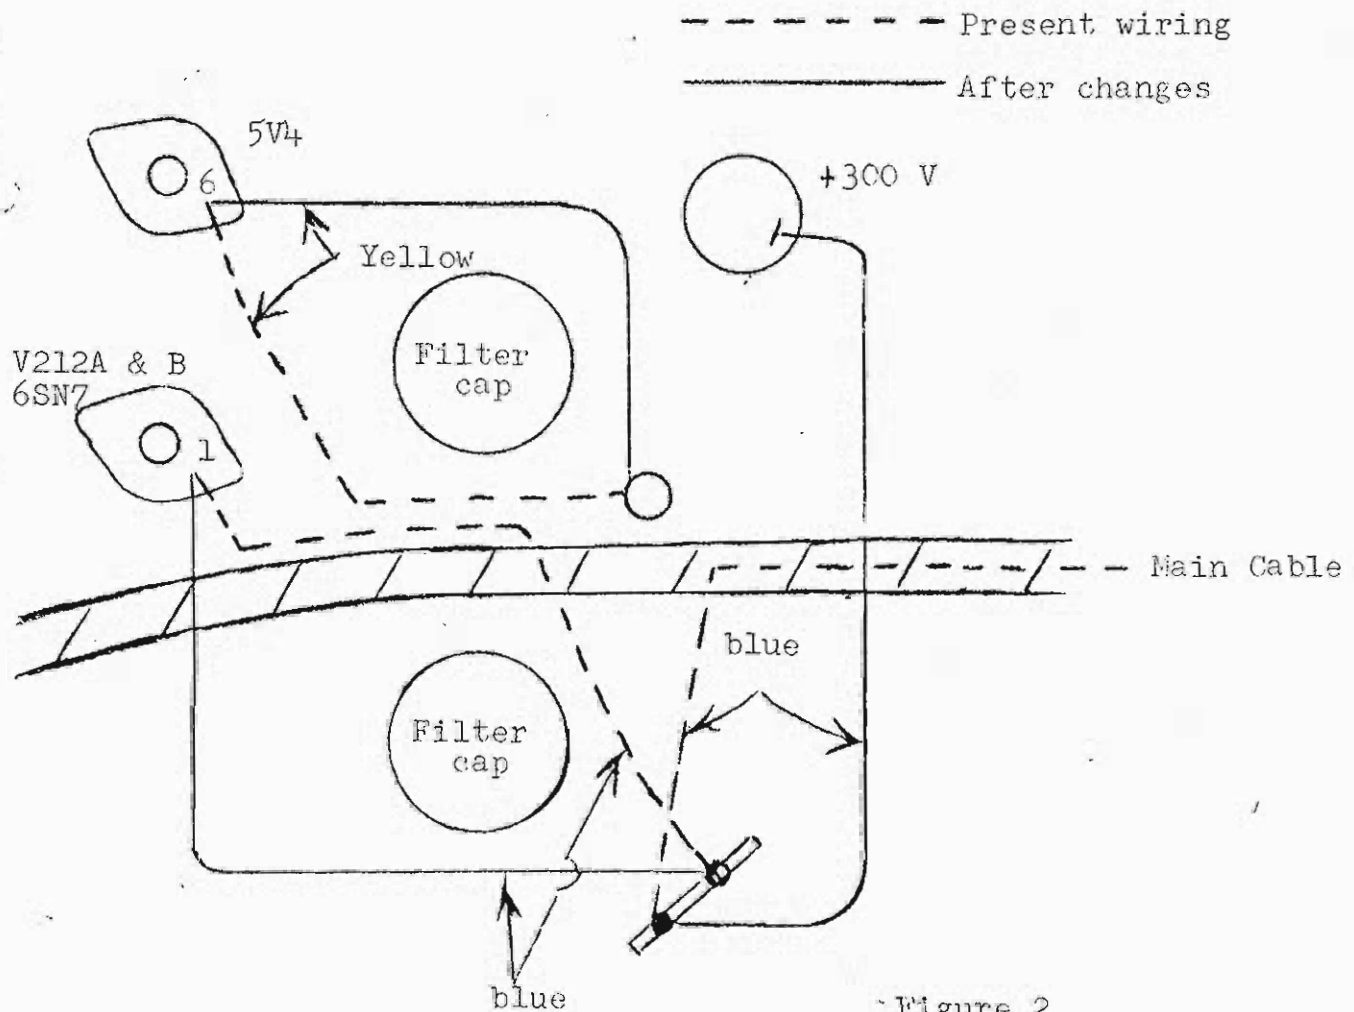
Figure 2

This condition has been caused by feedback of the pulses of the horizontal output system into the horizontal sync circuits and video amplifier.

(a) The lead from the coupling capacitor (C306) to the grid of the sync clipper (V212A) should not be run under the main cable between the two large filter capacitors. Rather it should go straight from the terminal board toward the rear of the chassis, and then after a 90° turn it goes to the grid of V212A so that it passes under the main cable at right angles.

(b) The lead from the high side of the yoke now goes to pin 6 of the 5V4 by running parallel with the main cable through the space between the two large filter capacitors and then to the 5V4. This lead (colored yellow) should go toward the linearity coil after emerging from the grommet and then after a 90° turn to pin 6 of the 5V4.

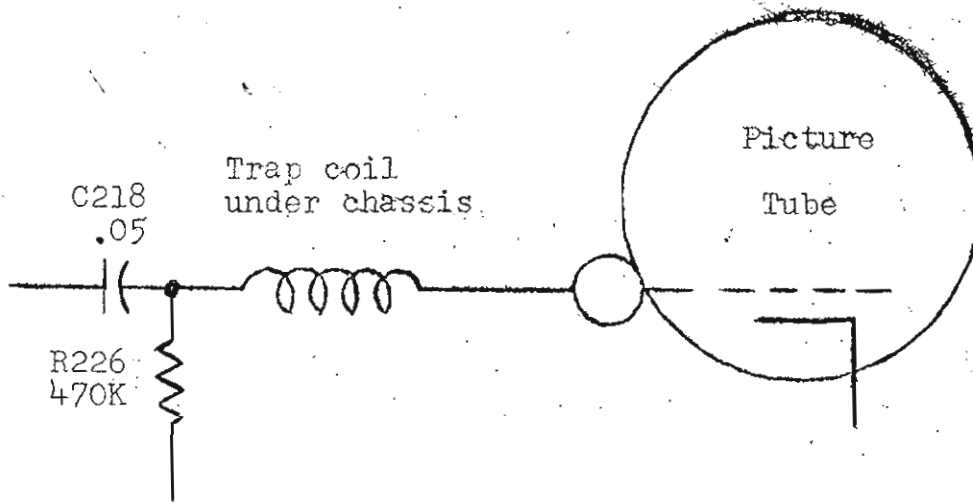
Figure 3
Location of Trap.

This condition is caused to a major extent, by feedback of the third harmonic of the video IF, from the CRT grid lead back to the antenna and RF section of the tuner. Since the lead to the CRT grid is longer in the RA-104A and RA-110A models, it is obvious why regeneration has been greater in these sets.

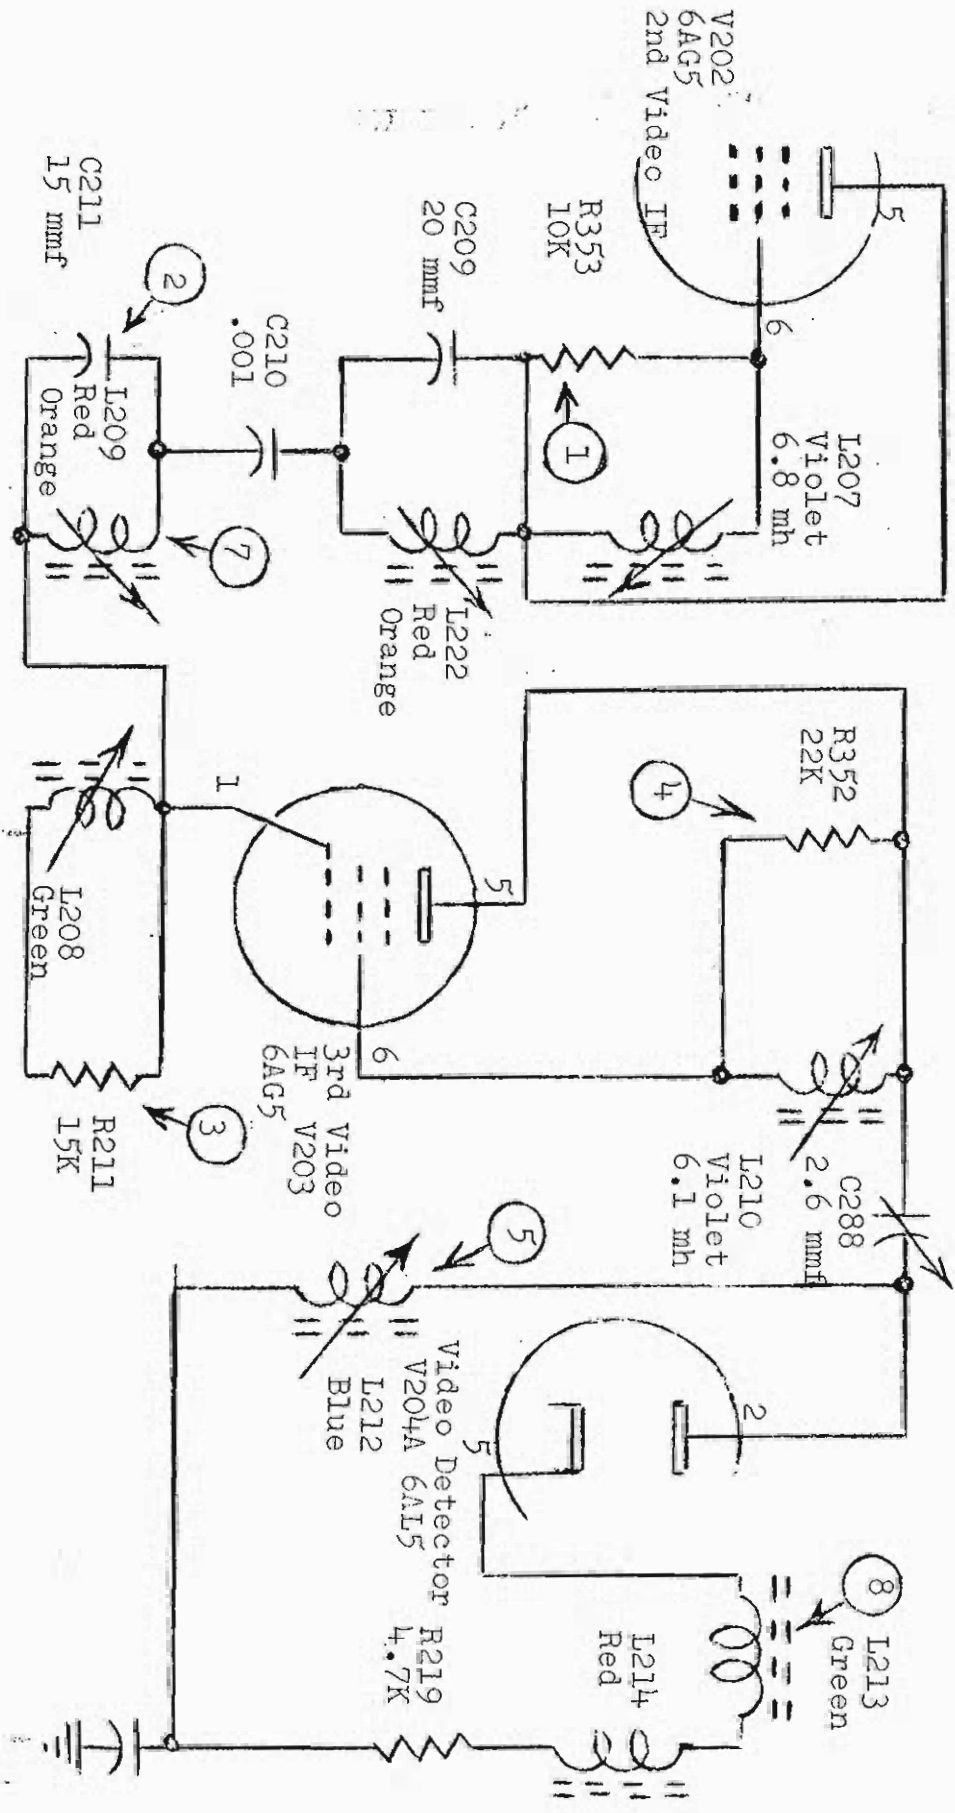
Figure 1. Simplified schematic showing changes necessary to reduce regeneration on all channels and improve picture quality. The only items affected are indicated by an encircled numeral. See page 13d for detailed instructions. There are no wiring changes, only additions and deletions of certain components and changes in value of certain other components.

In addition to reducing regeneration, these changes will also improve picture quality.

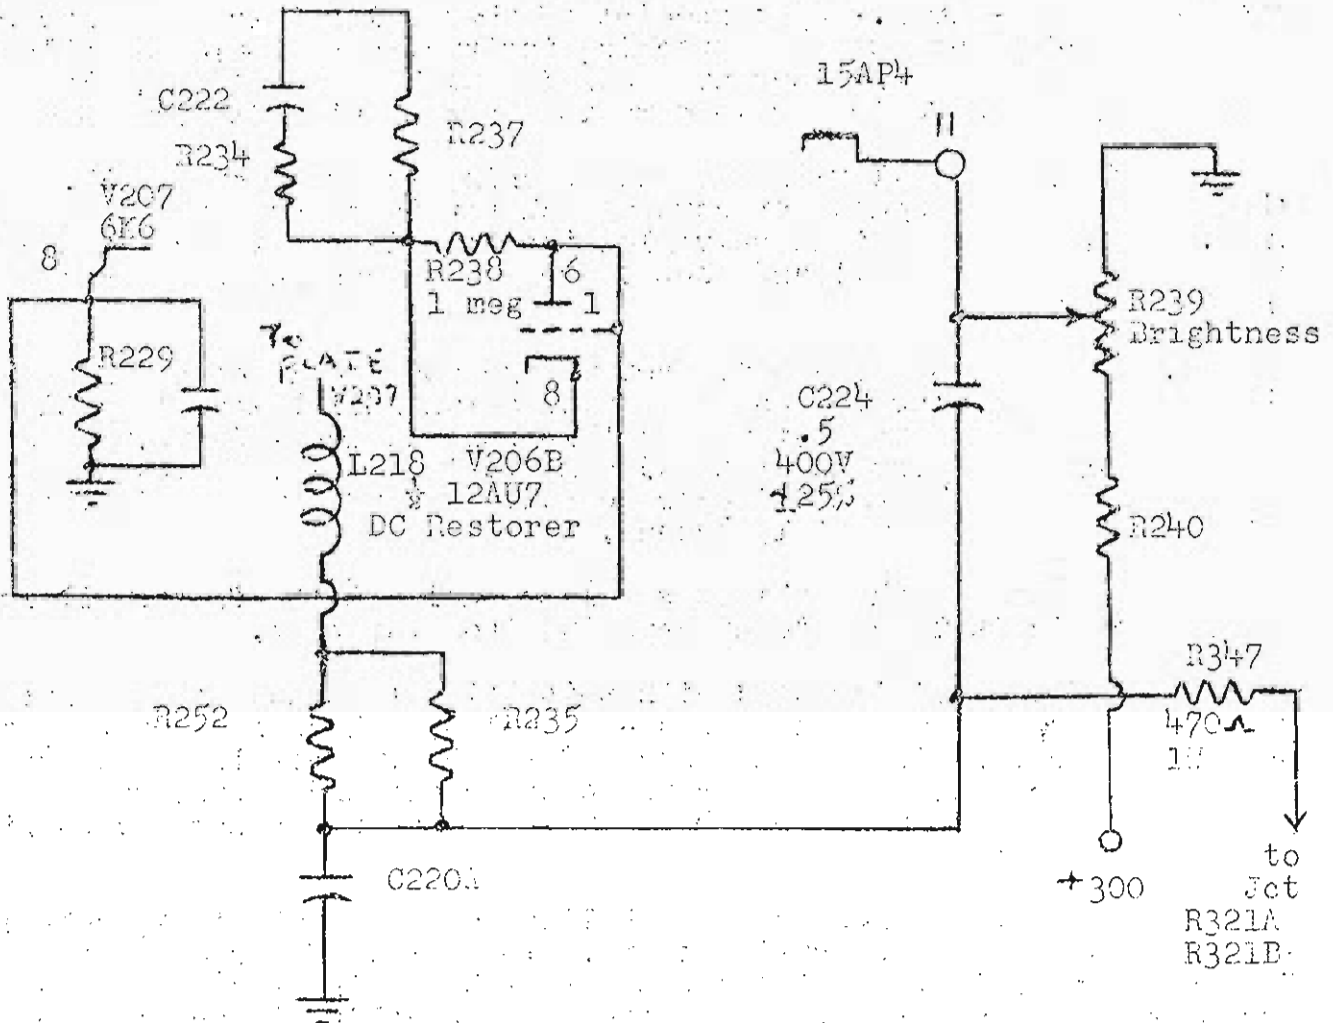
The schematic shown below illustrates changes made in the RA-105, RA-106 main chassis to reduce flicker. The flicker referred to results from periodic line voltage fluctuations such as are produced by reciprocating pumps and like devices. This change is sometimes referred to as an "anti-flicker circuit".

1. Pins #6 and #7 on V206-B the DC restorer tube are removed from ground.
2. Pins #6 and #7 on V206-B are connected together and a lead is run from pin #6 of V206-B to pin #8 of V207, thus returning the DC restorer to the cathode of the third video amplifier instead of ground.
3. Capacitor C224 is changed from .1 200V \pm 25% to .5 400V \pm 25%. The part number of the new capacitor is 03014260.
4. Capacitor C224 is connected between pin #11 of the CRT and the junction of R235 and C220A.
5. Resistor R347 470 ohms 1 W 10% (part #02034730 alternate part #02044730) is connected in series between R232 and R321.

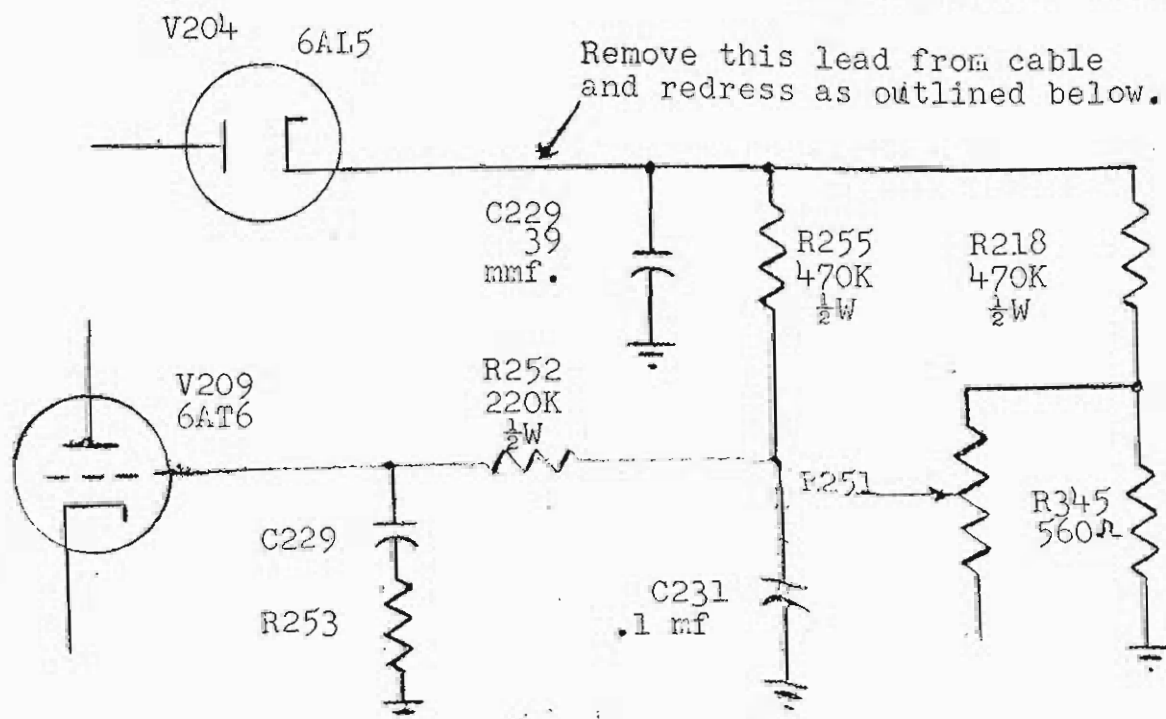
Very humid weather normally encountered in the summer months has been the cause of considerable difficulty with the AGC circuit as used in the early RA-105 Telesets. The condition that is normally encountered was a fading of both picture and sound. When the serviceman checks the set he usually finds that all components are normal and is at a loss to determine the reason for the faulty operation of the receiver. Where this trouble is encountered it is recommended that the following changes in the AGC circuit be made. These changes have been included in production on all of the sets made after March, 1949. The purpose of these changes is to reduce the impedance of the grid circuit of the 6AT6 AGC stage and thus improve the stability of this circuit. The list of changes follow:

R218 was changed from a 1.2 meg. resistor to 470K, $\frac{1}{2}$ W, part number 02032090. It was disconnected from the junction of R252, R255 and C296 and connected to the junction of R345 and R251.

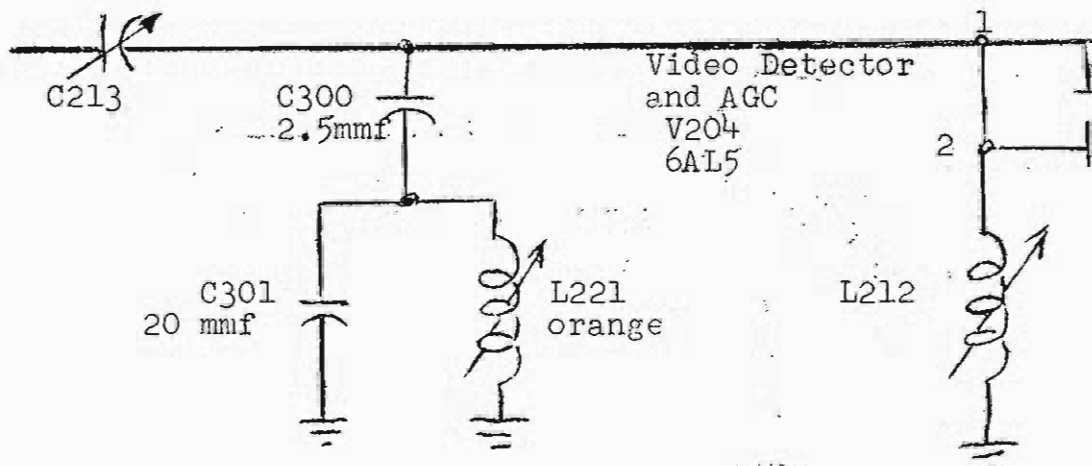
Figure 1

In certain areas where television signals are received on two adjacent channels (such as half way between two cities having television stations) adjacent channel video interference has been observed on RA-105 and RA-106 Telesets. When tuned to the lower frequency channel of two such adjacent channels, interference is usually seen as horizontal sync running back and forth through the desired signal.

This may be corrected in the field by the addition of a series-parallel resonant trap in the third video IF amplifier as illustrated in Fig. 1. (Note the latest RA-105 and RA-106 Telesets include this trap).

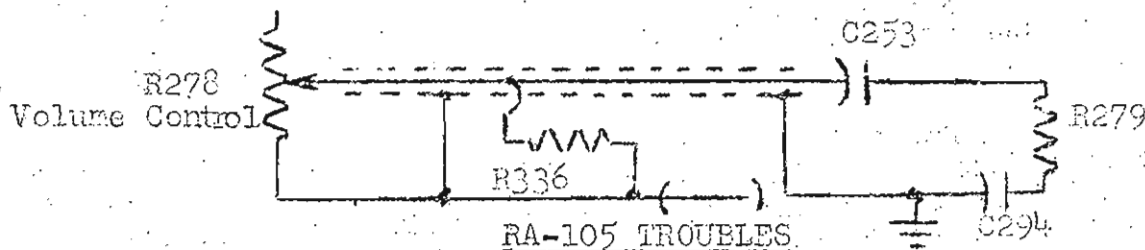
(The error is in the volume control circuit, where R336 is shown shorted out and the "hot" wire of the shielded lead is shown grounded. The sketch shows the correct connections).
