Restoring a GE HM 185

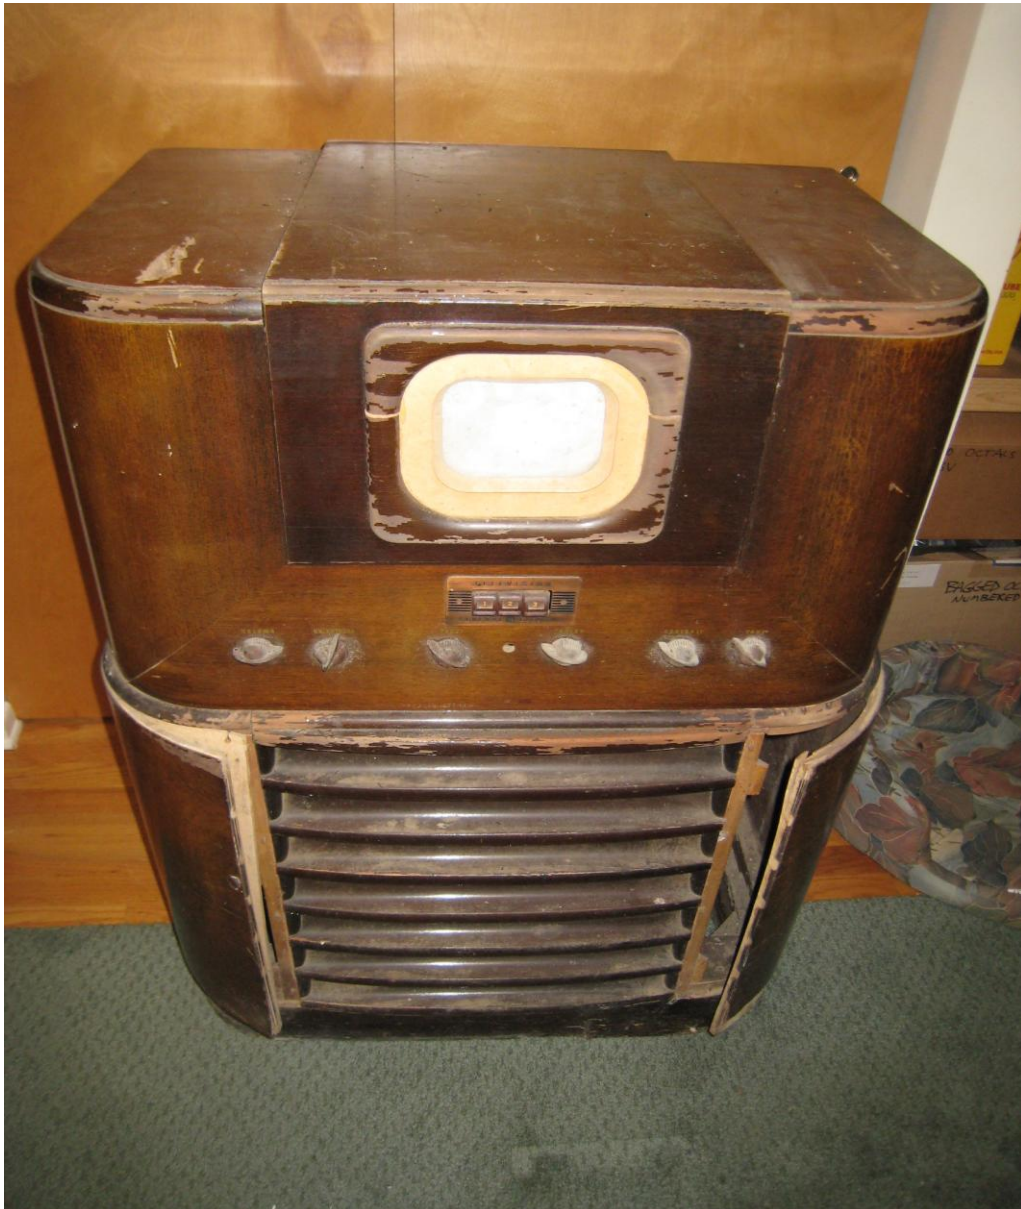
This set belonged to a local family and it was in their possession since the early 1970's. The cabinet was basically complete missing only the indicator lamp bezel and a couple pieces of veneer, however, it had been in a damp place and the sides had come loose from the front grille section and popped outward. The base also had rotted wood on the bottom inch or so. The chassis looked intact with some rust but not too bad, the speaker was intact and although the base locator pin had been broken off the CRT and the 5BP4 did not appear to have been broken or lost vacuum.

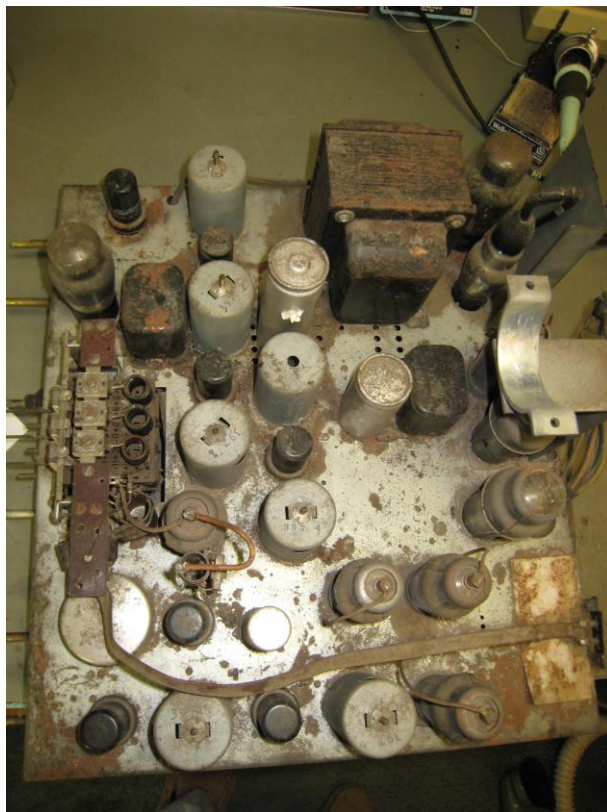
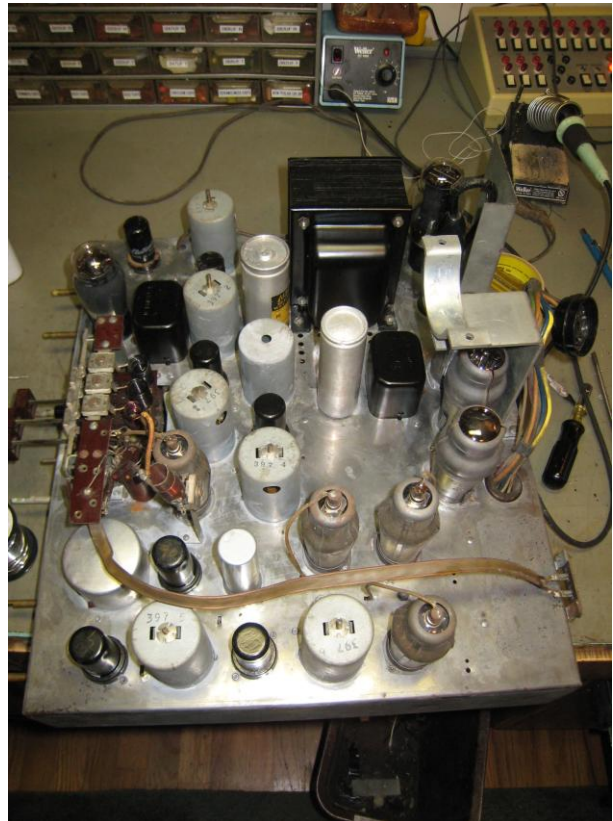
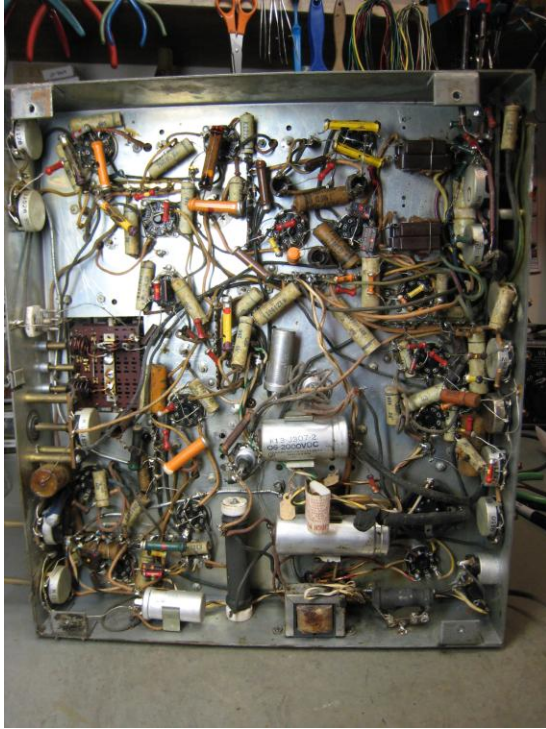
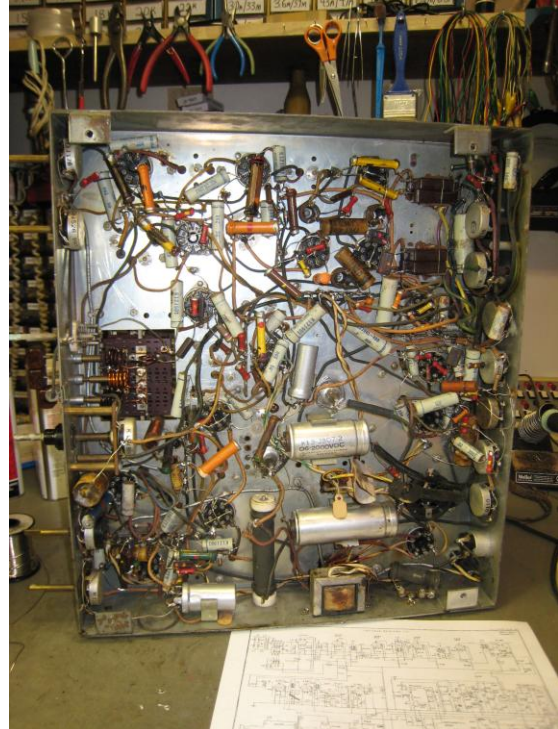
The chassis was examined on removal and very little seems to have been done to it and that was probably long ago. The first filter electrolytic off the B+ had been replaced and one of the wax capacitors as has the power transformer. One of the fine-tuning coils has also fallen off the center tuning slug on the tuning gang. I replaced the filter can as the new one was the wrong type and re-stuffed a correct type as well as all the other electrolytic capacitors on the chassis. I then proceeded to re-stuff all the paper capacitors which was a matter of melting out the end caps, removing the guts and replacing them with new units and running the leads out thru the old ends. The high voltage capacitors were Mica in one section, which I left intact, but rebuilt the Oil capacitors (only two of them) which rounded out the recapping of the chassis.

On the topside I removed the covers from the power transformer, sandblasted and painted them, and removed the 2 transformer cans, sandblasted and painted them. The chassis itself had moderate rust which I removed chemically with Naval Jelly in multiple applications then waxed the entire topside to prevent future corrosion.
