## Introduction

## Volumes

# TV

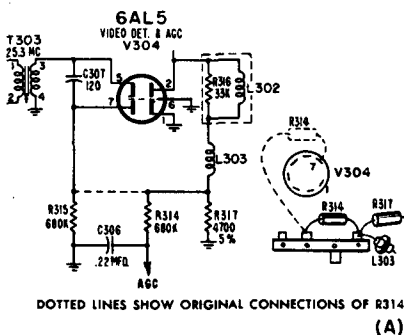
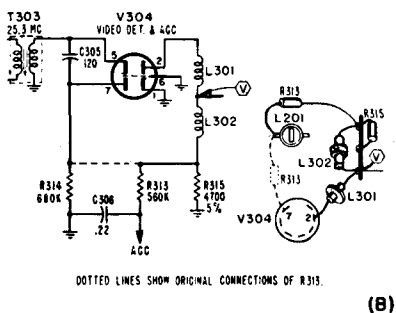
Fig. 1 — Admiral

**Agc change for high-noise areas (see Fig. 1).**

The following may be of aid in improving reception under conditions of weak signal and high-noise level.

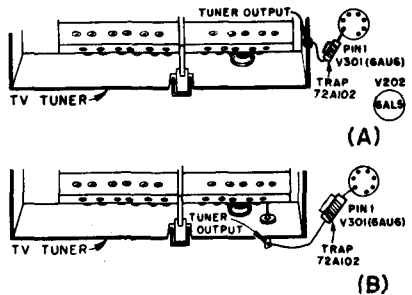
Fig. 2 — Admiral

The picture may have a herringbone interference pattern produced

by the adjacent lower channel sound carrier. Close examination will often reveal the fine lines of herringbone pattern varying in accordance with the speech or music on the adjacent lower channel. Since f-m interference from other sources also produces a herringbone pattern, the presence of a station on the adjacent lower channel should be definitely determined.

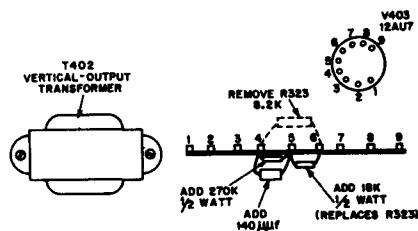
**Fig. 3 — Admiral**

**ADMIRAL****Chassis 21B1,  
21C1****Improved noise immunity for  
horizontal sync (see Fig. 3).**

In some areas where the noise level is high, the noise peaks may affect the sync circuit and cause the picture to shake horizontally or lose horizontal sync.

A change in resistor value and an additional filter in the sync circuit may be incorporated to reduce this trouble. The circuit change may be found already made in late runs of the chassis.

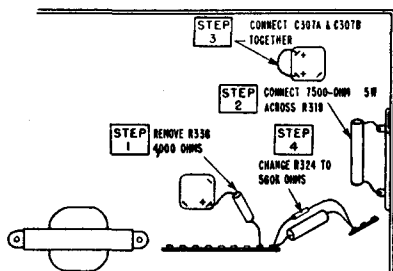
Fig. 4 — Admiral

### Preventing picture cut-off (see Fig. 4).

Blocking may occur if the tv set is tuned to a very strong tv signal which could drive the video amplifier to cut-off. With the video amplifier at cut-off, B+ voltage applied to the cathode of the picture tube will increase, thereby making the grid voltage more negative with respect to cathode, and driving the picture tube to cut-off. Also, since the gated agc tube is dependent upon voltage from the video amplifier for its operation, blocking of the video amplifier will prevent agc voltage from developing and the system will remain blocked.

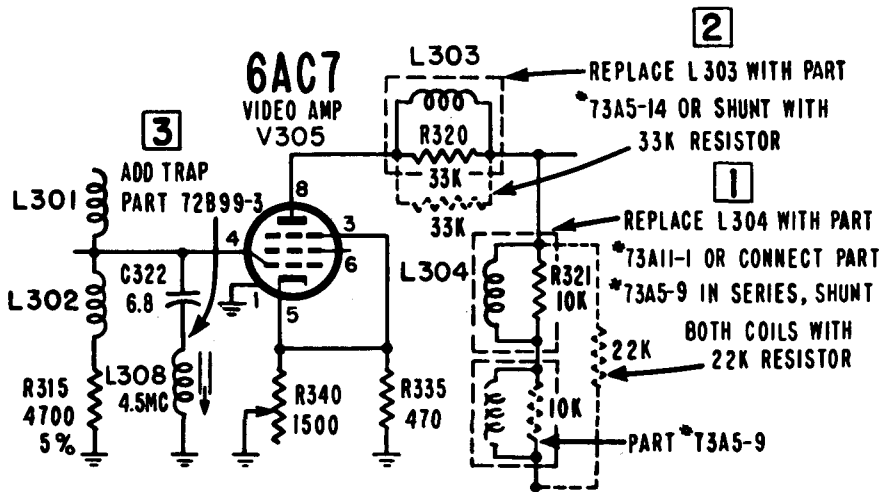
Fig. 5 — Admiral

Picture smear or poor picture definition may be caused by improper receiver tuning to avoid receiving 4.5-mc beat interference. The natural tendency is to tune the set to eliminate the 4.5-mc interference in the picture, but this results in incorrect setting of the fine-tuning control for best picture.

To reduce or eliminate 4.5-mc interference in the picture, the following is recommended. Note: Some later production sets may have this change incorporated.

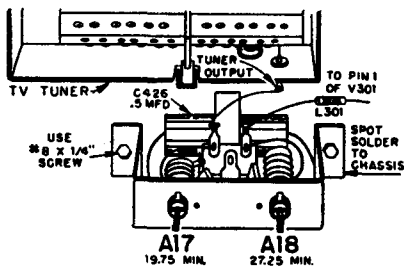
Fig. 6 — Admiral

**ADMIRAL**Chassis 24D1  
through 24H1**Eliminating adjacent-channel interference (see Fig. 6).**

Two adjacent-channel traps *L309* (27.25 mc) and *L310* (19.75 mc) may be added between the output of the tv tuner and the input of the first video i-f amplifier *V301* (6AU6). This is done to eliminate the possibility of interference from the video carrier of the adjacent channel above, and the sound carrier of the adjacent channel below, the desired channel.

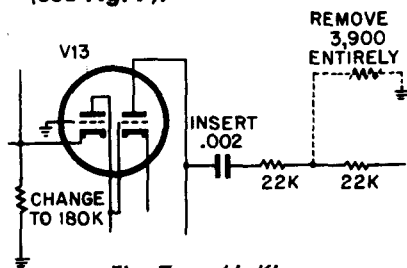
Fig. 7 — Air King

**AIR KING** 700-series Chassis  
**Increasing vertical sync stability**  
(see Fig. 7).

To increase vertical sync stability a .002- $\mu$ f capacitor should be inserted between the 22,000-ohm resistor and plate (pin 1) of the sync amplifier and phase splitting tube (V-13) as shown in the drawing. In conjunction with this change the 3,900-ohm resistor from the junction of the 22,000-ohm resistor to ground should be removed.

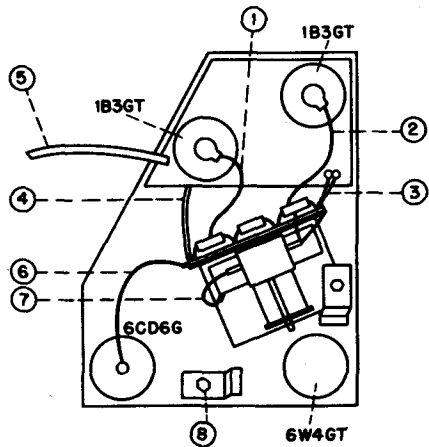
Fig. 8 — Andrea

**ANDREA** Chassis VL-16  
**Preventing arcing and burning**  
(see Fig. 8).

Whenever any work must be done in the high-voltage compartment or if a tube is replaced in this section, proper lead dress must be maintained. Extreme care must be used to prevent connecting wires to the tube caps from touching any portion of the metal compartment or other components. Failure to observe this precaution may cause arcing and burning.

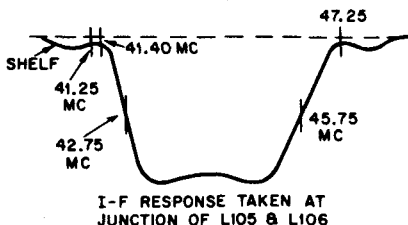
Fig. 10 — Arvin

#### Intercarrier buzz reduction (see Fig. 10).

1. Check buzz due to intermodulation within the sync and audio tube, *V19*, by pulling out *V1*, 6AU6. Change *V19* if buzz is still audible.

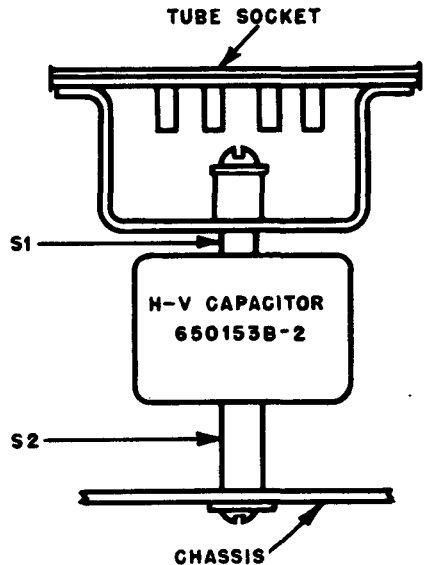
Fig. 20 — Capehart-Farnsworth

#### *Internal arcing in h-v capacitor (see Fig. 20).*

This is the 500- $\mu\mu\text{f}$ , 200,000-volt high-voltage filter capacitor, part No. 650153B-2.

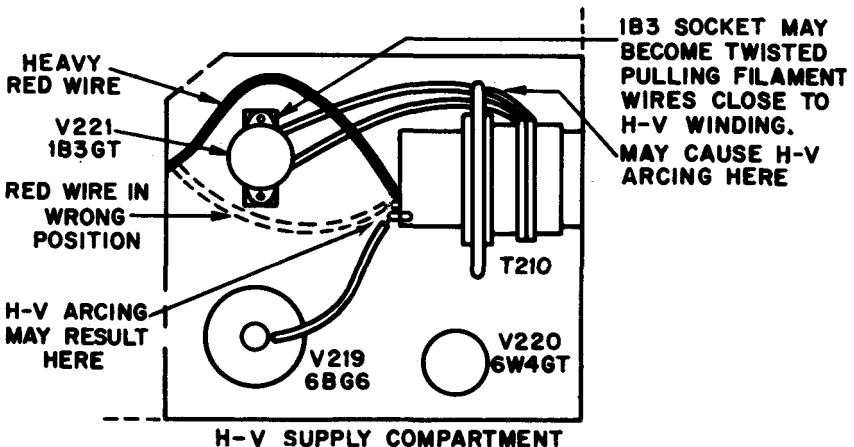
Fig. 21 — Capehart-Farnsworth

If necessary to replace the 1B3 rectifier tube in h-v section of the receiver, it is possible, if care is not exercised, to disarrange the wiring. This might cause high-voltage arcing or a short to develop resulting in a burned-out transformer. Note carefully in the sketch the proper position of the 1B3 socket, so as to avoid drawing the filament-supply leads against the transformer coil. Also note correct position of the heavy red wire between the horizontal-output transformer and the deflection yoke.

It must be between the 1B3 tube and power-supply shield — not between the 1B3 and 6BG6 tubes.

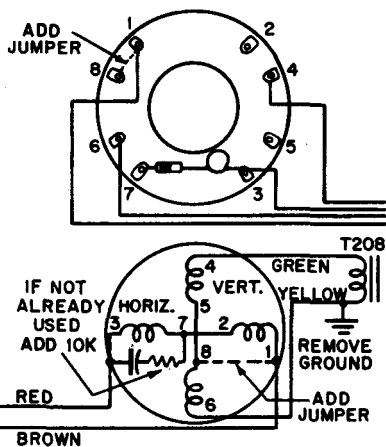
Fig. 27 — Capehart-Farnsworth

Some high-voltage breakdowns between yoke windings have been reported in yokes 750192A and B which are furnished with models 335 and 337 (with the above chassis). To reduce the potential difference between windings, the following change procedure should be followed:

1. Remove the chassis.

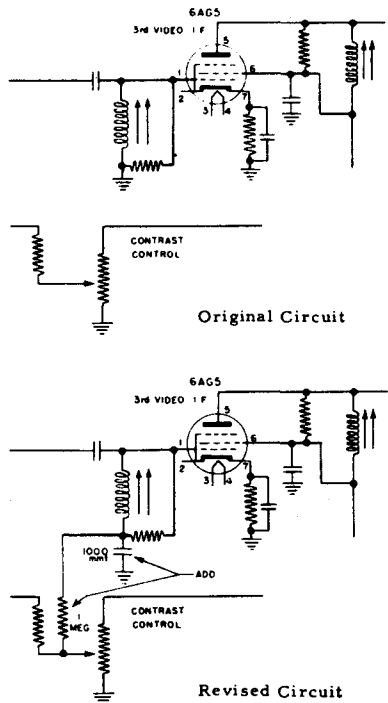
**Fig. 29 — Crosley**

In some cases where these sets are operated in areas where the signals from one or more stations is exceptionally strong it may cause the contrast control to operate very critically. This condition can be corrected without losing sensitivity in the re-

ceiver by adding a variable bias to the third picture i-f stage. This can be accomplished by making the following wiring changes:

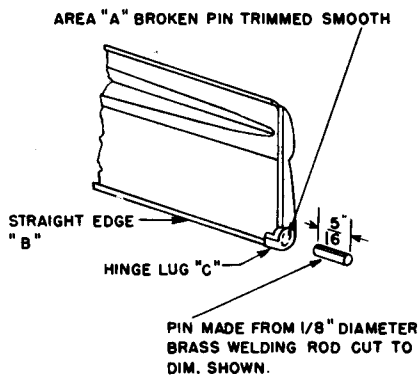
Fig. 30 — Crosley

### Repair of broken hinge (see Fig. 30).

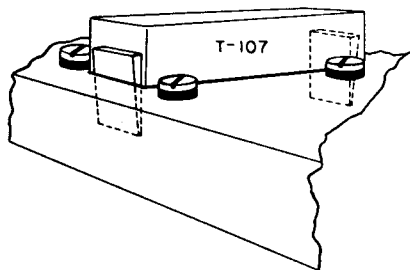
Fig. 32 — Crosley

Horizontal-sweep sing can be caused by vibration of the mounting bracket on the horizontal-output transformer, *T107*. This mounting

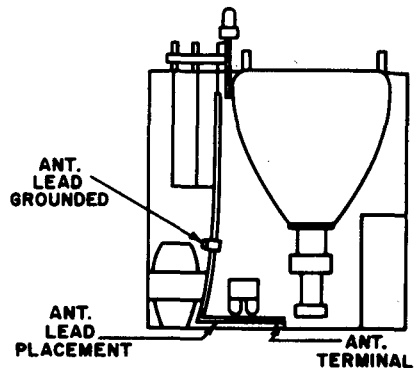
Fig. 38 — DuMont

Separate from the complaints of channel 5 regeneration and all-channel regeneration, complaints of a beat on channel 7 have been received. This

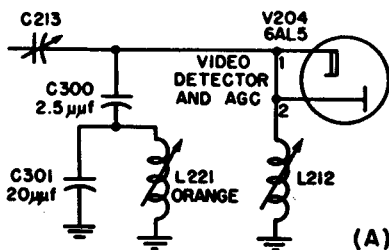
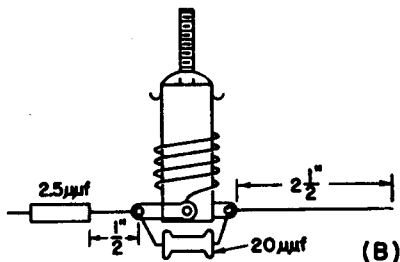
Fig. 40 — DuMont

**Adjacent-channel interference (see Fig. 40).**

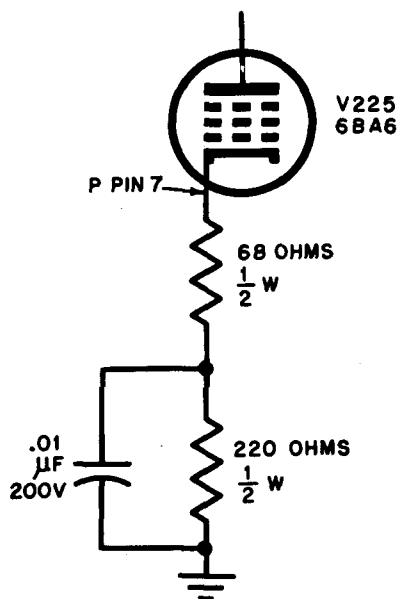
Fig. 41 — DuMont

**Correcting vertical jitter**  
(see Fig. 41).

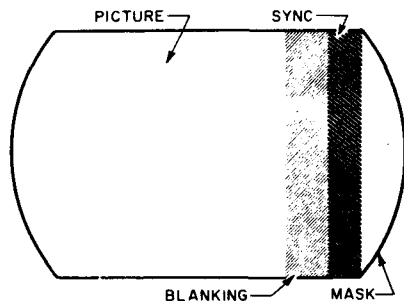
Fig. 43 — DuMont

A few complaints have been received concerning horizontal instability which displays itself as horizontal

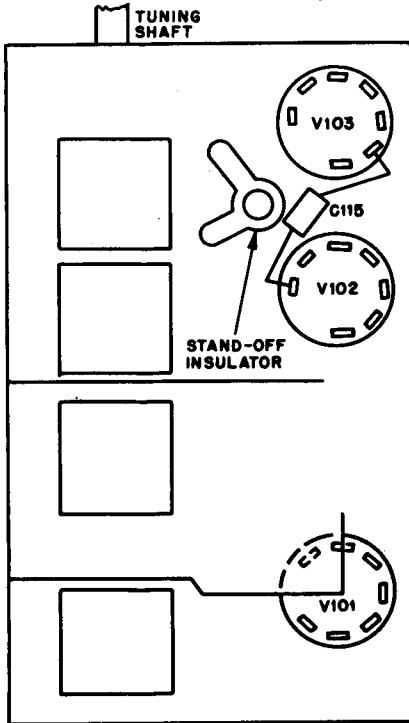
Fig. 44 — DuMont

A few field complaints have been received indicating that the high-channel sensitivity of the receiver is low in certain areas, as a result of low oscillator-injection voltage. If this condition should be encountered it is suggested that the following procedure be followed to improve the sensitivity:

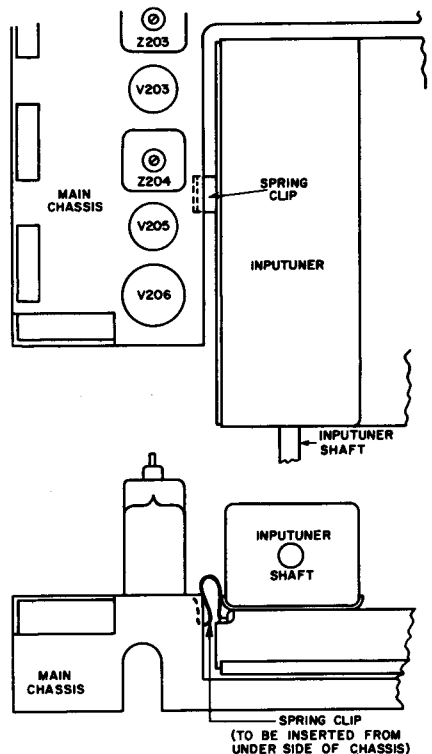
Fig. 45 — DuMont

**DUMONT Model RA-109A**  
**Elimination of channel 7 beat**  
(see Fig. 45).

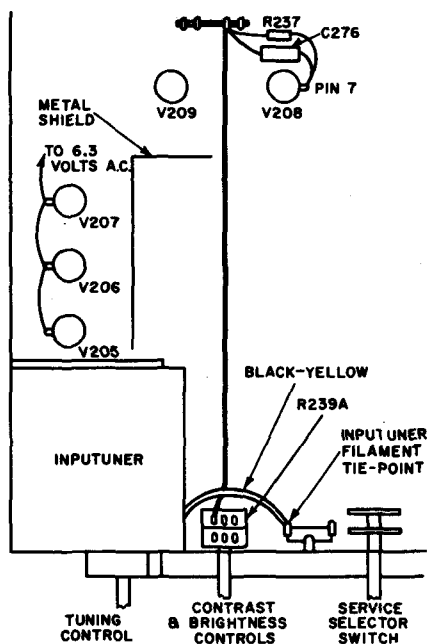
Fig. 47 — DuMont

**Regeneration in video i.f.**  
(see Fig. 47).

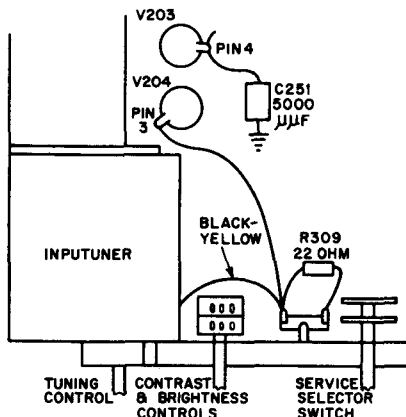
Fig. 50 — DuMont

**DUMONT Model RA-111A**  
**Elimination of channel 7 beat**  
(see Fig. 50).

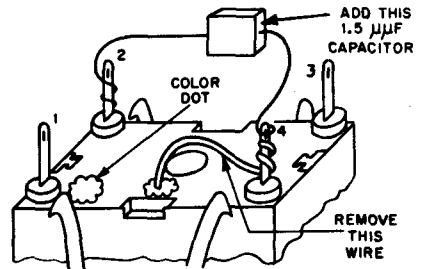
Fig. 51 — DuMont

Some complaints of breakdown of the ceramic coupling capacitor in the video i-f transformers have been received. The condition encountered
