Introduction

TV

MANUFACTURERS' RECEIVER TROUBLE CURES

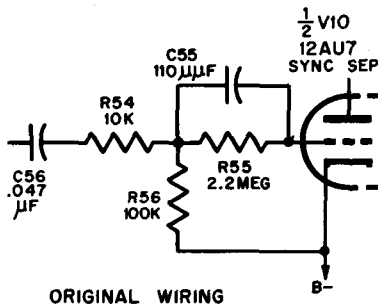
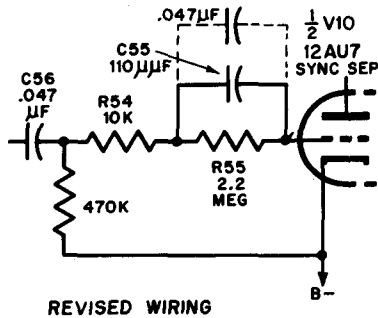
Fig. 5 — Emerson

EMERSON Chassis 120129-B, -D,
 120140-B, -G, -H,
 120144-B, -G, -H
Improving sync stability in fringe areas (see Fig. 5).

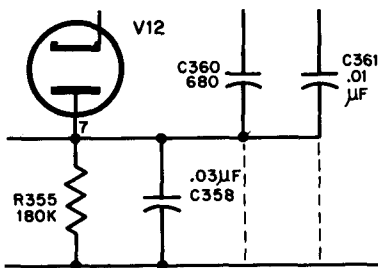
Fig. 20 — General Electric

Curl at top of picture (see Fig. 20).

A few receivers have shown a slight displacement (to the right) of the first few horizontal scan lines which shows up as a slight curl at the top of the picture. This trouble is caused by a delay in recovery of the horizontal afc circuit after the occurrence of each vertical sync pulse, and is compensated for by feeding a correction voltage of proper magnitude and phase into the afc circuit. The circuit revision is shown in the sketch; the procedure follows:

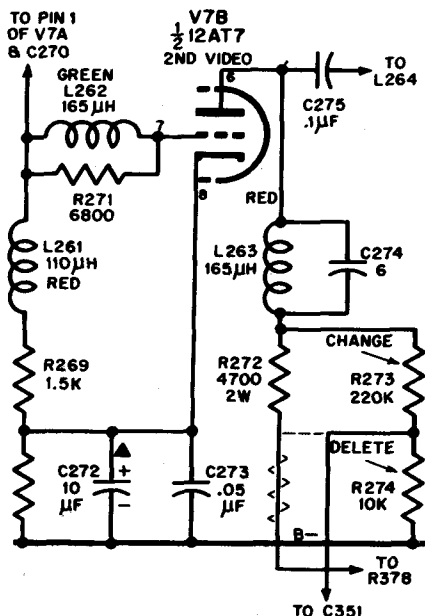
Fig. 22 — General Electric

Correcting bending at top of picture (see Fig. 22).

In early production receivers R-273, R-274 and the sync voltage take-off capacitor C-351 were connected as shown in the figure. To correct bending at the top of the picture R-274 is deleted. R-273 is changed to 220 ohms and is reconnected in series with R-272. C-351, the sync-coupling capacitor, is now connected at the junction of R-272 and R-273 as shown in the dashed lines.

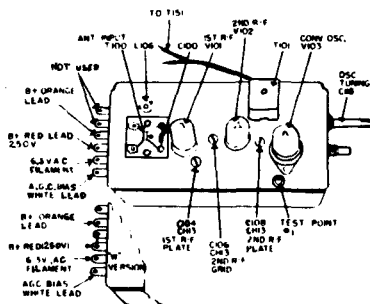
Fig. 25 — General Electric

F-M interference reduction in tuner (see Fig. 25).

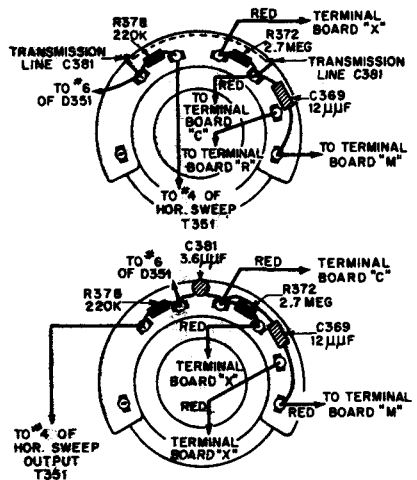
Fig. 26 — General Electric

Improved deflection-yoke installation (see Fig. 26).

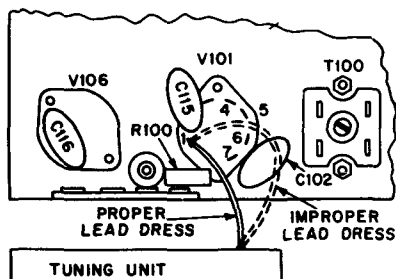
Fig. 37 — Hoffman

Channel-11 picture interference
(see Fig. 37).

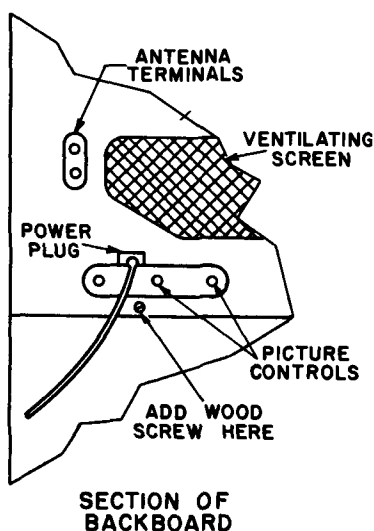
Fig. 43 — Hoffman

HOFFMAN Chassis 146
Power-cord interlock looseness (see Fig. 43).

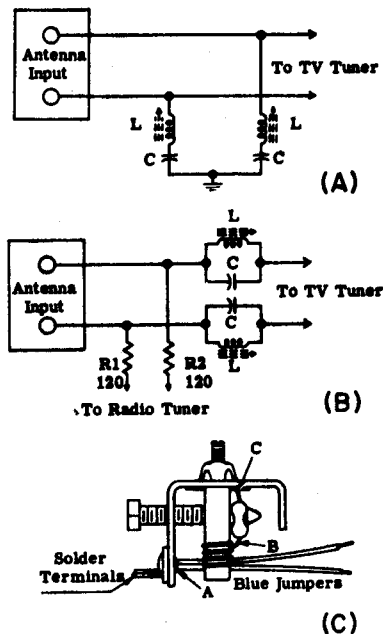
Fig. 45 — Hoffman

Interference trap for channel 2 (see
Fig. 45).

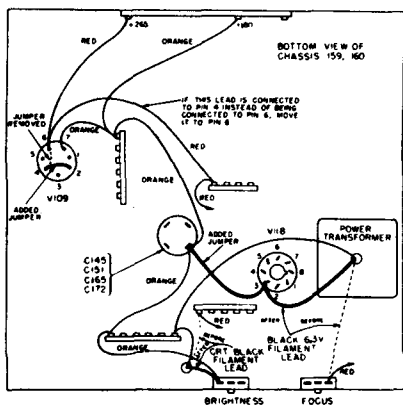
Fig. 48 — Hoffman

Forestalling heater-cathode breakdown in picture tube (see Fig. 48).

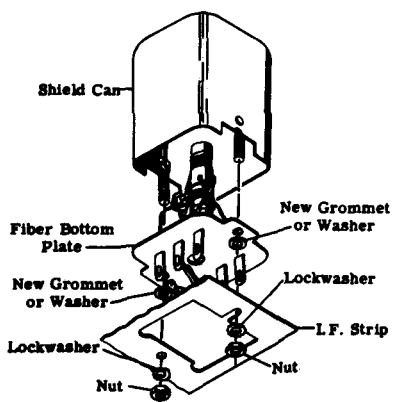
Fig. 50 — Hoffman

Mounting modification of 3rd i-f transformer shield (see Fig. 50).

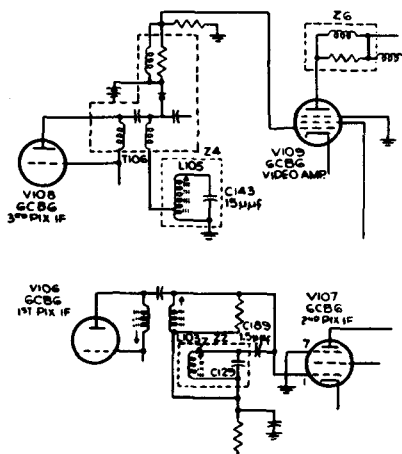
Fig. 51 — Hoffman

Removing 4.5-mc beat interference (see Fig. 51).

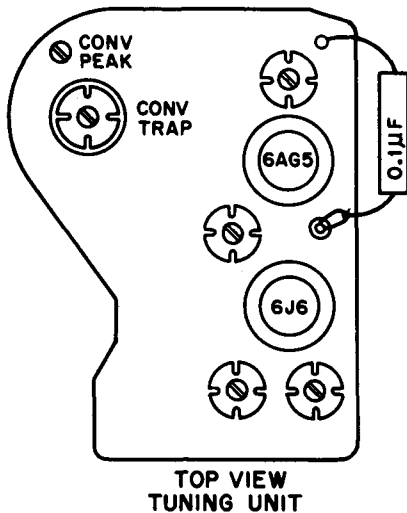
Fig. 58 — Hoffman

HOFFMAN Chassis with turret tuners RF-3 through RF-6
Tunable modulation hum (see Fig. 58).

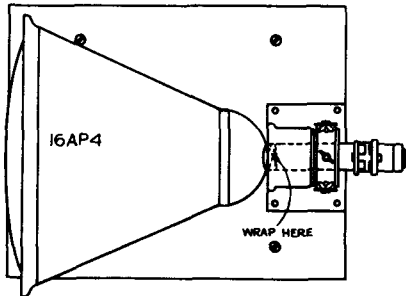
Fig. 59 — Hoffman

HOFFMAN Chassis with
16-inch metal picture tubes
**High-voltage arcing around
picture-tube neck (see Fig. 59).**

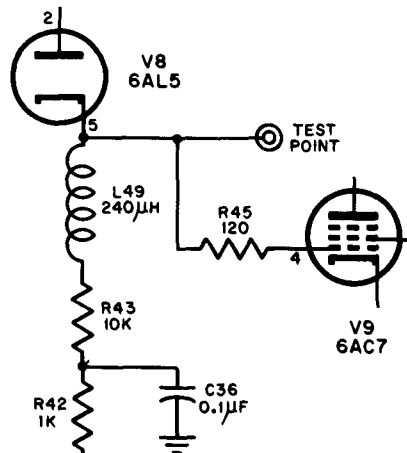
Fig. 61 — Industrial

Removing intercarrier hum (see Fig. 61).

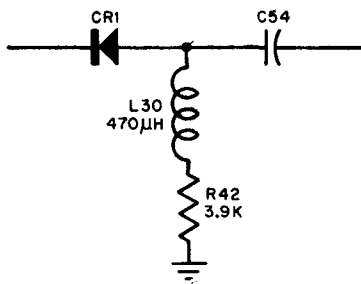
Fig. 63 — Industrial

INDUSTRIAL Chassis IT-35R
Improvement in video response
 (see Fig. 63).
