Introduction

TV

MANUFACTURERS' RECEIVER TROUBLE CURES

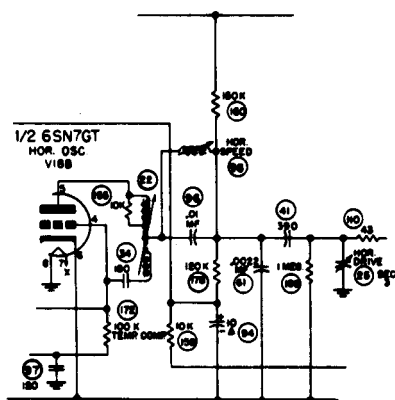
Fig. 1 — Magnavox

MAGNAVOX Chassis CT214
Improved horizontal stability
 (see Fig. 1).

An iron-slug speed coil (part No. 360346G1) as horizontal-oscillator frequency control is used in later production runs of the above chassis instead of the 120- μmf unit originally employed. Should it be desired to install this unit for improved stability of horizontal deflection, instructions outlined below should be followed:

1. Remove fixed capacitor *C33* (connected to pin 3 of sync clipper) and replace with mica capacitor 180 μmf , 10%, 500 volts (part No. 250159G85). Note: The capacitor which is removed may be used in step 3 below.

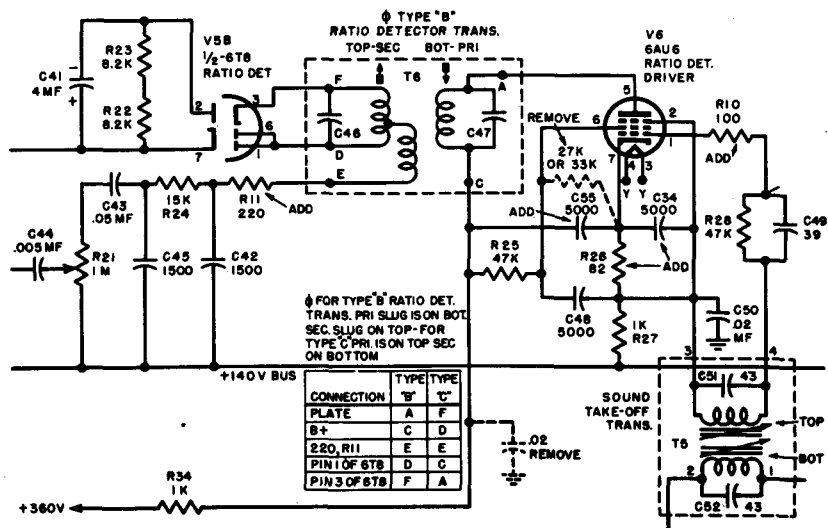
Fig. 2 — Majestic

Because of unstandardized FCC regulations, some tv stations are transmitting signals whose white level is near zero carrier. This condition may cause an objectionable buzz on receivers using the intercarrier sound system. To minimize this buzz on 94, 97, or 98 series receivers, the following circuit revision is recommended. Note: This revision has been made on production receivers which are identified by a rubber-stamped letter "B" on the rear panel of the chassis.

1. Remove the .02- μ f, 400-volt paper capacitor (6AU6 plate decoupling at junction of 1-k (*R34*) and 47-k (*R25*) resistors, located at a

terminal of the ratio-detector transformer).

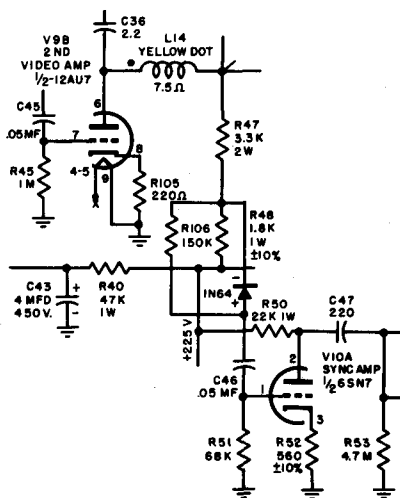
Fig. 3 — Majestic

MAJESTIC Chassis 99 through 103, 105
Improved sync clipping and better horizontal hold
(see Fig. 3).

A crystal diode 1N64, is connected in series with the sync take-off lead to provide additional clipping action. The value of *R51* (grid resistor of sync amplifier) is changed from 1 meg to 68,000 ohms.

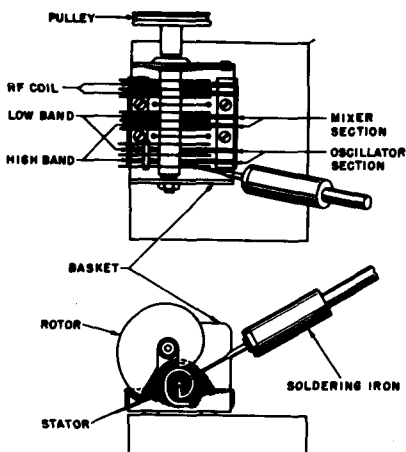
Fig. 4 — Meck

MECK Chassis with
TT-10006 tuner
Intermittent or low-sensitivity tuners (see Fig. 4).

The TT-10006 tuner depends upon a variable inductance for its correct operation. This variable inductance unit consists of the carriage, mounted on top of the tuner, the stator coil assembly, and the rotor plate assembly. The carriage is the U-shaped bracket which holds the copper rotor plate assembly and the rotor shaft. The stator coil assembly consists of six printed coils which are molded on linen bakelite strips. The center of each printed coil is terminated in a tinned eyelet which extends through the linen bakelite.

Tuners in which this bond between the coil center and the eyelet is intermittent, can be repaired with a small soldering iron with the tip

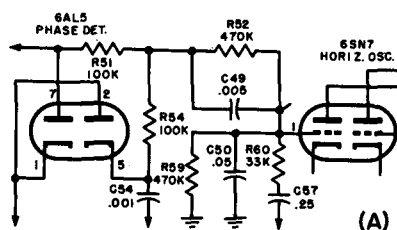
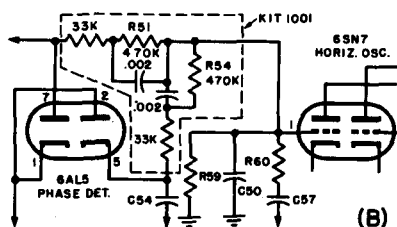
Fig. 7 — Montgomery Ward

To correct this condition changes are made in the 6AL5 phase de-

tector circuit. Chassis already having these changes incorporated are stamped "YB" on the rear flange. Sets without these changes are stamped "YA." Part (A) of the figure shows the original (YA) 6AL5 circuit and part (B) shows the revised (YB) circuit. All parts necessary to make this change are supplied pre-connected in kit form. The component parts in this kit are listed below:

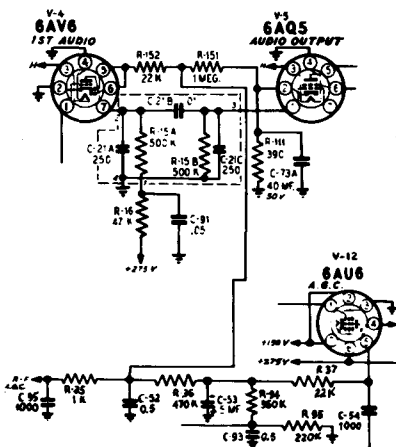
Fig. 9 — Montgomery Ward

Near the end of production a change was made in the agc circuit to improve the signal-to-noise ratio for fringe-area operation. This

Remove the Following Components
in the Plate Voltage-Divider Circuit
of the Agc Tube

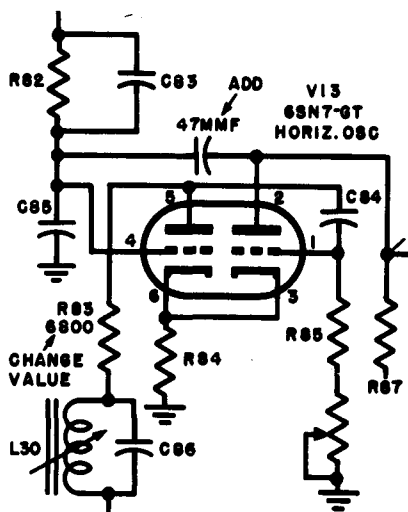
Fig. 11 — Montgomery Ward

Models 84HA-3010 A, B, C
Improved horizontal sync
(see Fig. 11).

To improve the horizontal sync, proceed as follows:

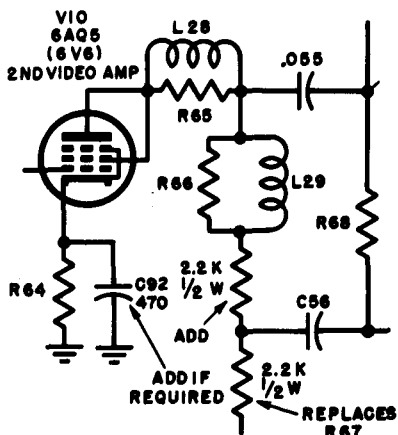
Fig. 12 — Montgomery Ward

(see Fig. 12).

To obtain a greater white to black ratio proceed as follows:

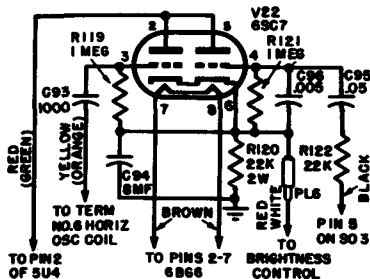
Fig. 13 — Montgomery Ward

After these sets reached the field, a picture-tube protective circuit kit was made available for installation. The purpose of this circuit is to cut off the intense electron beam in the picture tube in event of failure in either the horizontal- or vertical-sweep circuits. This prevents burning a line into the face of the picture tube and rendering the tube useless.

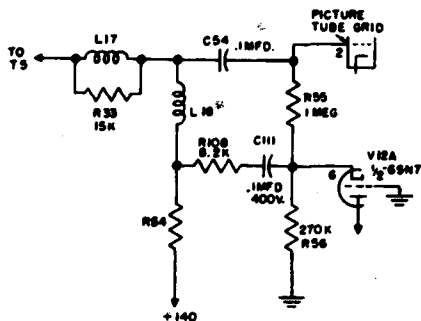
Fig. 14 — Montgomery Ward

Picture twist at high brightness settings (see Fig. 14).

If picture twist occurs mainly upon advancing the brightness control, the d-c restorer circuit should be altered as follows:

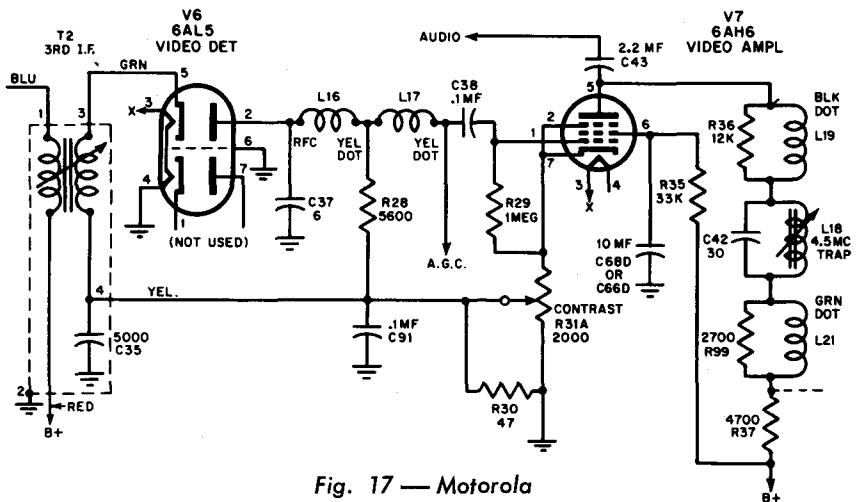
Fig. 17 — Motorola

MOTOROLA Chassis TS-89, TS-95
Improved compensation
(see Fig. 17).

An improvement in picture quality is achieved with a change in compensating coils. *L17* (in video-detector circuit) is changed from a red-dot coil to a yellow-dot coil; *L19* (in plate circuit of video amplifier) is changed from a red-dot coil to a black-dot coil; and *L21* (in plate circuit of video amplifier) is changed from a green-black dot coil to a green-dot coil. With this change in compensation, the R-C network on the tapped contrast control, *R31A*, is eliminated. Later production runs already include this modification.

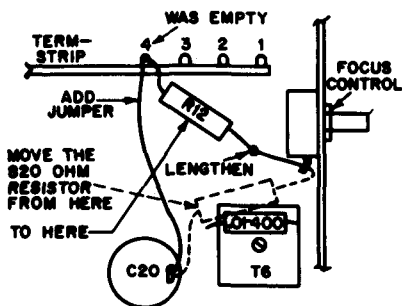
Fig. 26 — Muntz

MUNTZ Chassis 17A series
Improved horizontal stability
(see Fig. 26).

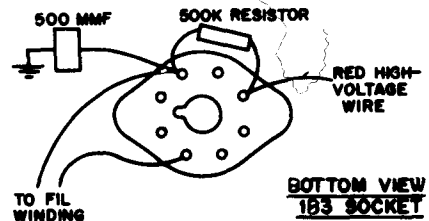
Fig. 29 — Muntz

MUNTZ Chassis M169
Frying sound at low picture-control settings (see Fig. 29).

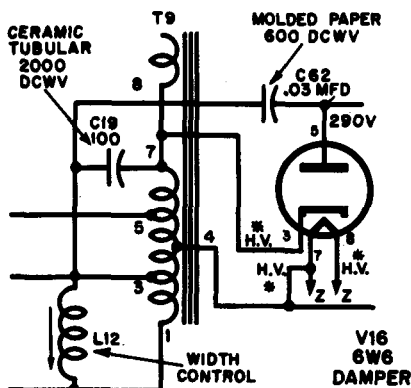
Fig. 34—Pacific Mercury

PACIFIC MERCURY All models
Horizontal-sync instability
 (see Fig. 34).

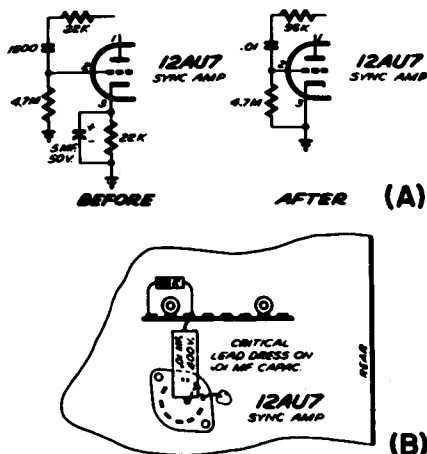
Fig. 37 — Packard Bell

Most of the instability encountered in weak-signal areas is caused by noise pulses of long duration. The changes to the sync amplifier as shown in part (A) of the figure are to be used in fringe areas only. The lead dress of the .01- μ f coupling capacitor is critical. See part (B) of the figure for proper lead dress.

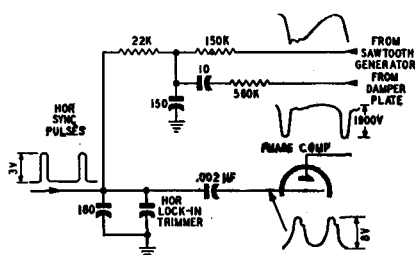
Fig. 42 — Philco

PHILCO Models 50-1403,
50-1630
Horizontal foldover
(see Fig. 42).

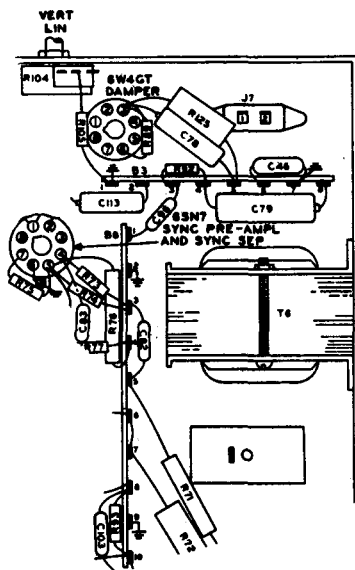
Fig. 45 — Philco

Horizontal tear at the top of the picture may be caused by a horizontal-damper lead radiating energy

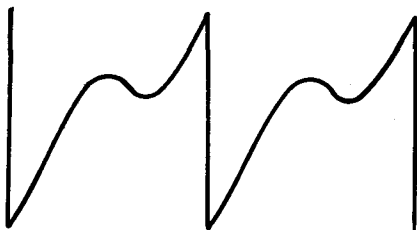
Fig. 46 — Philco

PHILCO Model 50-T1400
Horizontal-oscillator squeal
(see Fig. 46).

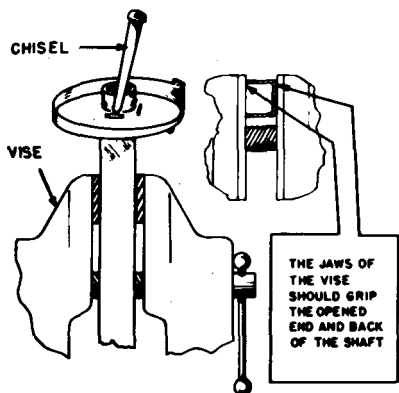
Fig. 48 — Philco

PHILCO Model 51-PT1200
Replacement of fine-tuning cam (see Fig. 48).

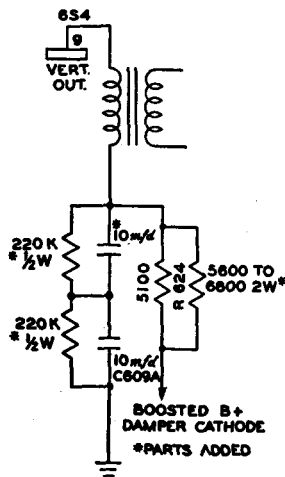
Fig. 55 — Philco

If vertical foldover is encountered at the bottom of the screen, in most cases it is due to the 6S4 be-

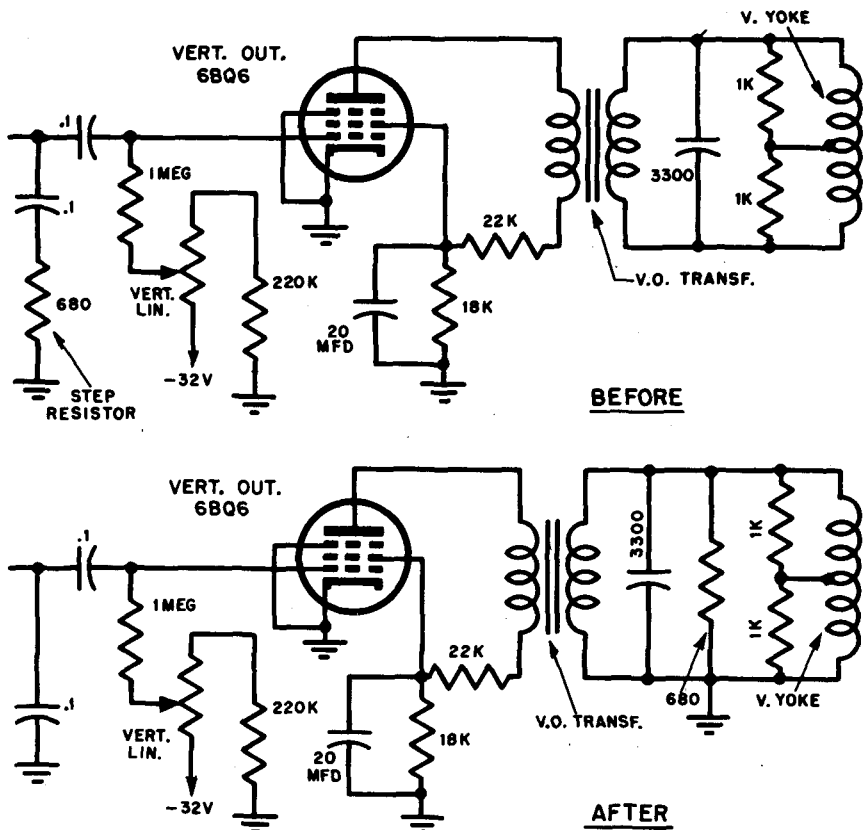
Fig. 59 — Philco

Some cases of vertical-output transformer hum have been reported. In order to minimize the buzz in the transformer (part No. 32-8515), the peak voltage on the transformer primary and secondary can be reduced by the following expedient without any compromise in performance. This reduction in peak voltage is accomplished by removing the 680-ohm step resistor in the vertical-

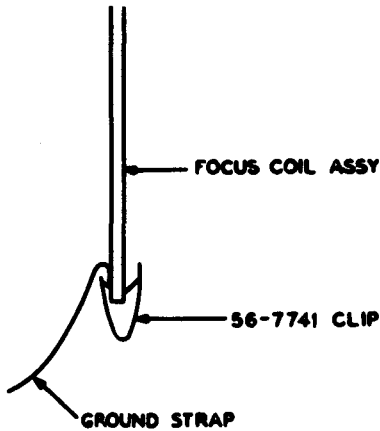
Fig. 63 — Philco

Reducing harmonic beat
(see Fig. 63).
