Introduction

This is a series of volumes which deal with specific TV receiver troubles and their cures. These trouble cures are the TV manufacturers' answers to some of the problems that may arise in their particular receivers.

TV

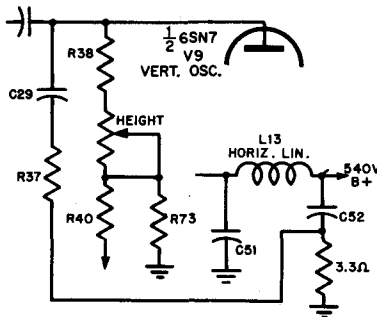
Fig. 1 — Philharmonic

1. Place a 3.3-ohm resistor in series with C52 (.05 μ f) to ground. This capacitor, shown in the figure,

is connected to one side of the linearity coil.

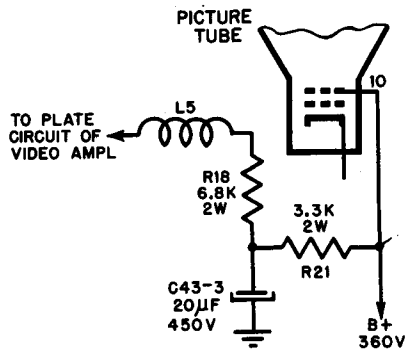
Fig. 2 — Philharmonic

If the set is going to be operated under conditions of low line voltages (less than 105 volts), make the following changes:

1. Remove C58, .02- μ f, 1,000-volt capacitor connected between pin 10 of the picture tube and ground.

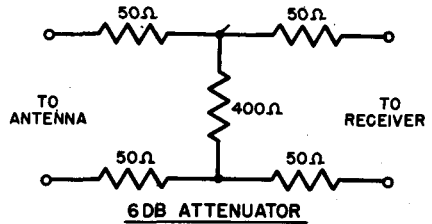
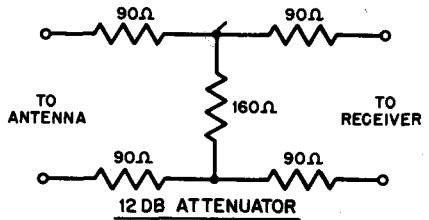
Fig. 3 - Pilot

In strong-signal areas, excessive input at the antenna terminals will produce picture smear and picture jitter. This is due to cross-modulation effects in the r-f amplifier which

may operate as a detector on the nonlinear portion of its curve near cut-off. An attenuation network at the antenna terminals will remedy this condition. A 6-db and a 12-db attenuator network are shown in the figure.

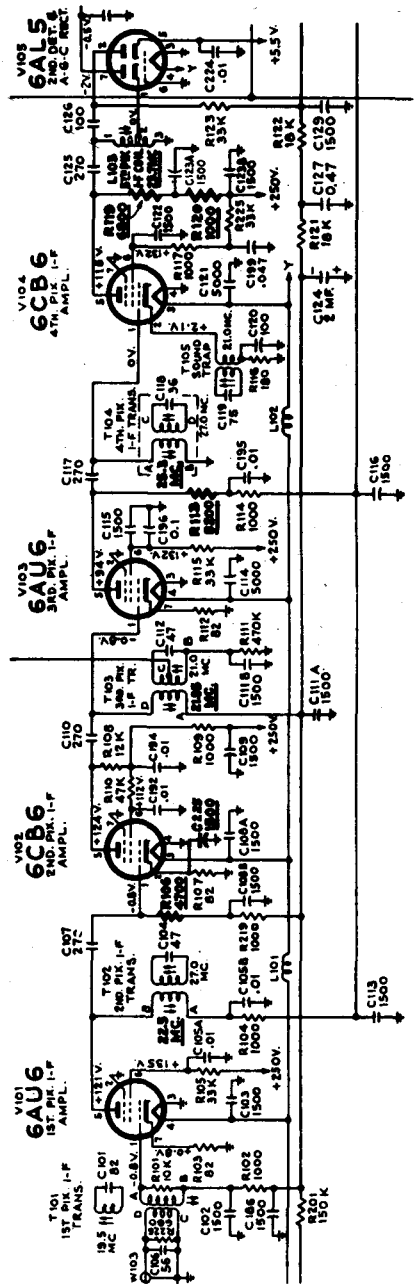
Fig. 5 - RCA Victor

In those fringe areas where additional sound gain is desirable, the

following suggestion will effect up to a 4 to 1 increase in sound gain. See the figure for a partial schematic diagram showing the changes for model 7T103.

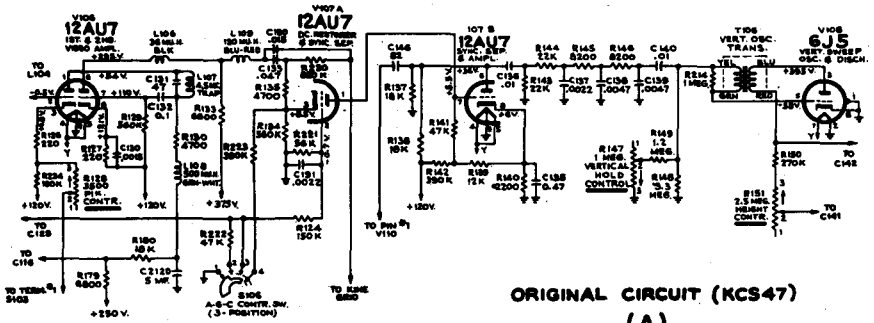
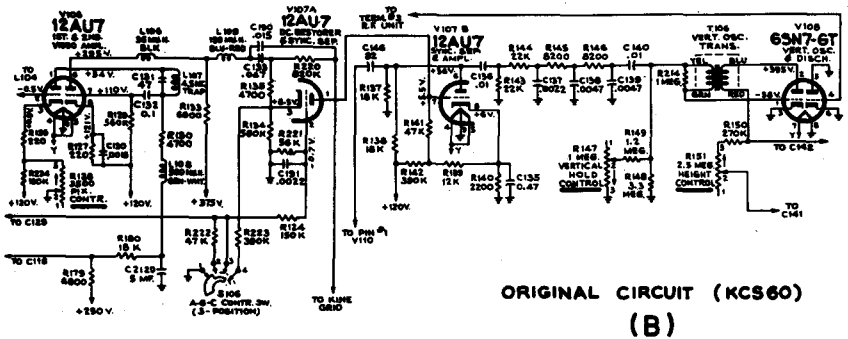
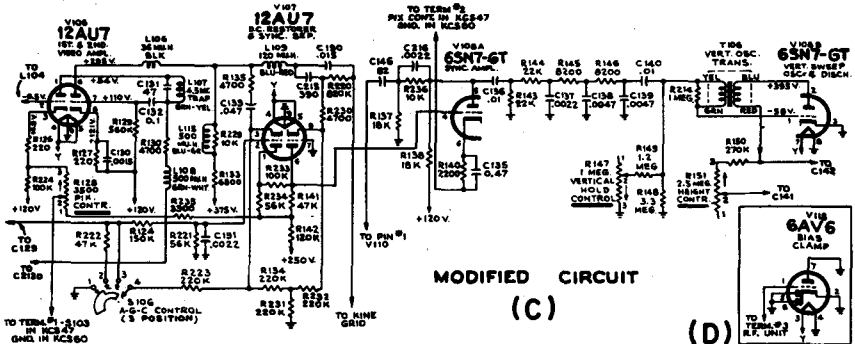
Fig. 6 - RCA Victor

Comparing part (A) with part (C), it will be noted that V107, which was originally used as a d-c restorer, sync separator and amplifier, is reconnected with the first half of the tube as d-c restorer and horizontal-sync separator, and with the second half connected as a vertical-sync separator. V108, which was a 6J5 type used as a vertical-sweep oscillator and discharge tube, is replaced by a 6SN7 type, half of which is used as the vertical-sweep oscillator and discharge tube, while the

remaining half is used as a sync amplifier.

tion of the 6SN7 tube V108 which was formerly used as a bias-clamp is reconnected as a sync amplifier, and it is necessary to install a separate bias-clamp tube. The connections for the additional bias-clamp are shown in part (D) of the figure. Although type 6AV6 is recommend-

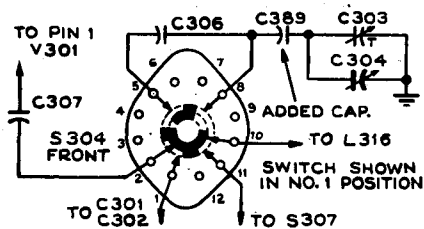
Fig. 7 — RCA Victor

RCA VICTOR Model 9TW390
Preventing heater-choke burnout (see Fig. 7).

Early production models of the receiver will not have this capacitor in the radio chassis.

When the radio-function switch is in the TV position, the filament voltage is present on the high side of the tuning capacitor (C303/C304) due to the function switch design. Any shorting of the tuning capacitors to ground causes L314 (filament choke) to burn out. The insertion of the capacitor removes filament voltage from the tuning capacitor without affecting its operation.

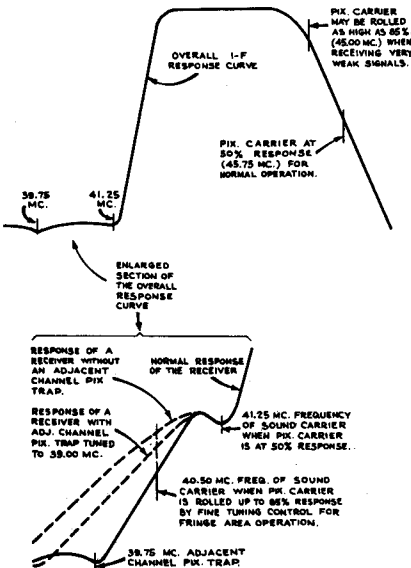
Fig. 8 — RCA Victor

It is possible to overcome the above described difficulty in many cases by a simple adjustment which can be made in the field without the aid of test equipment. When the picture carrier is rolled up the slope by .75 mc, the adjacent channel picture carrier is lowered in frequency to 39.00 mc and no longer falls into the adjacent channel picture trap. If the trap is returned to 39.00 mc, it will permit the response at 40.50 mc to rise somewhat, produce stronger sound, and will produce greater adjacent channel picture rejection un-

der the actual operating condition. If a strong signal is available on another channel and the fine tuning is adjusted to roll the picture carrier down the slope to the normal 50-percent point, the adjacent channel picture trap will appear mistuned. However, it is not likely that adjacent channel picture interference will be experienced on strong signals.

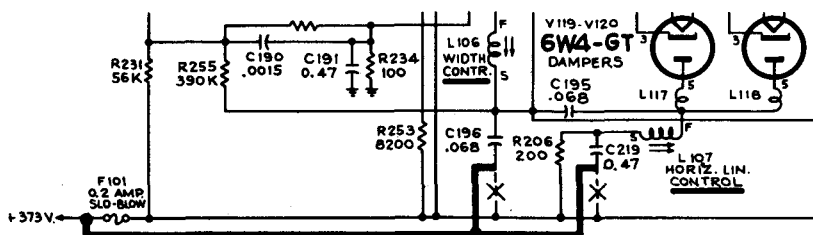
Fig. 9 — RCA Victor

In a few 21-inch receivers, the slow-blow fuse has been known to fail due to a-c from the sweep circuit flowing through *F101*. To elim-

inate this difficulty the factory has made a wiring change. *C196* (.068 μ f) and *C219* (.047 μ f) were changed from their original connection and reconnected to the +373 volt bus side of the fuse as shown in the partial schematic diagram.

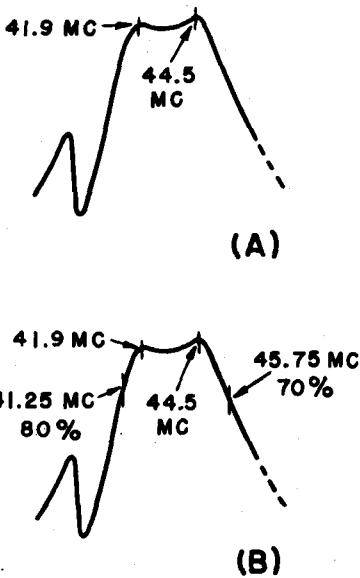
Fig. 10 — RCA Victor

It has been found desirable to align *T1* (converter transformer) and *T104* (1st picture i-f grid transformer) to the response shown in part (B) of the figure rather than as it appears in the service data (see part A).

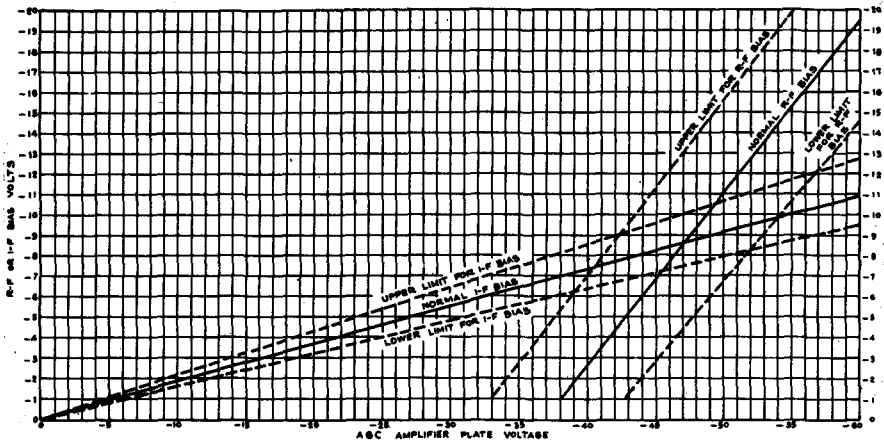
Fig. 11 — RCA Victor

According to the graph, when the agc amplifier plate measures -45 volts, the i-f bias should be -8.2 volts. If the i-f bias actually measured -10 volts, it indicates that *R143* (68-k resistor in i-f agc bus) or *R145* (150-k resistor connected to plate of agc amplifier) is too low

in value and/or *R144* or *R150* (82-k and 150-k resistors connected to ground in the i-f agc bus) is too high. If, however, the i-f bias actually measured —6 volts, it indicates *R143* or *R145* is too high in value and/or *R144* or *R150* is too low. The resistors originally employed in production were 10 percent tolerance units. However, if *R143* and *R145* are at one limit of their tolerance and *R144* and *R150* are at the other limit of their tolerance, a considerable error in i-f bias is produced.

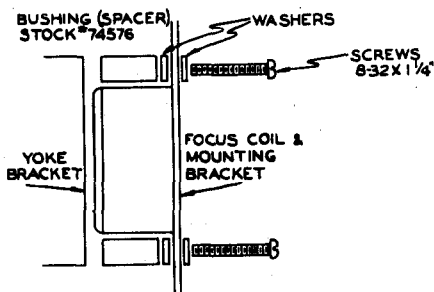
Fig. 14 — RCA Victor

If it is impossible to remove picture-tube shadows by the prescribed method (see service notes) of adjusting the focus coil and ion-trap magnet, then make the following test:

1. Remove the two focus coil mounting screws (8-32 x $\frac{3}{8}$ ") and reverse the focus coil. Temporarily replace it in a position adjacent to the deflection yoke.

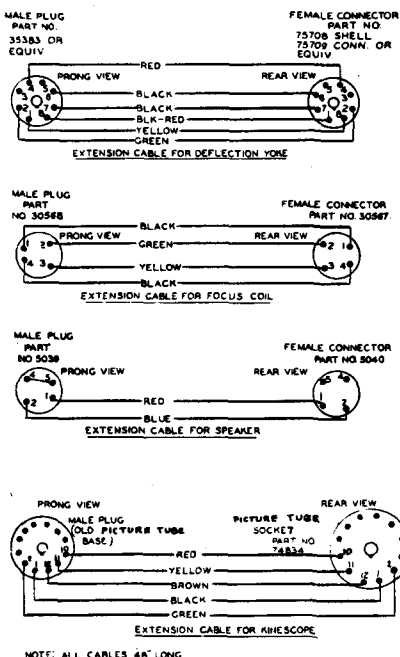
Fig. 16 - RCA Victor

The yoke, focus coil, and picture tube are fastened to the cabinet in the above series receivers and not to the chassis as in all previous models.

When the chassis is removed from the cabinet for service, it will be necessary to unplug the yoke and focus coil. With either of these two components out of the circuit, the receiver cannot be operated because of the +B disconnect incorporated in each plug.

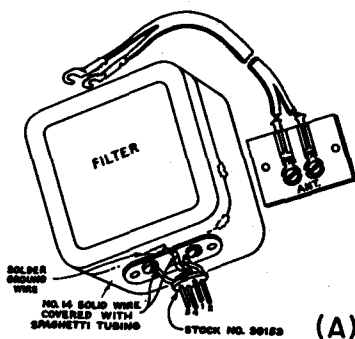
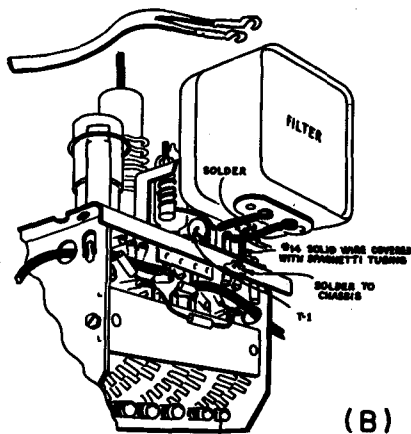
Fig. 18 — RCA Victor

Part (A) of the figure shows the method of attaching the antenna input connectors to the filter so that

it can be plugged directly into the antenna matching units employed with KRK5, KRK7, and KRK8 r-f tuners.

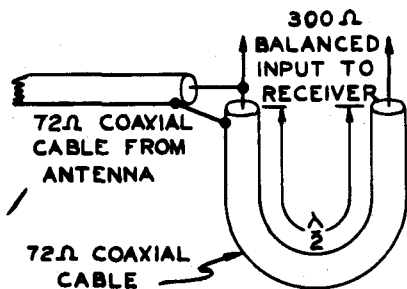
Fig. 20 — RCA Victor

RCA VICTOR Models with KRK2
tuners
**Coax to balanced line
matching network**
(see Fig. 20).

In some locations it may be necessary to use 72-ohm coax transmission line between antenna and receiver because of reflection or interference pick-up. Later receivers are provided with a 72-ohm coax input in addition to the usual 300-ohm input. Early receivers employing the above series r-f tuner units are provided only with 300-ohm balanced input. To connect the coax to these early receivers, construct a network as shown in the figure. The matching section should be one electrical half wavelength long for the picture carrier of the weakest signal received.

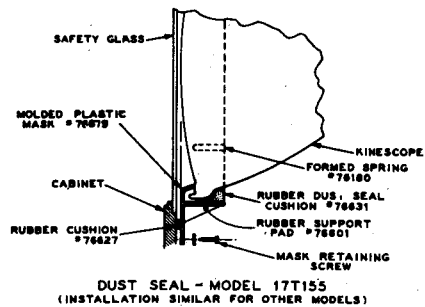
Fig. 23 — RCA Victor

To install the dust seal, proceed as follows:

1. Apply cement (see note below) around entire periphery of both the picture tube and the mask surfaces which are in contact with the dust seal. Caution: Do not apply cement to the high-voltage clip. The spring-mounting clips should be pushed securely in place so that they do not protrude beyond the mask flange.

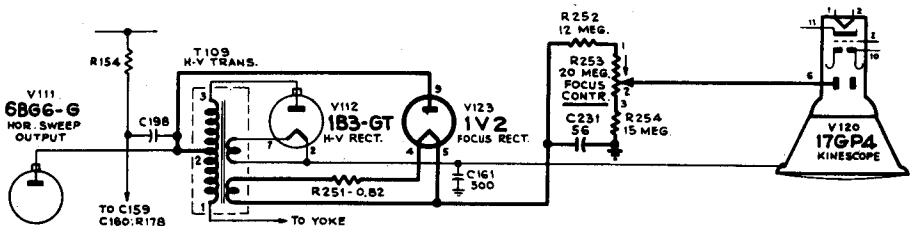
Fig. 24 — RCA Victor

Since the focus magnet is dispensed with on the 17GP4, a new centering magnet is provided to center the picture on the screen. This magnet assembly is in the form of two wire rings mounted on a non-magnetic form which is placed around the neck of the picture tube, and at a distance of about three-eighths of an inch in back of the deflection yoke. When the magnets are rotated on the tube so that the gaps in the rings are together, then maximum picture shifting effect is produced. When the rings are rotated so that their gaps are 180 degrees apart, then little or no shifting of the picture is obtained. To shift the picture, rotate one of the magnets with respect to the other. To move the picture in a desired direction, rotate the entire centering mag-

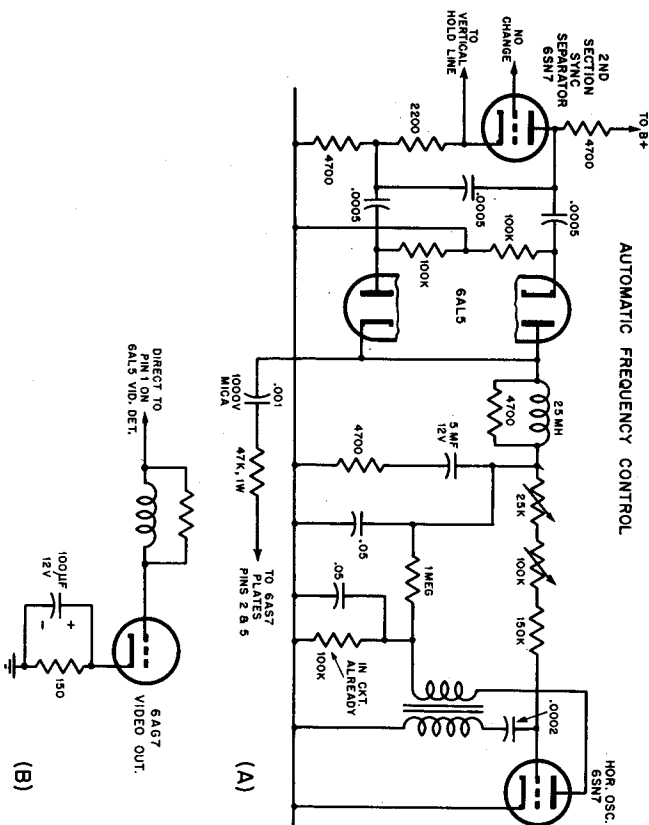
Fig. 25 — Remington

Increasing horizontal deflection.

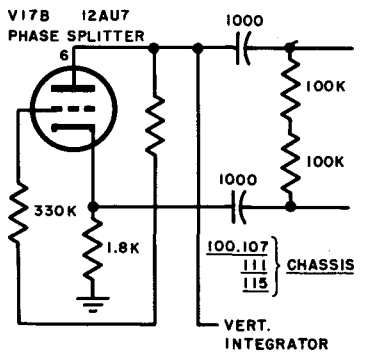
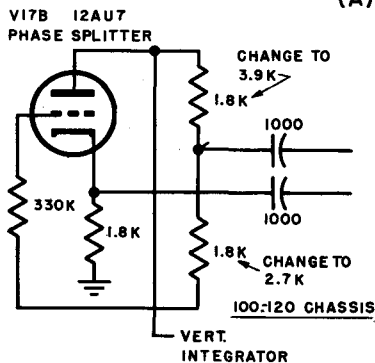
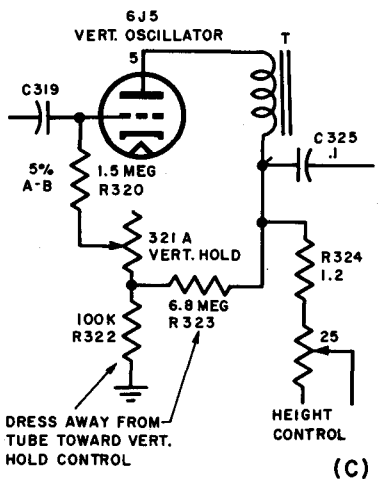
Fig. 27 — Sears Roebuck

For further improvement in this circuit and to minimize vertical drift, the following changes may be made in low-signal areas. Change the 1.8-k resistor R351, closest to the plate of the phase splitter, to 3.9 k, and the lower 1.8-k resistor R246 to

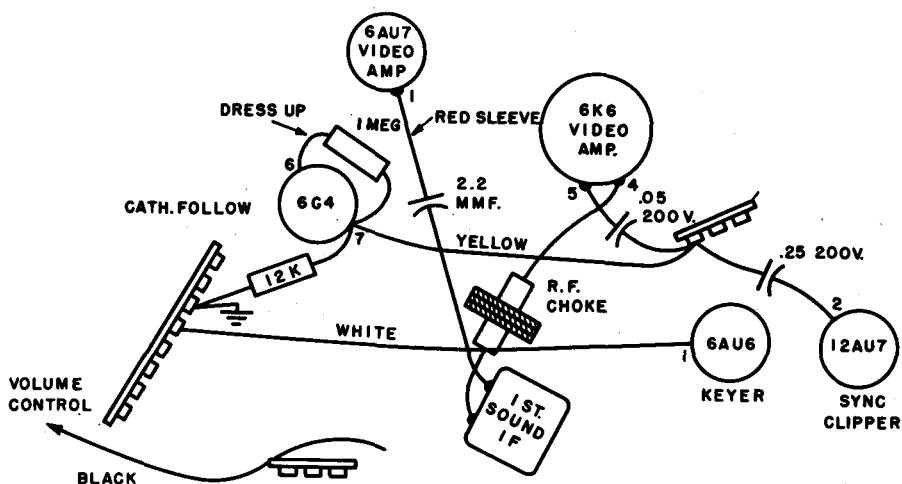
Fig. 28 — Sears Roebuck

This buzz can be eliminated through careful lead dress of the offending parts. In particular, the yellow lead to the cathode of the keyer tube and the white wire to the grid of the same tube. Both leads are

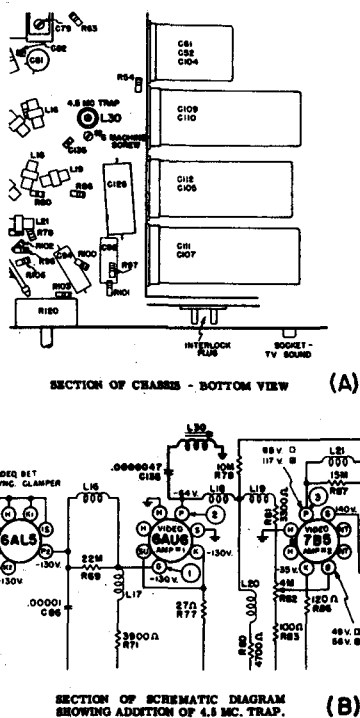
Fig. 30 - Sears Roebuck

Later production of the above chassis incorporates a 4.5-mc trap off the plate of the first video-amplifier tube 6AU6. This is necessary to

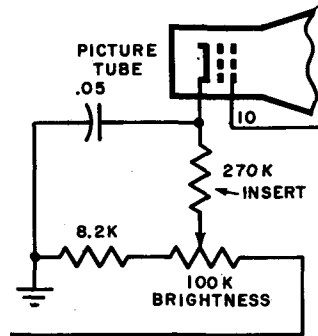
Fig. 32 — Sears Roebuck

To correct this condition, remove the yellow wire from pin 11, cathode, of the picture tube and remove the .05- μ f capacitor, *C28*, from the center arm of the brightness control. Attach a 270,000-ohm, 1-watt resistor to the center arm of the brightness control. Attach the other end of the resistor to the yellow wire from pin 11 and the .05- μ f capacitor. It will be noted that to obtain good

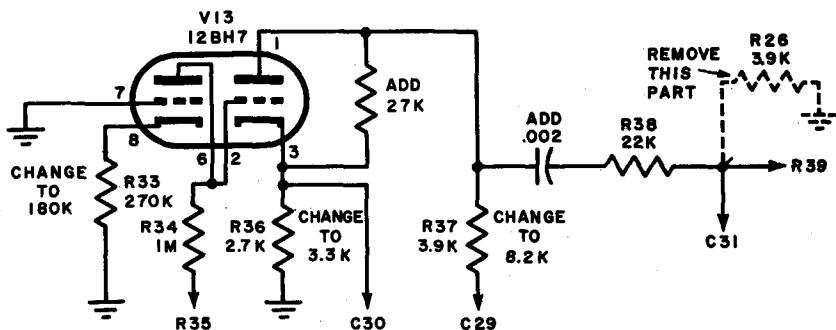
Fig. 33 — Sears Roebuck

In fringe areas where the above chassis is more critical vertically and more susceptible to noise pulses, it is possible by making a few minor component changes to improve the noise immunity and vertical stability. The changes should be made as follows (see the figure):

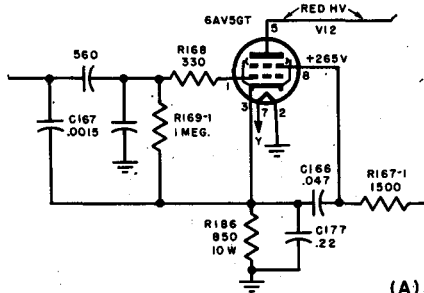
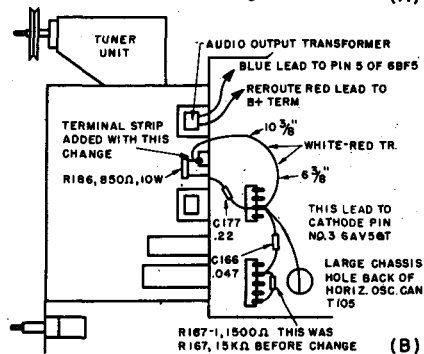
Fig. 34 — Sears Roebuck

Later production of the above chassis incorporate the accompanying circuit change to decrease the dissipation in the 6AV5GT horizontal-output tube and increase the life of this tube. In every case where a model 106 or 107 with the above chassis is returned for service, this change should be made. The following parts, available as a kit (part

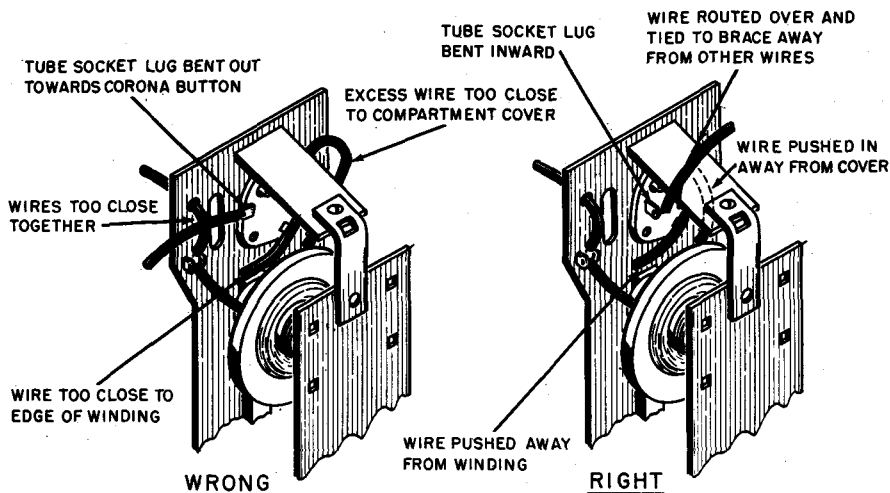
Fig. 35 — Sears Roebuck

In the future the leads in the compartments will be kept as short as possible with any excess pulled through to the back side of the bakelite mounting base and then routed through an additional polyethylene sleeving.

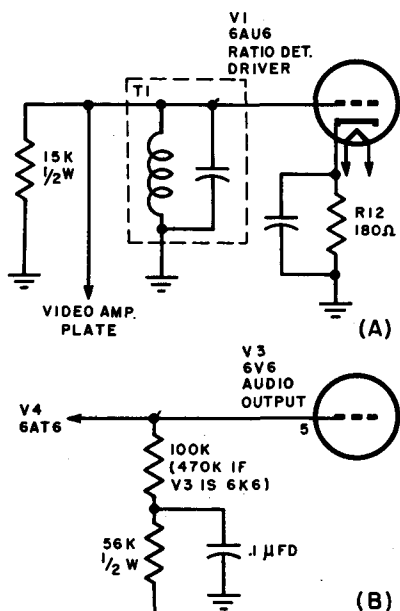
Fig. 36 — Sears Roebuck

A study of buzz conditions in the above models has revealed the

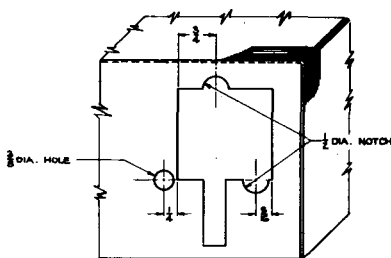
Fig. 38 — Sears Roebuck

SEARS ROEBUCK Chassis 528.631 Removal of tuner cover (see Fig. 38).

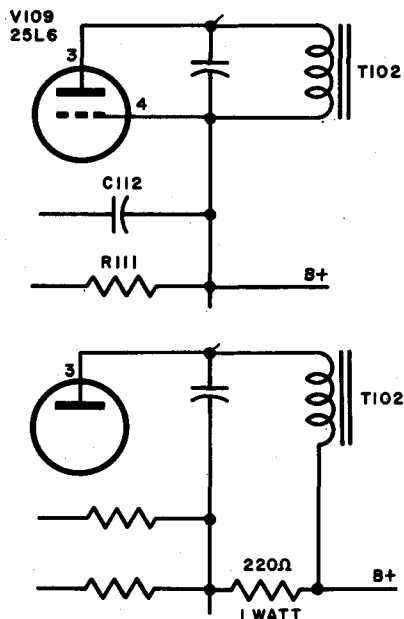
Fig. 39 — Sears Roebuck

SEARS ROEBUCK Chassis 549.102
Audio-hum reduction
 (see Fig. 39).

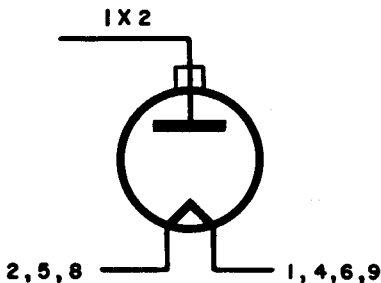
Fig. 40 — Sears Roebuck

Substitute 1X2 socket connections (see Fig. 40).

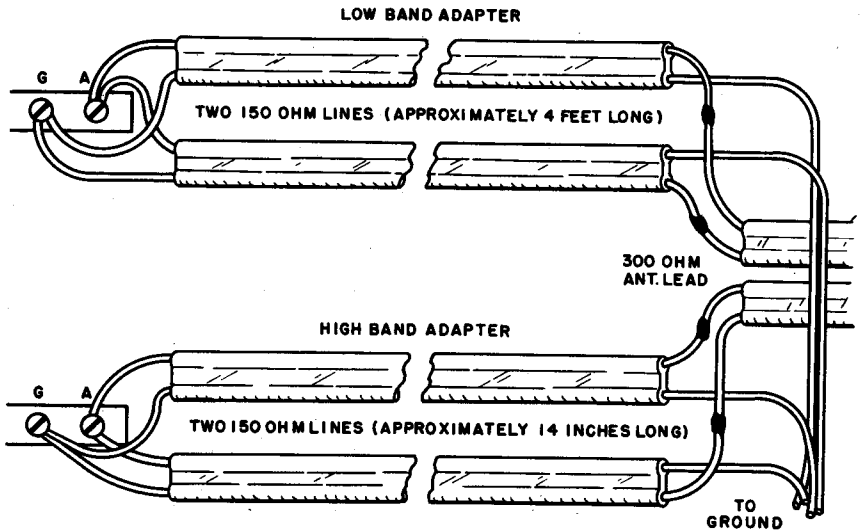
Fig. 41 — Sears Roebuck

The purpose of this arrangement (shown in the figure) is to connect a 300-ohm lead-in to those sets employing a 75-ohm antenna input. It consists of two adapters, one 14

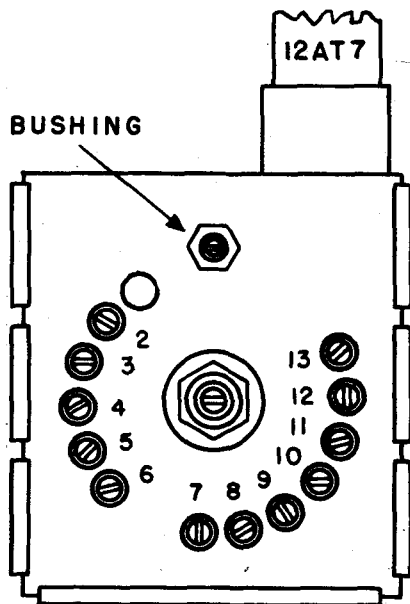
Fig. 43 — Sentinel

Tearing when set is jarred
(see Fig. 43).

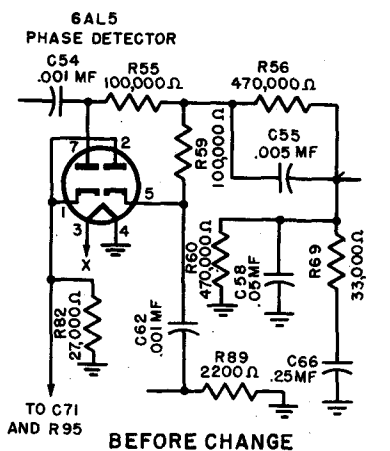
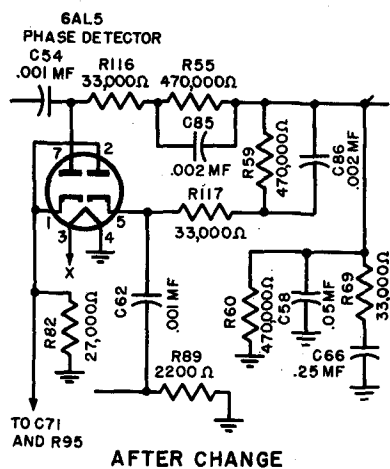
c. Two 33,000-ohm, 10%, 1/2-watt resistors *R116* and *R117* are added in series with *R59* and pin 5 and in series with *R55* and pin 7 on the 6AL5 phase-detector tube socket. Part number of these resistors are 27E333-2.

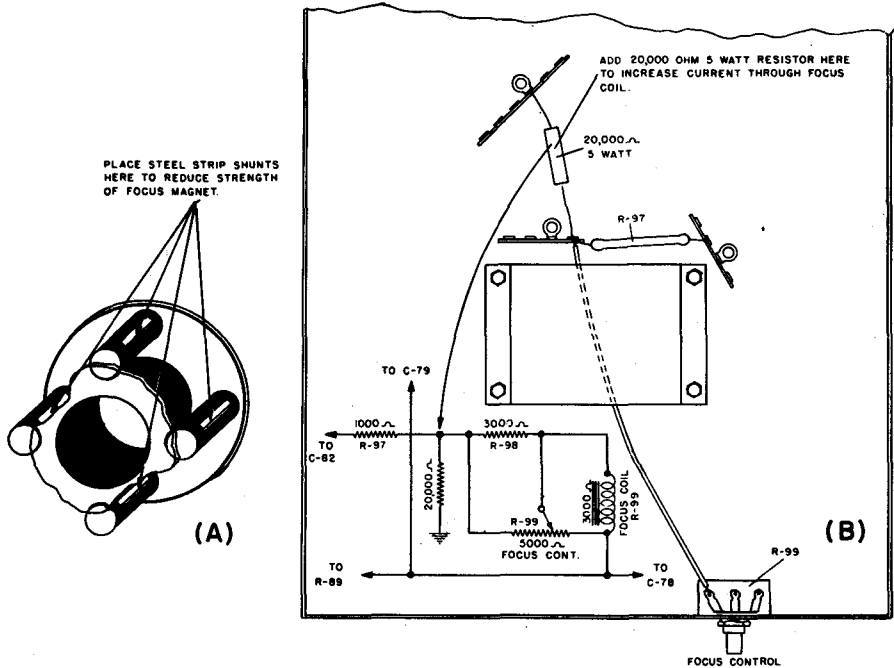
Fig. 48 — Sentinel

Place four steel strip shunts, approximately $\frac{3}{4}$ " \times $\frac{1}{8}$ " \times $\frac{1}{16}$ " around focus magnet as shown in part (A) of the figure. If this brings position of proper focusing within range of the focus control, no other changes are necessary. Should the addition of the four steel strip shunts improve focusing but still not bring correct focusing within the range of

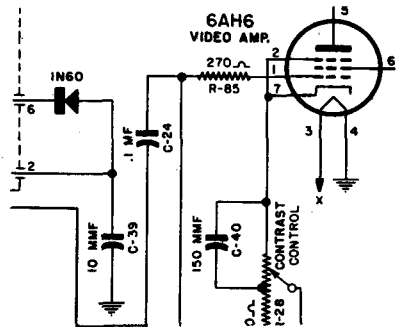
Fig. 49 — Sentinel

An early sign of crystal failure is excessive sound bars in the picture that are not due to fine-tuner mis-

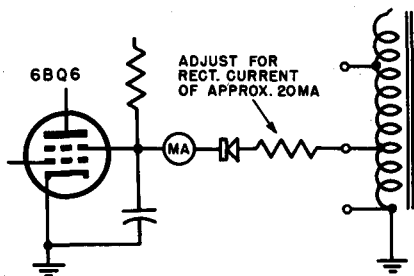
Fig. 55 — Satchell Carlson

When replacing a selenium rectifier in any of the models of F unit, be sure to check the rectifier current as a safety measure. The current must be held within the limits of 15 and 25 milliamperes, with 20 ma being considered optimum.

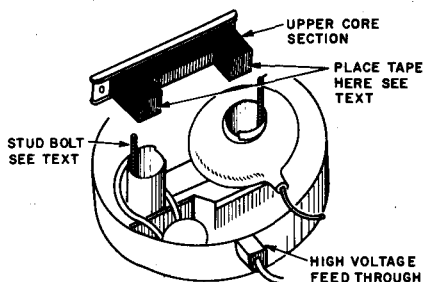
Fig. 56 — Satchell Carlson

Insufficient width and horizontal foldover (see Fig. 56).

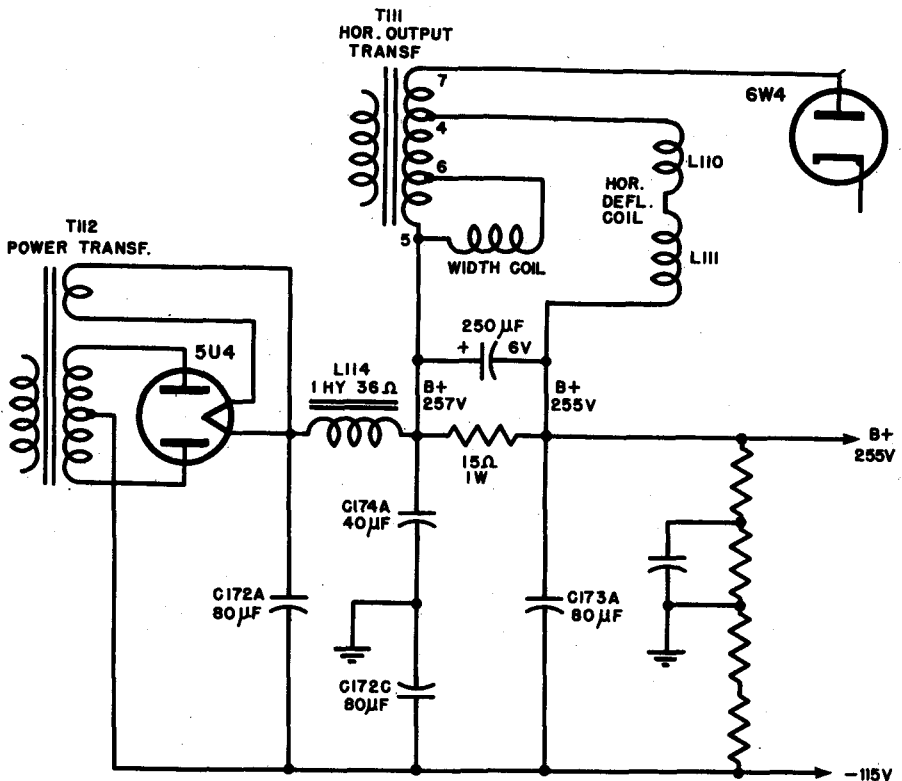
Fig. 57 — Shaw TV

SHAW TV Chassis 224
Improved horizontal centering
 (see Fig. 57).

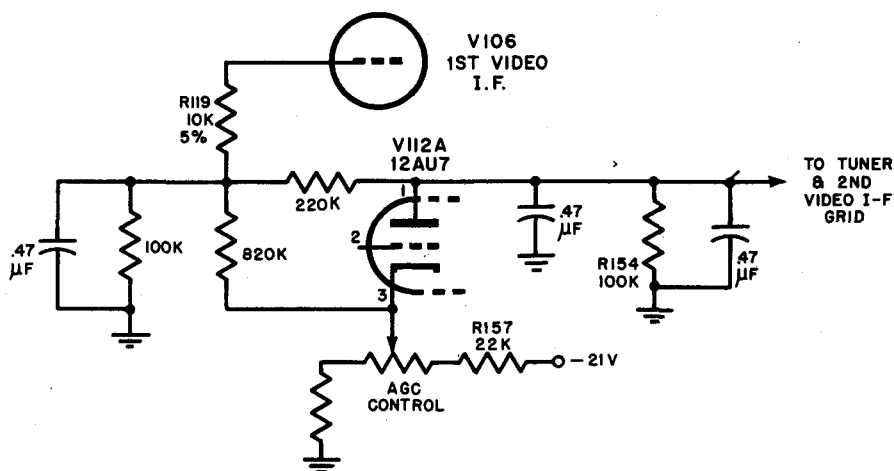
Fig. 58 — Shaw TV

1. Mount a single-lug terminal strip under the nut of the discriminator can (closest end to *V112* age tube).
