## Introduction

# TV

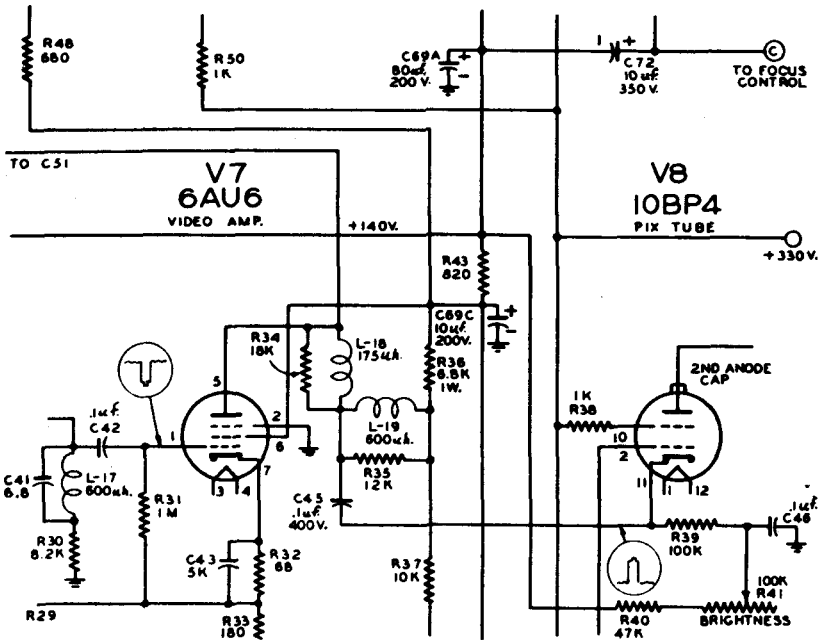
Fig. 1 — Sparton

**Reducing hum in final audio stage (see Fig. 1).**

To reduce objectionable hum introduced in the final audio stage through common coupling with the video amplifier, sync separator, and sync amplifier, a decoupling network has been devised in the +140 volt line feeding these points. A sectional schematic diagram of the video i-f circuit, showing *V7*, 6AU6 video amplifier, and its associated

R48. When this change is made, the 4-point terminal strip on the receiver chassis should be replaced with a 5-point strip to provide the additional tie point needed. C69C, the 10- $\mu$ f, 200-v capacitor, is an additional section in the original C69A and C69B filter.

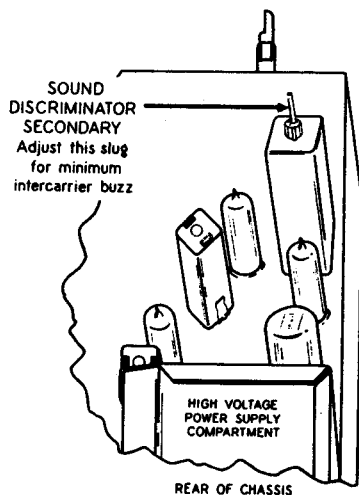
Fig. 10 — Stewart-Warner

If a prominent humming or buzzing sound is noted in the sound reception of a television broadcast, it may be due to a fault in transmission from the station, or incorrect adjustment of the discriminator transformer (tuning of secondary circuit) in the receiver.

This type of disturbance, which is only present when receiving a station signal, is known as "intercarrier buzz" and should not be confused with power supply hum that would occur upon failure of a filter condenser.

When intercarrier buzz is objectionable, first be sure that the receiver has been properly tuned to

the station. If intercarrier buzz is still too prominent, then it is advisable to check the adjustment of the sound discriminator secondary slug. This slug is accessible from the top of the chassis (see figure for slug location in a typical model).

As the slug is rotated approximately one-half turn in either direction, a "dip" point in the buzzing sound will be noted. At this position program sound will be clear and free from distortion, and buzz should be at an acceptable minimum if station transmission is not at fault.

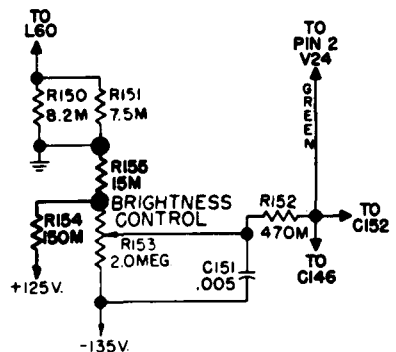
Fig. 20 — Sylvania

**SYLVANIA** Chassis 1-387-1, -437-3, -502-3  
**Improving operation of brightness control**  
*(see Fig. 20).*

To improve operation of the brightness control, two new resistors are added in later production. These are identified as *R154* and *R155* with values of 150,000 and 15,000 ohms respectively. See figure for connection. In some chassis, these resistors are identified as *R155* and *R156* or as *R156* and *R157*.

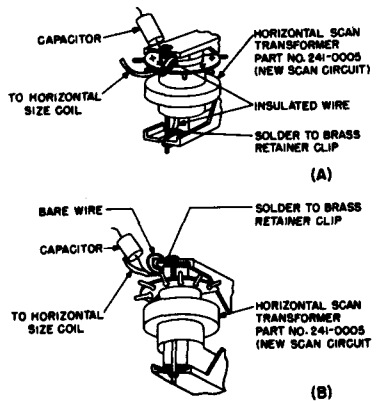
**Fig. 26 — Sylvania**

**SYLVANIA** All chassis with h-v transformer 241-0005  
**Arcing and corona in h-v transformer retaining clip**  
**(see Fig. 26).**

Arcing and corona in h-v transformer retaining clip may be corrected by connecting an insulated wire from the clip to the center transformer terminal as shown in sketch (A).

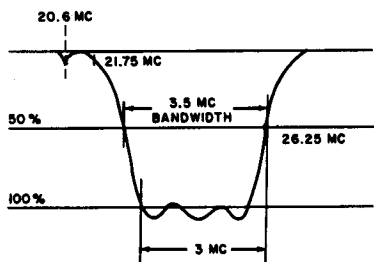
Fig. 28 — Trav-ler TV

To improve tracking of picture and sound in fringe areas, later production television receivers using the above chassis have incorporated a new i-f coil TV-L-142 in the second and third i-f stages. These are L42B and L42C respectively.

The new coil is approximately 2 inches in length and mounts in the original i-f coil chassis hole. There are two separate windings on each coil form. The winding nearer the chassis is the i-f winding and contains the same number of turns as the TV-L-13 previously used. Mutually coupled and approximately 3/16-inch from the edge of the i-f winding is the audio trap winding with a 47- $\mu\mu\text{f}$  ceramic capacitor in parallel. Both windings have separate tuning slugs and are adjusted individually.

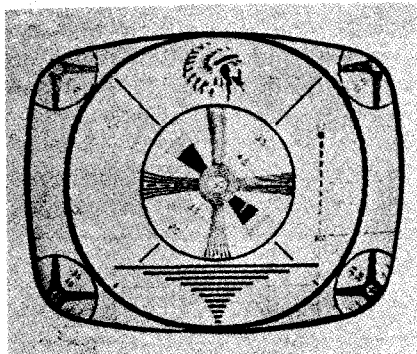
Fig. 39 — Westinghouse

**WESTINGHOUSE** Models with 6AU5 horizontal output tube  
**Ragged picture tube pattern**  
 (see Fig. 39).

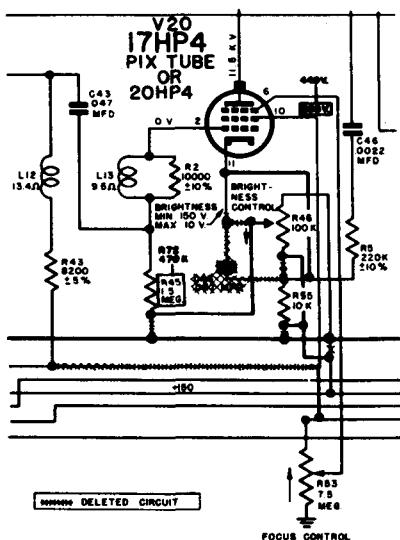
Fig. 46 — Zenith

The figure shows a revised brightness control circuit with original components and voltages shown inside boxes. Circuit changes were made to accommodate picture tubes with widely varying focus characteristics. The revised circuit can be used to advantage in those receivers where focusing difficulties are experienced with replacement picture tubes of makes other than those originally supplied in the receiver.
