TV

MANUFACTURERS' RECEIVER TROUBLE CURES

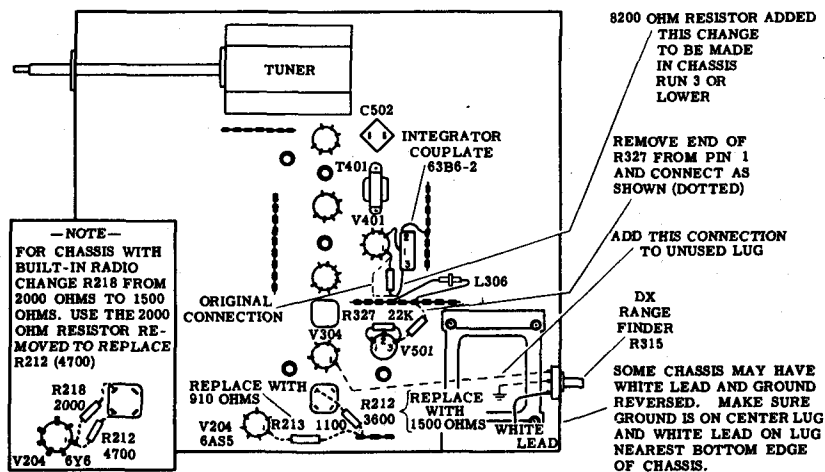
Fig. 2 — Admiral

The horizontal stability of the 19-series chassis is improved with the use of a new vertical sync integrator Couplate, 63B6-11. The circuit of this Couplate is the same as the 63B6-2 Couplate used in chassis stamped Run 6 or lower, except that resistor *R407* (22,000 ohms) is not contained in this new Couplate. In-

stead, resistor *R407* is connected externally from terminal 3 of the Couplate to pin 1 of *V401B*. This change in integrator Couplates improves the horizontal sync stability by increasing the amplitude and “squaring up” the horizontal sync pulses.

To replace the old Couplate, 63B6-2, with the new improved Couplate, 63B6-11, omit *R443*, the 8,200-ohm resistor added at Run 4. Chassis stamped Run 3 or lower will not have this resistor. Connect *R407*, a 22,000-ohm, 1/2-watt resistor, 60B8-223, between terminal 3 of the new Couplate and pin 1 of *V401B*.

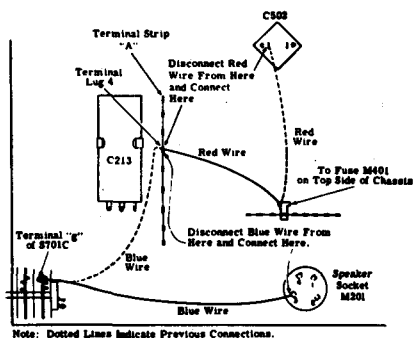
ADMIRAL Chassis 19E1, 19G1, 19N1 Preventing fuse failure (see Fig. 4).

In some of the above chassis, the $\frac{3}{8}$ -amp fuse *M401* may blow when the function switch is rotated from the Radio to the TV position. This occurs because in some 77B43

Note: Dotted Lines Indicate Previous Connections.

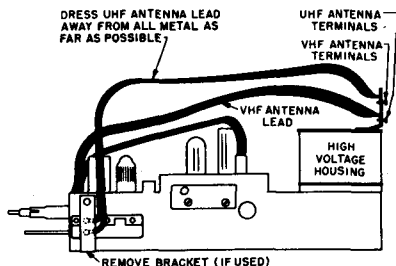
Fig. 10 — Admiral

Poor performance of all-channel receivers on uhf may be caused

by the uhf antenna lead from the uhf antenna terminals to the uhf tuner being close to or touching the metal brackets of the rear picture tube mount. This lead is purposely long and acts as a quarter-wave trap at the mean frequency of the higher vhf channels.

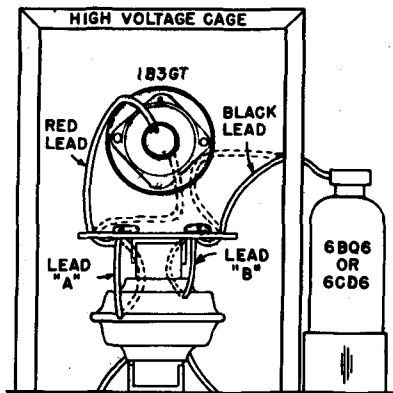
Fig. 19 — Capehart

It is important that the dress of the leads in the h-v cage be checked carefully after replacement of any tubes or components in this section. In the drawing, proper dress of high potential leads within the h-v cage is illustrated by the leads which are drawn with solid lines. This is the position in which they are placed in manufacturing. Leads represented by dotted lines indicated examples of improper dress. Note that lead A and lead B must be separated from each other and looped away from the transformer winding (toward rear of chassis). The red and black leads must be dressed away from each other. The red lead can be properly dressed by rotating the 1B3 tube cap in a clockwise direction. The black lead can be properly dressed by rotating the 6BQ6 tube cap in a counterclockwise direction on a 70-

degree chassis or on a 90-degree chassis, and by rotating the 6CD6 tube cap in a clockwise direction.
