Introduction

TV

VOLUME 7

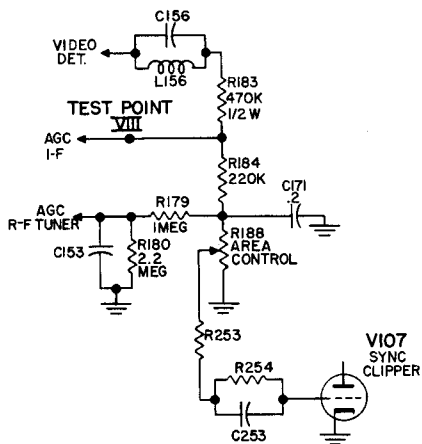
Improved interlace and vertical control range (see Fig. 1)

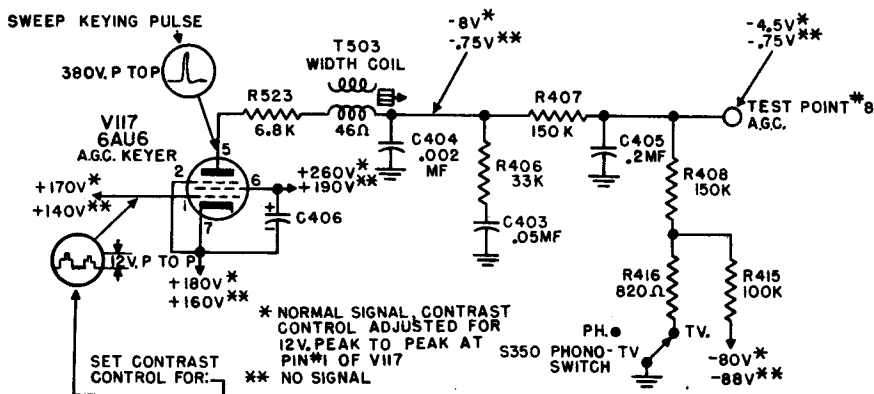
Fig. 3 — General Electric

The agc action may be seriously impaired or fail completely if the

2. With a vtvm, the voltage at the agc test point No. 8 should read at least -28 volts and in some receivers as high as -40 volts.

3. A further check of the voltages throughout the agc keyer circuit may be made by checking the voltages shown in the accompanying diagram. First adjust the receiver for normal picture. Then, with an oscilloscope, adjust the contrast control for a 12-volt peak-to-peak signal as shown at pin 1, *V117*. The keying pulse on the

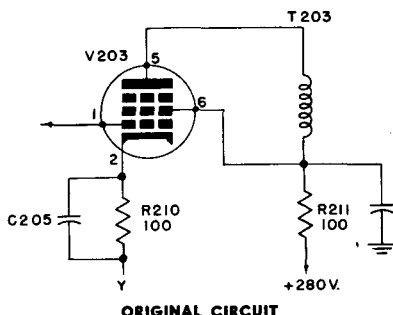
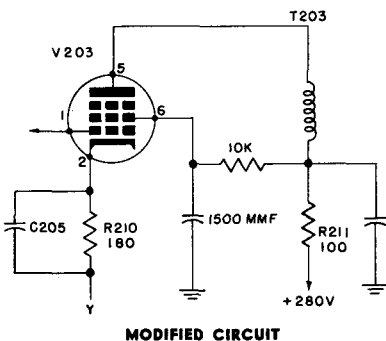
Fig. 13 — Magnavox

MAGNAVOX Chassis 105-series
Signal blocking in strong signal areas (see Fig. 13).

If signal blocks when tuning from weak to strong signals, proceed as follows:

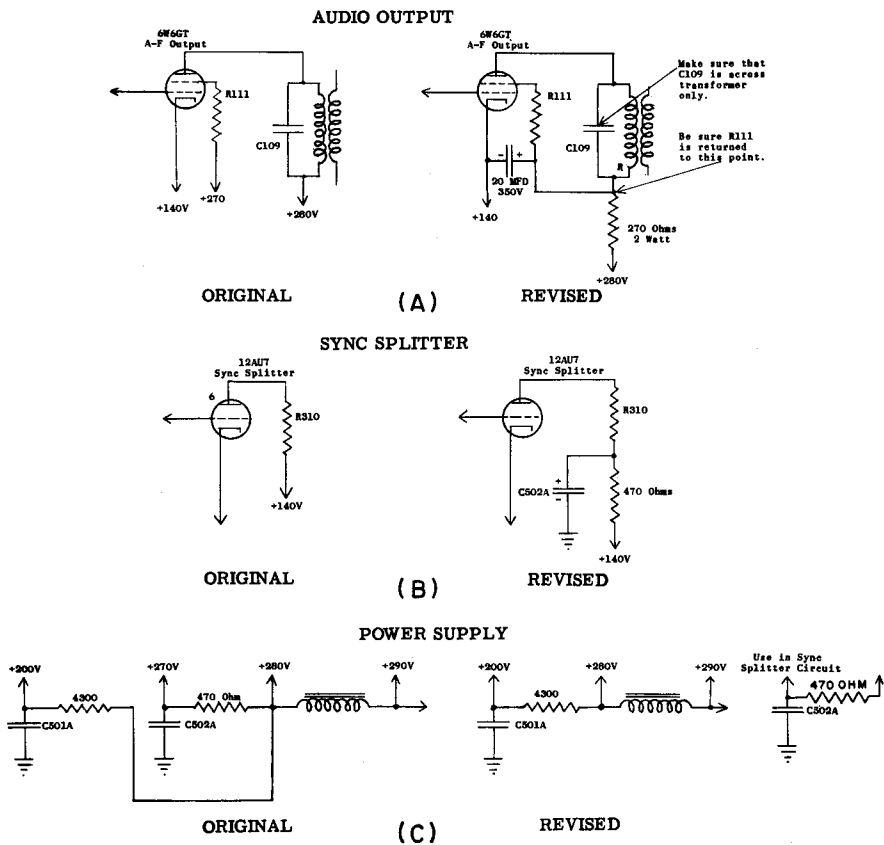
Fig. 14 — Magnavox

MAGNAVOX Chassis 108-series Reducing hum and buzz (see Fig. 14).

The schematic diagrams shown here illustrate the circuit revisions used for reducing hum and buzz in the above series chassis when necessary. Notes on the schematic diagrams indicate important points to check when making these changes to insure proper operation.

The changes involve the addition of decoupling filters in the audio output and sync splitter stages. Note that the components required for the sync splitter may be obtained from the power supply circuit.

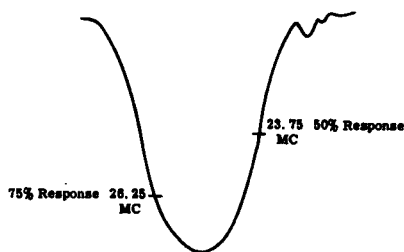
Fig. 17 — Mars

MARS TV Model 630-K3B
Extreme fringe area alignment
(see Fig. 17).

For extremely difficult fringe area coverage where signal-to-noise ratio is a problem, it is possible to narrow the 4-mc i-f bandwidth to 2 1/2 mc to obtain extra gain and a better signal-to-noise ratio. It has been found that in the nominal 100 to 150 mile sector where video reception is possible but not comfortably viewable, the 2 1/2-mc bandwidth will in most cases bring in the picture to a suitable viewable point, minimizing snow.

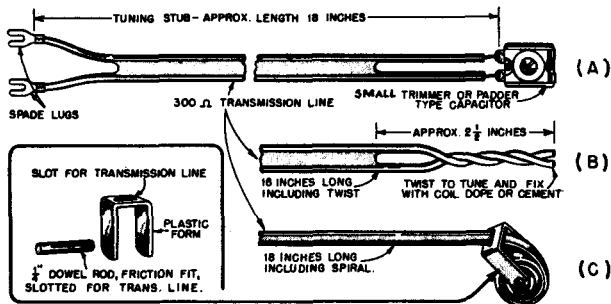
Fig. 22 — Motorola

Television interference from 2-meter amateur transmitters may occur on channel 10, especially in older model tv sets. The method usually used to improve tv reception in this case, is to use a quarter-wave open-end stub at the antenna terminals of the tv set.

Since the cut-and-try method of obtaining the correct length of the stub is not too effective in actual practice, a means of tuning the open-end quarter-wave stub is the logical answer to the problem. The sketches il-

illustrate these methods of accurately tuning the stubs for optimum performance.

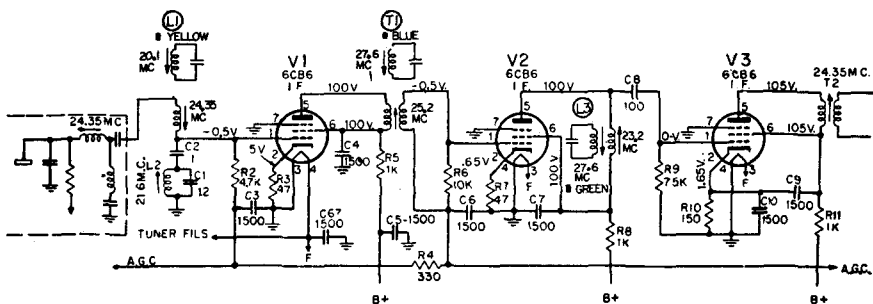
Fig. 26 — Pacific Mercury

Two basic methods have been developed for reducing or eliminating adjacent channel interference in the above chassis:

Method 1 — attaching appropriate traps on the i-f coils; **Method 2** — replacing original i-f coils with new ones that have built-in traps. The method to be used will depend on the amount of interference present. Replacement of the coils with ones containing built-in traps is recommended when the interference is very strong. If method (1) is employed, the traps should be used in one of the following combinations, again depending on the amount of interference encountered.

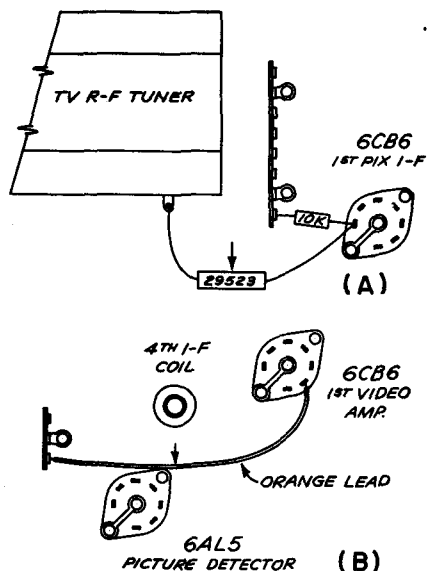
Fig. 29 — Packard-Bell

Unless the following precautions are taken in fringe areas, some re-

generation may occur which will contribute to noise in the picture.

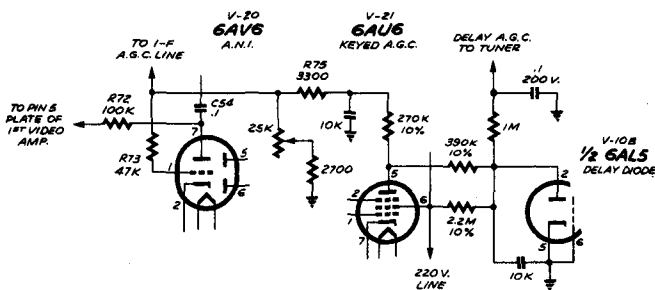
Fig. 32 — Packard-Bell

PACKARD-BELL Chassis 2740
Addition of delayed agec
(see Fig. 32).

The addition of delayed agc circuitry is incorporated in later production of the above chassis. Improved performance will be noted in fringe areas, as evidenced by an increase in signal-to-noise ratio due to the r-f amplifier bias being held near zero for low signal input. High signal areas will benefit because of the much greater input signal now required to produce overload or cross modulation effects. Chassis incorporating this delay circuit can be identified by the agc control located on the chassis rear apron near the horizontal drive control.

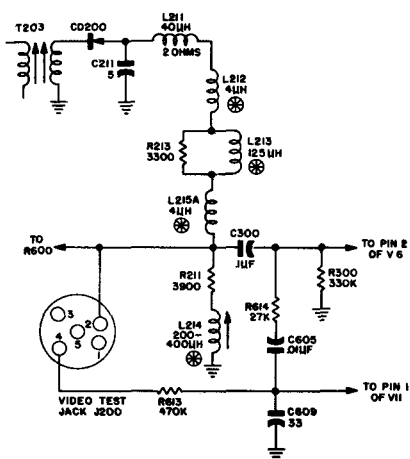
Fig. 37 — Philco

To reduce channel 5 picture beat, an additional 4- μ h series peak-

ing coil (*L215A*, part No. 324112-50) is added to the video detector load circuit. To install this coil, terminal board *B9* adjacent to the video test jack is changed from a 2-lug to a 3-lug type. The revised wiring of the video detector circuit, already done in later production run 18, is shown in the figure.

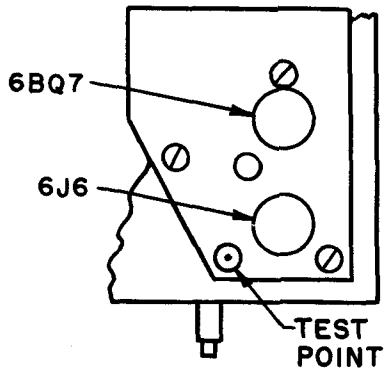
Fig. 43 — Radio Craftsmen

Receivers operating in unusually strong signal areas are sometimes

overloaded and a buzz or hum is heard in the speaker. To eliminate the buzz on models equipped with the turret-type tuner, especially the cascode tuner, add a 15,000-ohm, 1/2-watt resistor from the r-f test point to ground.
