Andrea T-VK12, BT-VK12, Ch. VK12

These models appear on pages 2-9, 10 through 2-37 of Rider's TV Manual Volume 2. The following corrections should be made on the schematic diagram.

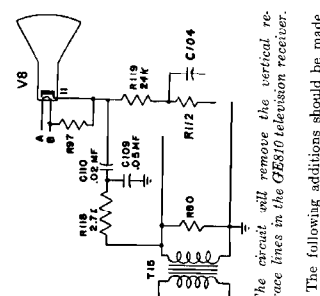
The circuit will remove the vertical retrace lines in the GE810 television receiver.

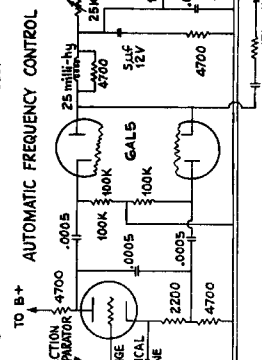
Fig. 1. The 6AL5 double-diode tube has been added to give automatic frequency control.

Section 2
Refer to Fig. 1. Z202 has been replaced by a new discriminator transformer, part number 32-4317. Balancing choke, L204, part number 32-4143-1, has been removed. The 5- μ f capacitor, connected from the plate of the second 6A5 tube (7H) to ground, has been removed.

Capacitor C208, 0.001 μ f, part number 45-3500-5, has been added between pin 3 of the second 6A5 tube and ground. L202C, part of Z202, has been added. C202A, Balancing capacitor, C202C, part of Z202, has been removed. C202B, 10 μ f, part of Z202, has been changed to 20 μ f, and resymbolized C202A.

C206, 0.001 μ f, part number 45-3500-5, was removed from the cathode (pin 7) of the second 6A5 tube, and connected as shown in Fig. 1. R222, 47,000 ohms, part number 66-3473340, was added. See Fig. 1.

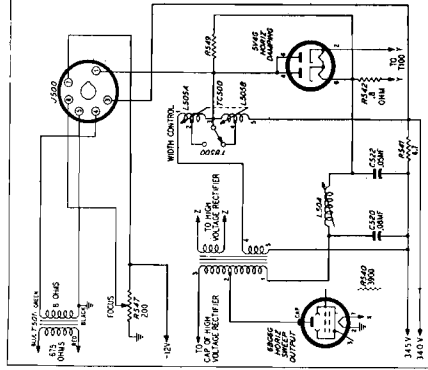
Fig. 2. Changes in wiring output circuit in Philco 48-1001.

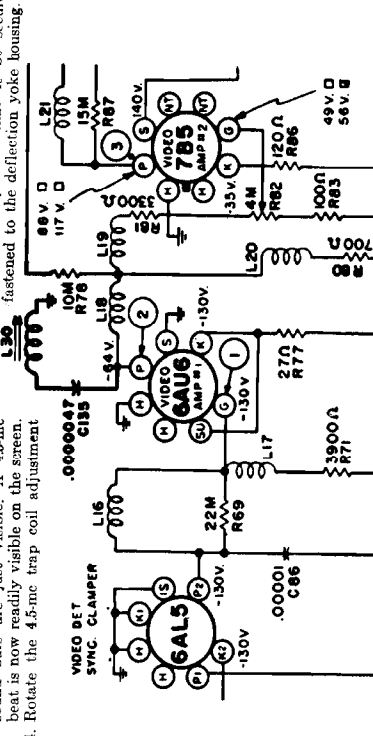
A 4.5-mc trap has been incorporated into the Sears television chassis 101-846.

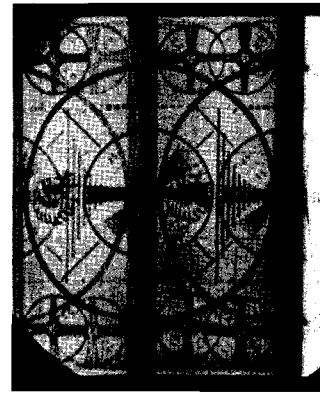
FIG. 8: VERTICAL HOLD MISADJUSTED

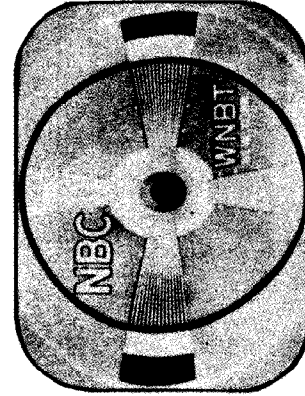
FIG. 19: HOR. LINEARITY MISADJUSTED - BUNCHES TO CENTER

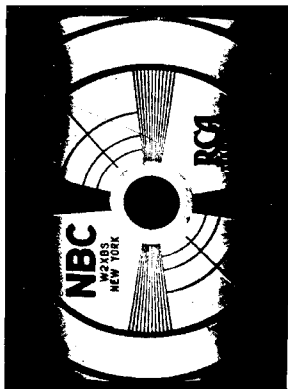
FIG. 28: EXCESSIVE RIPPLE IN VIDEO AMPLIFIER

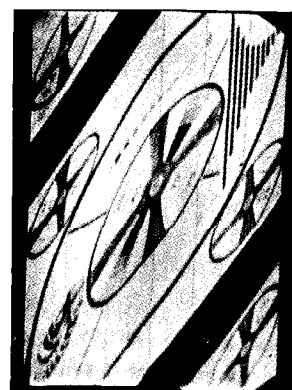
FIG. 25: HORIZONTAL HOLD MISADJUSTED

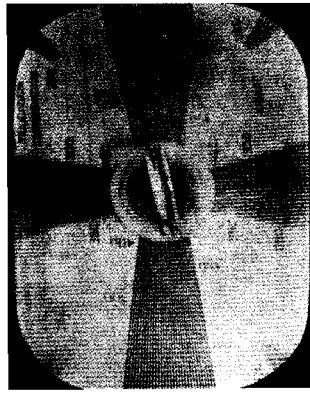
FIG. 42: BEAT FREQUENCY

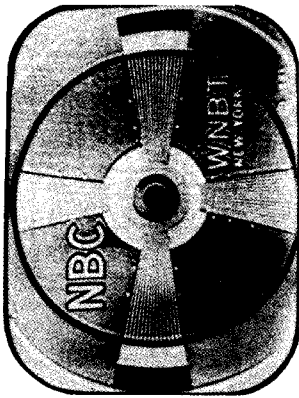
FIG. 34: TRANSIENTS

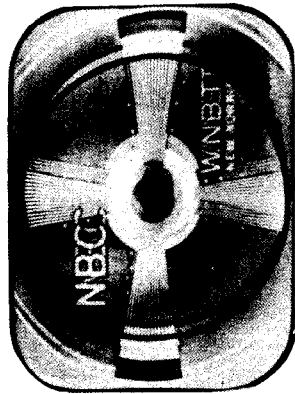
FIG. 33: MULTIPLE IMAGES - GHOSTS

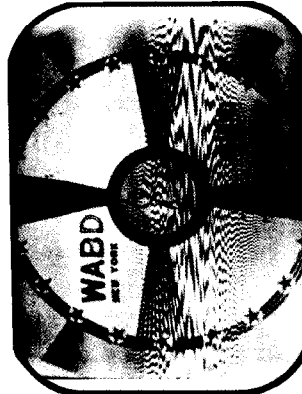
FIG. 37: DIATHERMY INTERFERENCE - MEDIUM
