The Antelope Valley Picture Tube Rebuilding Company

By Joe Ullo (Owner/Operator 1975-76). Photos by Dad (Joe Sr.)

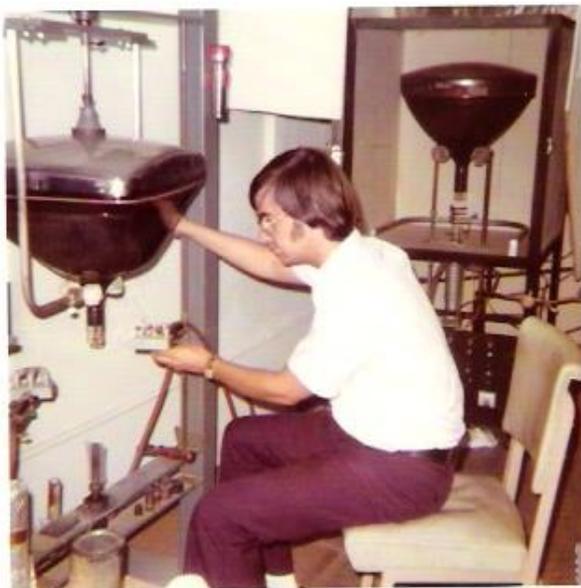
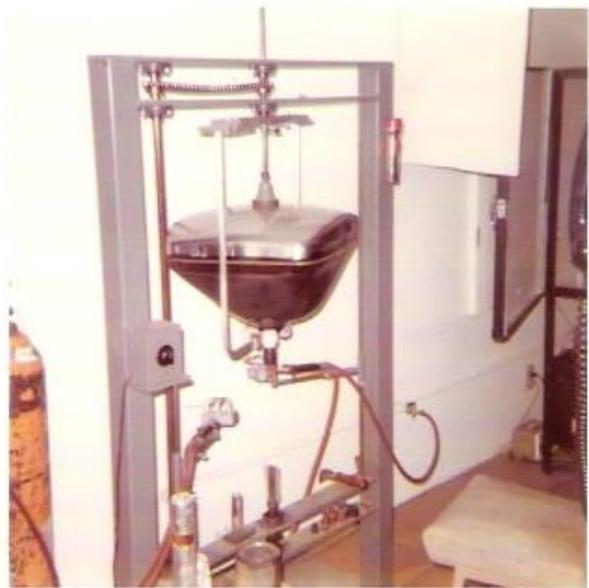
The photos show how close the lathe and oven were. The lathe used natural gas and oxygen to produce a flame hot enough to melt glass. The oven used natural gas only. The lathe has 2 sets of tri-tip flame nozzles. The one on the right was used for melting the glass. The one on the left was used just to keep the glass warm when the right side nozzles were moved away. Near the bottom of the picture you can see an annealing neck cover, a can of Aquadag coating used to coat the inside of the neck, the carpet knife, and various adapters for neck glass and gun base-stems. The flashlight hanging on the upper right of the lathe was used to shine inside the neck to show any bad spots in the new Aquadag coating.

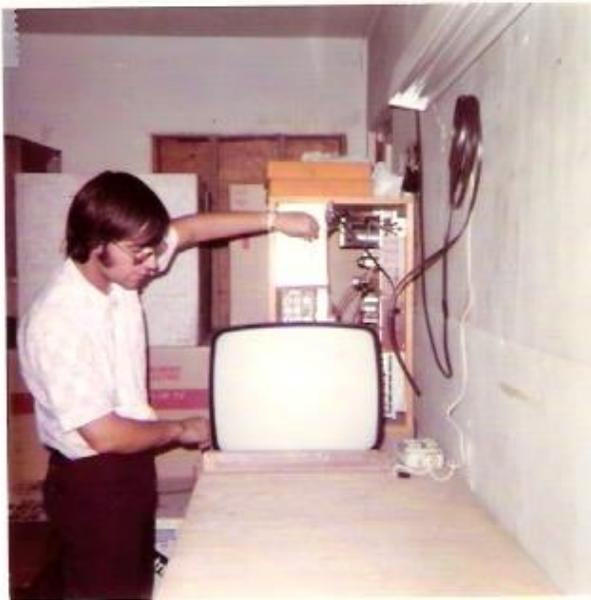
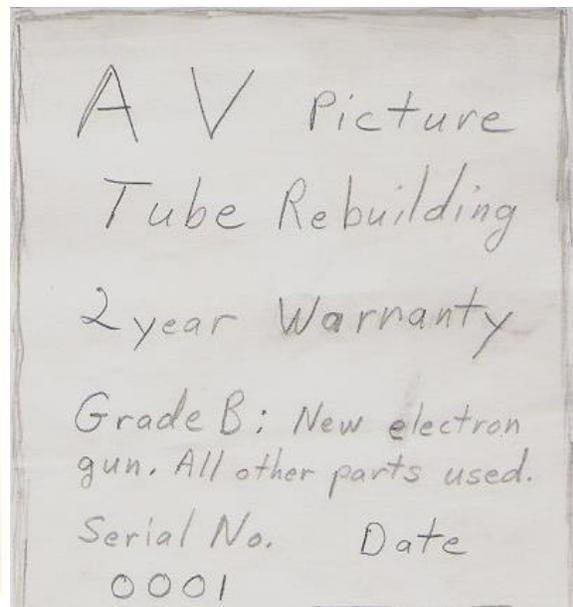
The photos show the Setchell Carlson test/burn-in jig and a prototype warranty sticker. The labels actually used had the industry standard 1yr. warranty.

19. I used an Amphenol CRT tester to check for shorts, gas, and good emission from all 3 guns. For the burn in test I made a test jig from a Setchell Carlson modular chassis in a box made from 1x12 pine mounted on a plywood base with supports to let the tube neck reach the chassis yoke, base, and high voltage connections for easy installation and removal. I used a Heathkit dot generator for a purity check and quick alignment and then let the tube show an over the air television channel for about an hour.
20. If everything checked out (fortunately, it almost always did) I replaced the safety faceplate if the tube had one, masked and repainted the outer Aquadag coating, and finally attached the A. V. Picture Tube warranty label and serial number. The first 5 labels were handmade. Then I got a local print shop to professionally make 100 labels. I actually used them all.

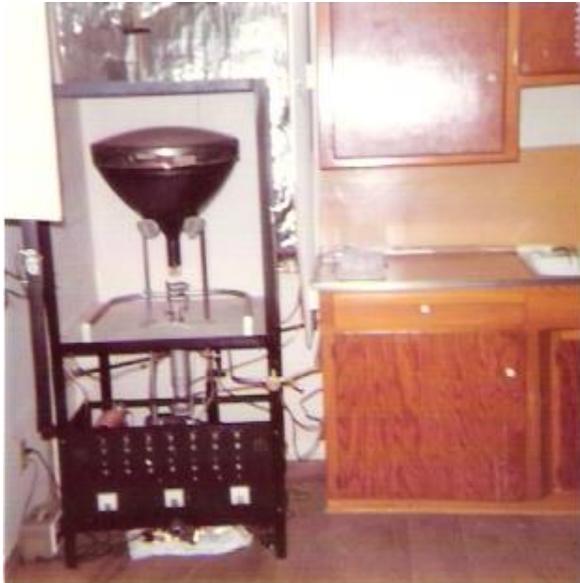
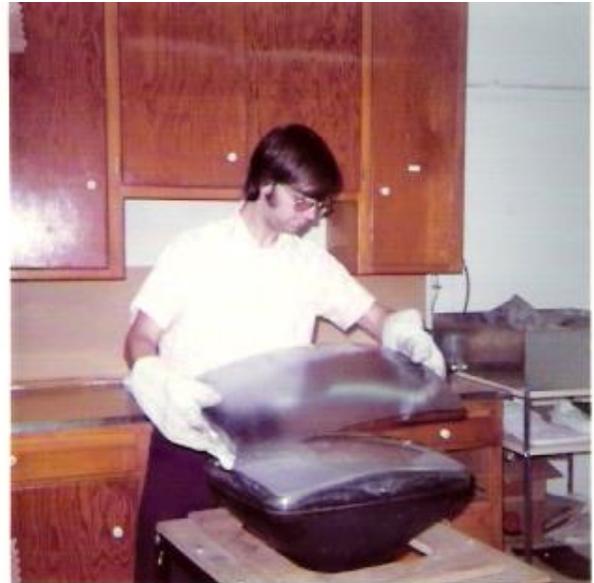
The oven was also used to heat the tubes to remove bonded safety glass faceplates. On some the bonding glue came off easy like the one in the photo. Other tubes like the 23EGP22 had the stickiest hard to clean off gooey mess I had ever encountered. It required alcohol, Windex, and lots of elbow grease. The holding fixture table really helped when cleaning the screen and when reattaching the faceplate. There was no re-gluing process available so the faceplates were reattached using double sided sticking rubber foam weather stripping around the edges to space the faceplate off the tube face. Then heavy duty duct tape was used to completely seal and hold the faceplate and tube securely together.

The right side of the safety glass removal photo also shows the washing pan for the “always dirty” incoming tubes. Sitting in the pan is the heavy canvas safety bag used to cover hot tubes when removing them from the oven and when flashing the getter. The heat resistant gloves were definitely needed but they probably had asbestos in them in those days.

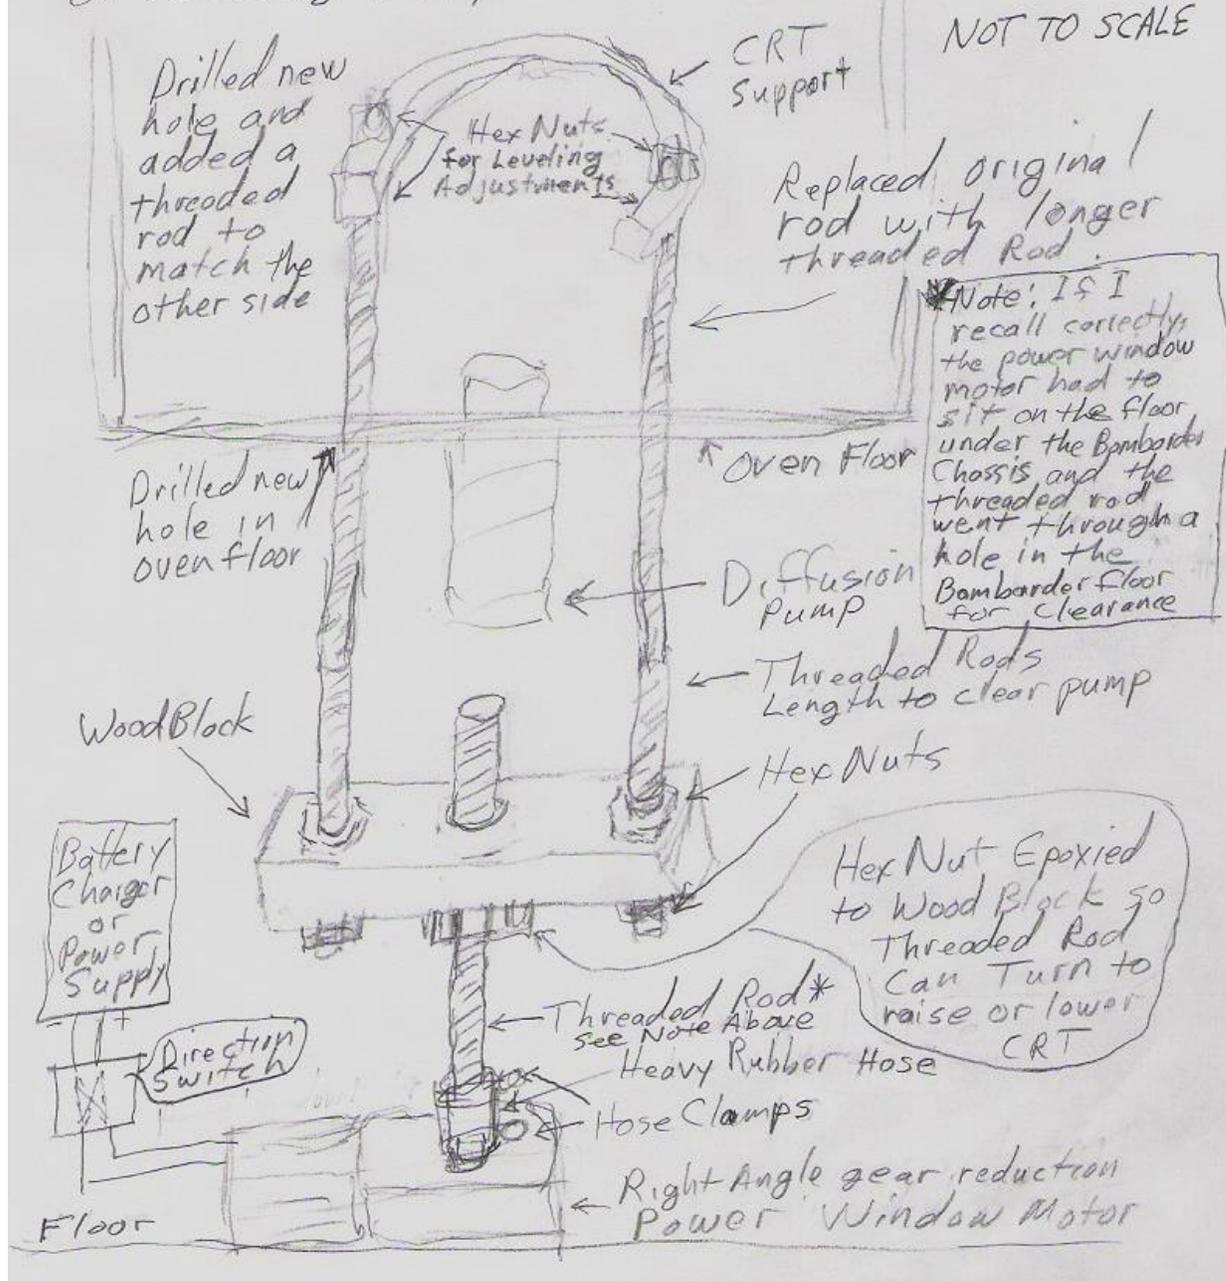
POWER CRT LIFT

The oven photo shows the power lift. The added second support rod is just to the left of the tube neck. The 12v battery charger is on the floor to the left of the bombardier. The direction switch and car power window motor can be seen on a pad under the bombardier. A diagram of the power lift setup:

A really poor quality drawing of the power CRT lift I built and used on my CRT Color Champion oven to prevent stem breakage when installing or removing heavy and hot CRTs from the Oven.

designed originally with B&W tubes in mind. The heavy color tubes caused a slight tilt. Also, maneuvering heavy and/or hot tubes with delicate vacuum stems in and out of the diffusion pump inlet without breaking the stem was not easy. I built a power lift device using threaded rods, a wood block, a car power window motor, and a battery charger. It gave support to both sides of the CRT support and actually worked pretty smoothly for raising and lowering the tube. A photo and a very poorly drawn diagram of the lift are shown further on in this article.

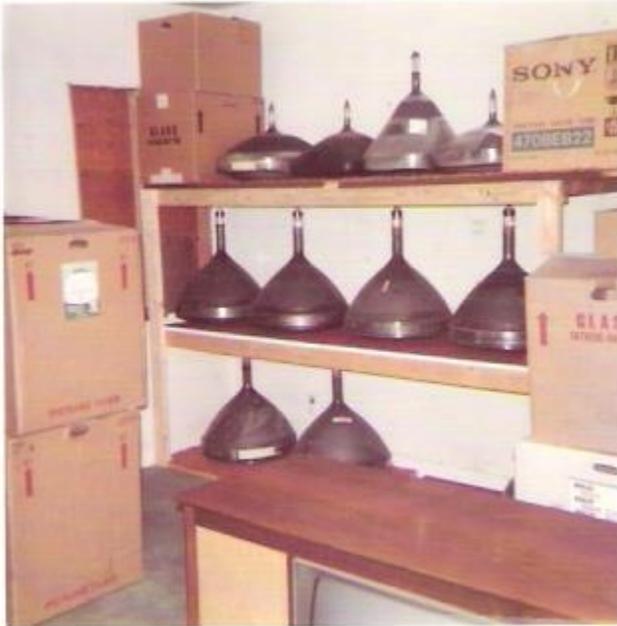
This early photo shows part of the storage room. Too many used "roundies" on the shelf and not enough rectangulars for rebuilding! This was when I had to buy some extra tubes from Dunbar Rebuilding. Rebuilt tubes in boxes on the left and a repaired television for sale on the right.
