Service News

PUBLICATION OF THE TELEVISION SERVICE CONTROL DEPARTMENT
ALLEN B. DUMONT LABORATORIES, INC., PATTERSON, N. J.

MARCH-APRIL, 1952

THE RA-160, RA-162 TELESET

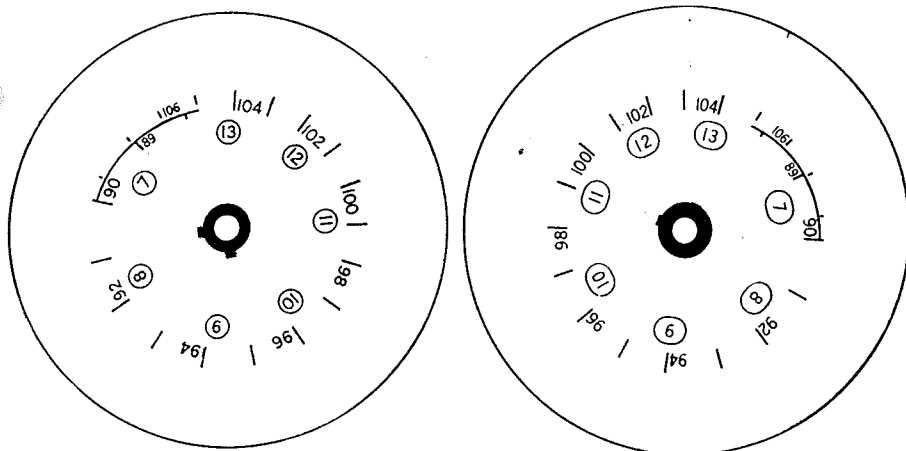
Part Number 15B12565
Part Number 45000211
Figure D-2. RA-103C vernier dials: 15B12565 is numbered counter-clockwise. 45000211 is numbered clockwise.

The dials used with these Telesets are illustrated in Figures D-1 through D-4 and their distinguishing features are described in the captions. Note that the RA-103C dials consist of two parts, a main-tuning dial and a transparent vernier dial. 15B12564 and 15B12565 are used together as are 45000221 and 45000211.

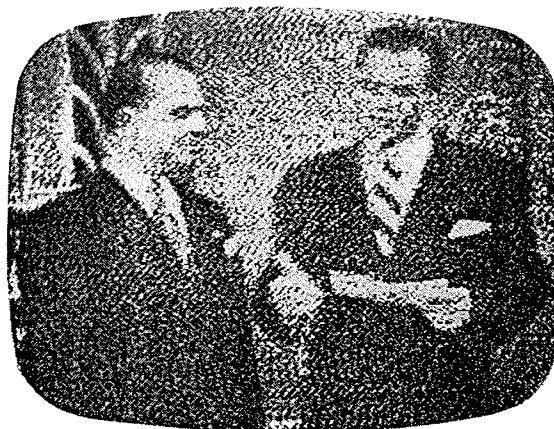
Figure F-3. A—Picture obtained on best competitive receiver. B—Picture on RA-160-162 under identical conditions (filter connected in circuit).

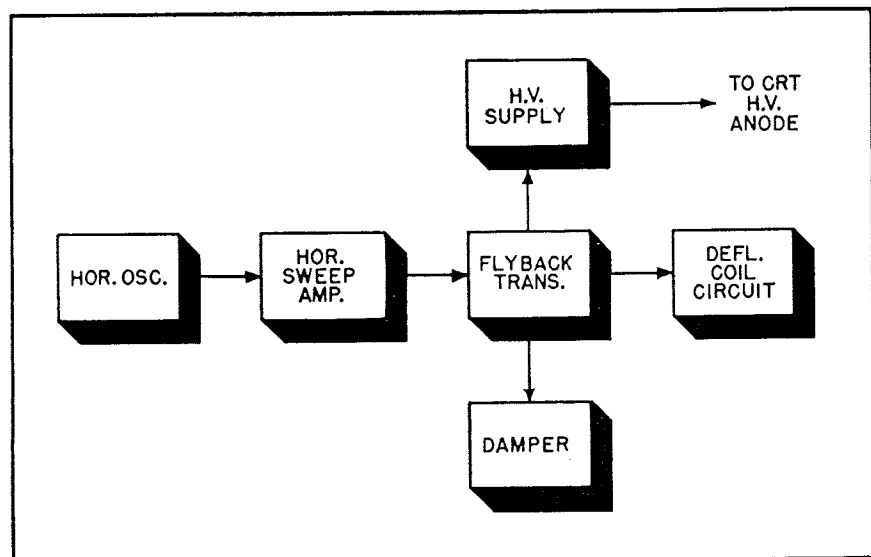
Figure H-1. Block diagram of Sweep Circuits for the RA-112, 113, and 117 chassis.

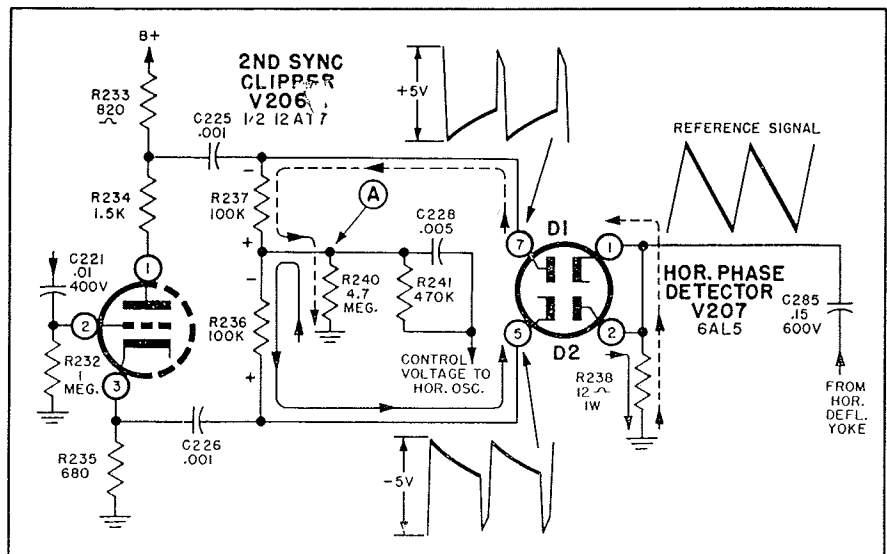
Figure R-5. Schematic diagram of the 2nd sync-clipper and horizontal-phase-detector stages.

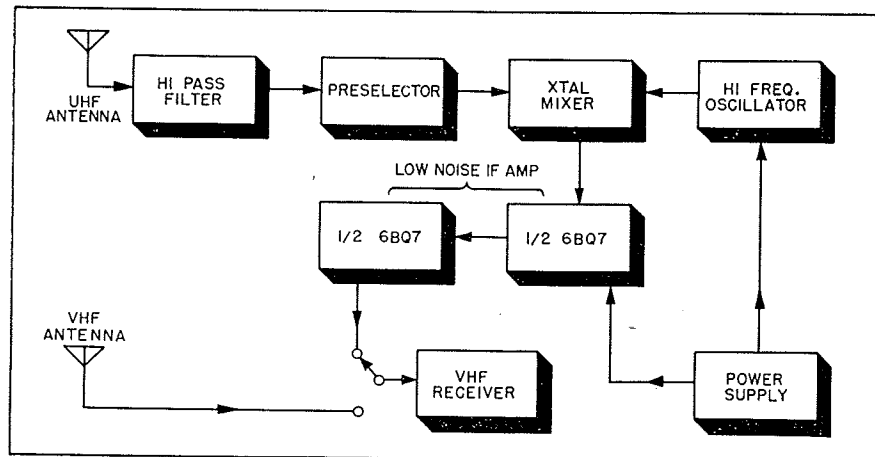
Fig. R-1. Block diagram of a UHF converter.

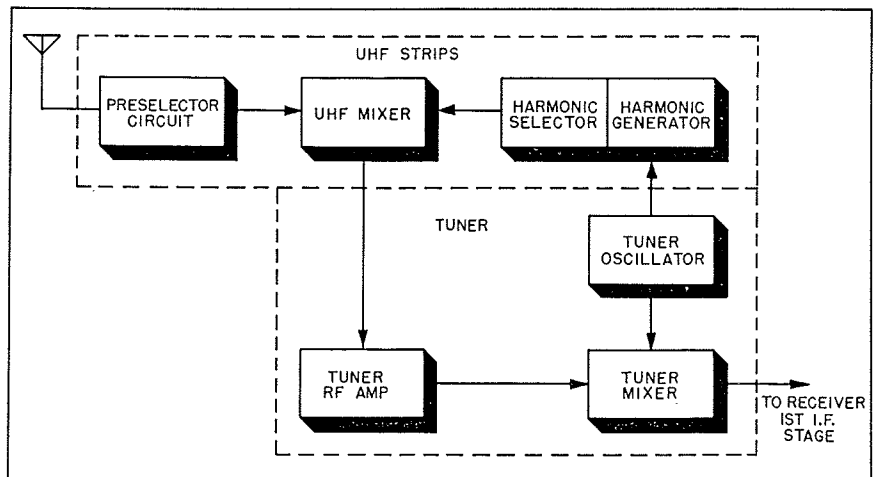
Fig. R-3. Block diagram of turret tuner UHF channel strips.
