RADIO AGE

The Newsletter of the
Mid-Atlantic Antique Radio Club

THE 1932 RCA FIELD TEST TV RECEIVER

by Jeff Lendaro

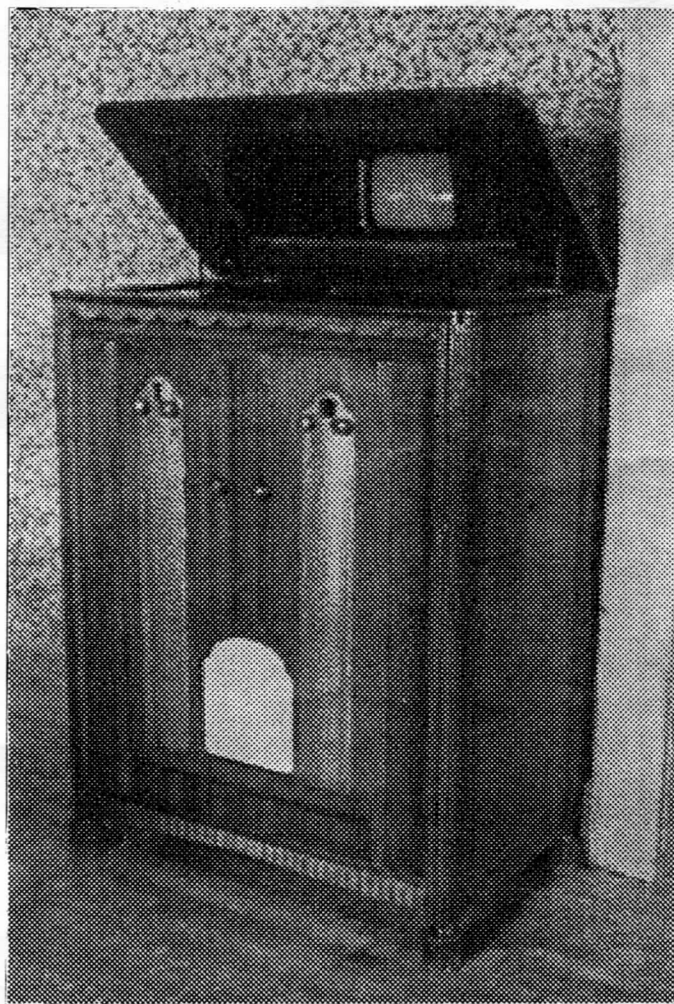
Figure 1. The 1932 RCA field test TV receiver.
(Compartment for sound chassis on the right.)

Because of my conversation with Morris, I had assumed that all of these early receivers had been destroyed. I was wrong. In November 1984 the receiver shown in Figs. 1 - 3 still existed, but was heading for the scrap pile, presumably after 52 years in RCA's possession. It took someone cleaning an Indianapolis warehouse less than a minute to place a one-foot-long piece of masking tape on the top and write the word "SCRAP." I was lucky enough to have joined RCA as a design engineer eleven months earlier. Not long after I arrived it became well known that I collected early RCA radios and televisions. When someone told me that a warehouse was being cleaned out on the other side of the Indianapolis complex, I really did not expect to see much.

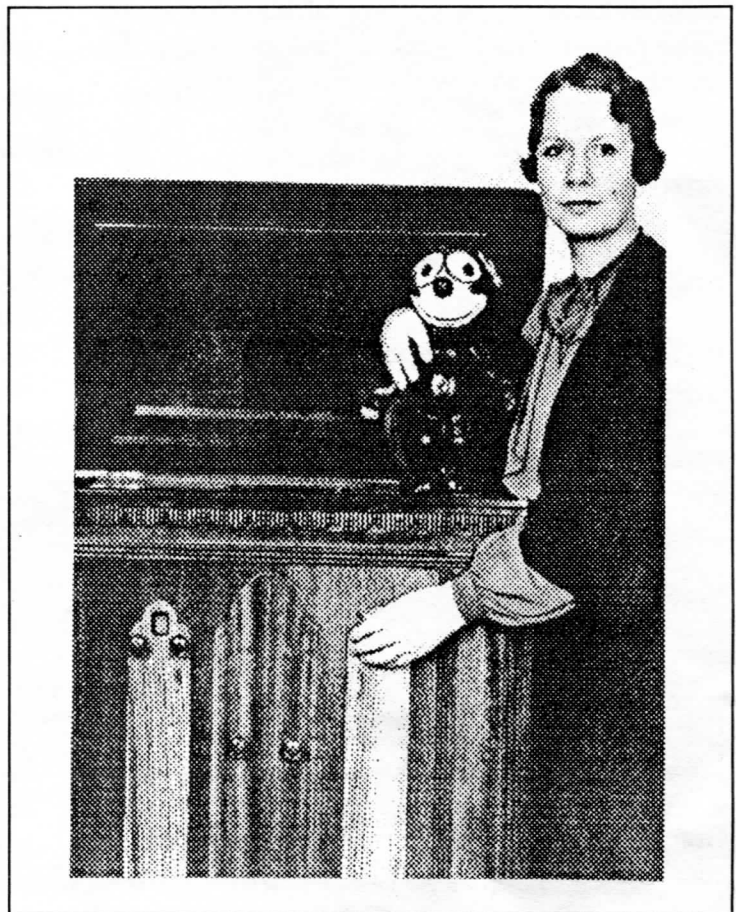
Figure 8. Edna Wilson, secretary to Chief Engineer O. B. Hansen, with Felix the Cat and the 1932 television. Is her hand covering the missing sound chassis?

kinescope looks rather fragile compared to modern CRTs.) It is likely that only six or eight receivers of this type were made. Ours has the number 2 stamped on all removable parts of the wood cabinet. If you examine closely the RCA/NBC publicity photo of Edna Wilson and Felix the Cat in Fig. 8, you will see that the veneer grain patterns match our set exactly.

When I acquired the set, the audio chassis was missing. The two knobs on the right are mounted on screws. It is clear from the RCA/NBC photograph that Edna is awkwardly holding her left hand over this area. She is apparently covering the fact that the audio chassis was missing then, too!
