# CRT REJUVENATOR

# NEON TEST INDICATORS

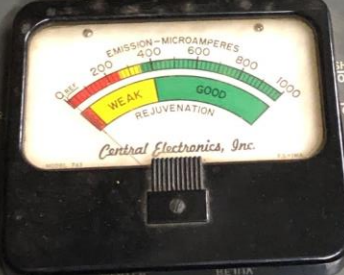
MULTIPHASE  
REJUVA-TUBE

ADJUST EMISSION  
REFERENCE  
DECR. INCR.

EMISSON REJUV.  
SHORTS OPENS REJUV.  
AC OFF SPARK HTR. CATH

READ EMISSION HEATER ON HEATER INCREASE REJUV. INCREASE REJUV. ON OFF POWER PILOT  
MODEL RE-1 PATENT PENDING 115V-60~
