Service News

Volume 1

JANUARY, 1951

Number 1

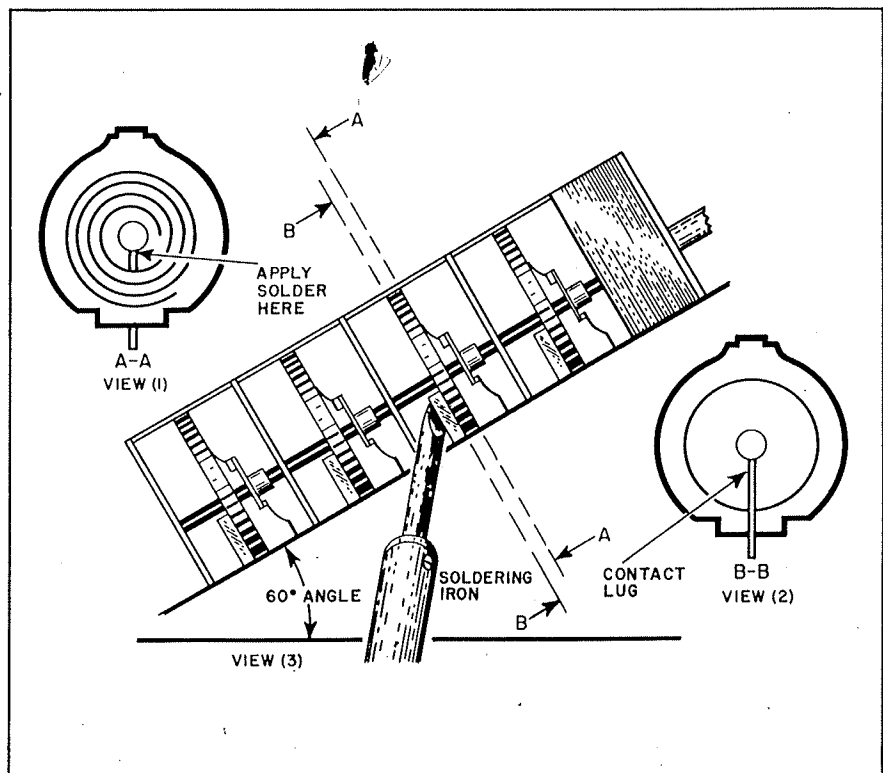
FIGURE T-2

Probable Fault: L109 in oscillator section of the Inputuner is intermittent or the soldered joint near the inside end of the Inductuner oscillator spiral is defective.

Caution: Care should be exercised to prevent solder from getting on the surface of the spiral. If too much solder is used at the joint, it will cause the "button" on the slider arm to raise and break contact. This will result in loud crackling noise when tuning through channel 7 to 8.

Remedy: Replace or resolder L109, if required, or resolder the inner end of the Inductuner oscillator spiral as described in the troubleshooting hint below.

5. After soldering each spiral, wash the soldered areas with carbon tetrachloride and apply a thin coat of Lubriplate 105 (available from your Du Mont distributor).
6. Make a final check of each Inductuner section by checking continuity between each rear lug and its associated slider arm. Since there is a coil shunted across the oscillator spiral, this section will show continuity even if the rear contact lug is not properly contacting the spiral.

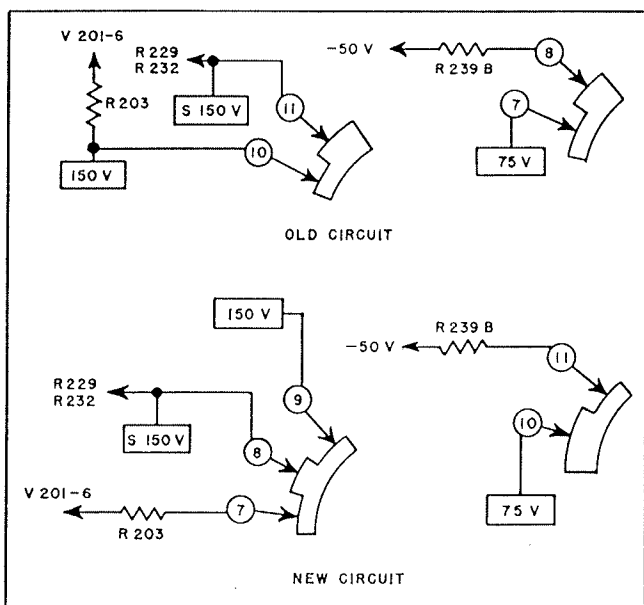
Figure P-2. Change No. 39, RA-112A - RA-113.

The addition of a video output jack to provide for use of the receiver with a color convertor.

Replace and rewire S201 as shown in figure P2. Connections not shown remain the same.

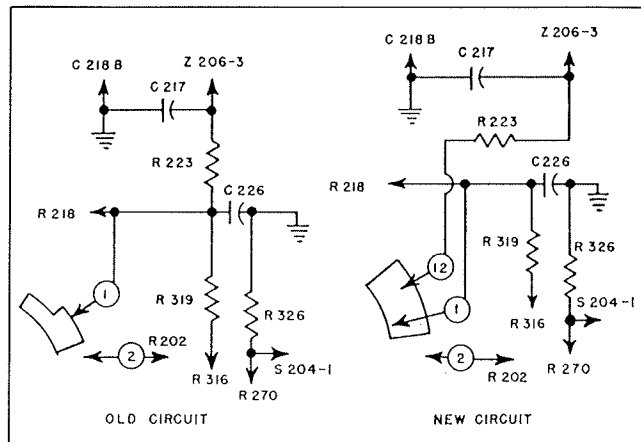
Figure P-3. Change No. 40, RA-112A - RA-113.

To eliminate a pattern of fine diagonal lines, referred to as "snakes," which sometimes occurs on channel 8 in receivers equipped with a channel 5 trap. This interference is caused by the seventh harmonic (183.75 mc) of the video i.f. (26.25 mc) and the video carrier of channel 8 (181.25 mc) which combine to produce a 2.5 mc beat.

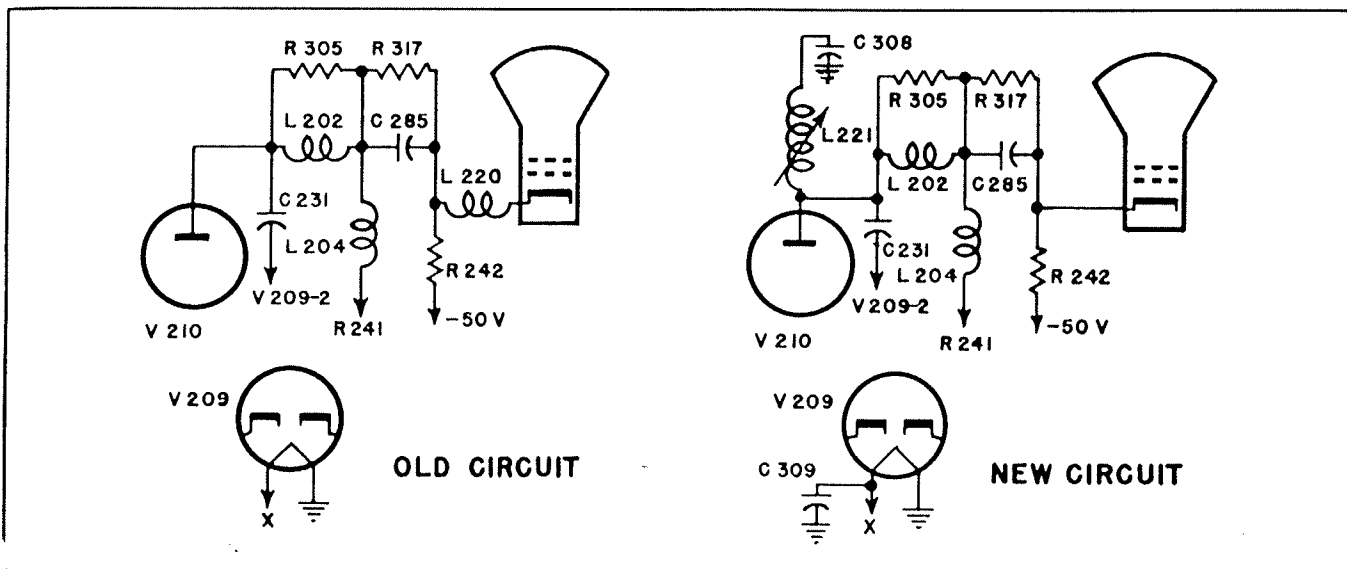
Figure P-1. Change No. 52, RA-112A - RA-113.

Reason:
To increase the effectiveness of the Channel 5 beat interference traps added by Change No. 33. The beat was caused by the 3rd harmonic (78.75 mcs) of the video i-f carrier (26.25 mcs) which was radiated from the CRT leads and combined with the carrier of Channel 5 (77.25 mcs) to produce a 1.5 mc beat. The fixed trap in the cathode lead of the CRT is deleted and a tuneable trap is added from the plate of the video amplifier to ground. A 100 mmf capacitor is added from the filament of V209 to ground to prevent coupling, between V209A the video detector, and V209B, the d-c restorer, through their common filament. The new circuits are illustrated in Figure P-1.

- Procedure:**
1. Delete L220.
 2. Connect the free end of brown lead, previously connected to L220, to the junction of C285, R242 and R317.
 3. Rotate the terminal strip to which the jumper from the plate of V210 attaches, about 15° away from V210.
 4. In the space made available by step 3, make a hole as shown in Figure P-2. If a punch is not available, the hole may be drilled using 5/16 inch and 3/64 inch drills.
 5. Mount L221 in the hole.
 6. Connect the side of L221, nearest the terminal board, to the junction of the jumper from the plate of V210, R305 and L202.
 7. Connect C308 from the other side of L221 to the nearest ground lug.
 8. Add C309 from V209-4 to ground, keeping its leads about one-half inch long.
 9. Tune the receiver to Channel 5 and, observing the beat

interference, tune L219 and L221 until the interference disappears.

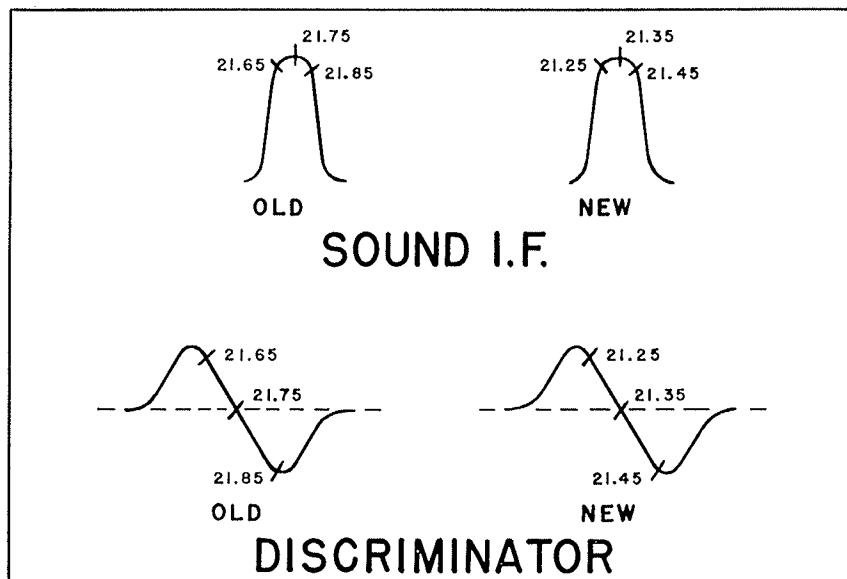
All RA-109A chassis incorporating this change are stamped "L".

If the carrier is 70 to 80% down from maximum response, as it sometimes is if the receiver is not carefully

aligned, the receiver will usually perform satisfactorily in strong signal areas. In a fringe area however, very poor results will be obtained. The picture will be snowy and lack contrast, and the sync noise immunity will be poor. By repositioning the carrier on the response curve better results can be obtained.

In changing the sound intermediate frequency follow the alignment procedure given in the Service Notes. Only those steps pertaining to the sound i-f's and the narrow-band sync need be performed. The marker frequencies shown in Figure R-3 should be substituted for those in the Notes. The new narrow-band sync center frequency should be 25.85 mc.
