# Service News

A PUBLICATION OF THE TELESET SERVICE CONTROL DEPARTMENT OF ALLEN B. DU MONT LABORATORIES, INC., EAST PATERSON, N. J.

AUGUST, 1951

## PICTURE ANALYSIS No. 1

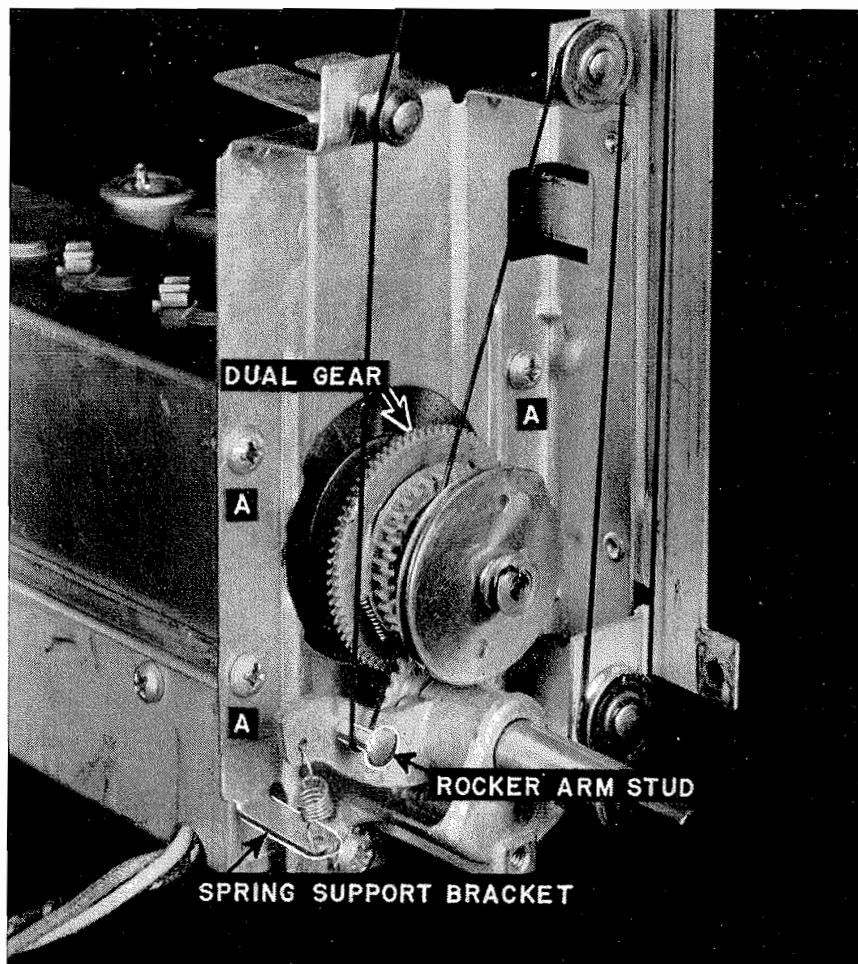
After an RA-109A dial cable has been strung it may be slightly too loose or too tight. The cable tension may be adjusted by bending the rocker-arm spring supporting bracket. The bracket is shown in Figure D-1. To increase the tension on the cable, bend the bracket downward; to reduce the tension, bend the bracket upward. The bracket should not be bent more than 1/4 inch in either direction.

If the dial cable continuously becomes unstrung, check the rocker arm stud. In early production, spiral type RA-109A tuners, a pulley was mounted on this stud (See Figure D-1). If there is a pulley on the stud, restrung the cable so that it rides on the stud, instead of the pulley. The pulley should be pushed back against the rocker arm so that the cable can ride on the outer end of the stud.

When play in the fine tuning control of an RA-109A tuner is encountered, check the large dual gear on the inductuner shaft. This gear is equipped with two small springs and is designed to eliminate backlash and play in the gear train. The springs apply tension to the two sections of the gear so that a positive mesh with the vernier gear is always maintained. A sharp blow on the end of the fine-tuning-control shaft, or loosening of the three Phillips-head screws which fasten the dial-plate assembly to the tuner, may unmesh the

If the holes are not aligned, loosen the three Phillips-head screws, A in Figure D-1, and unmesh the vernier and backlash gears. Rotate the sections of the backlash gear, remesh the gears and tighten the Phillips-head screws.

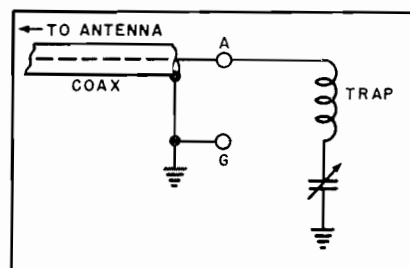
Figure 2. Series Tuned F-M Trap.

In the above case, an f-m interference pattern was also produced on channel 11. This pattern was found to be the result of the generation of the second harmonic of the 99.5 mc f-m signal. This harmonic was produced in the front end of the receiver by overloading, as described earlier in this article. The insertion of a 99.5 mc trap in the antenna of the receiver eliminated all of the interference encountered.

One of the simplest traps consists of an inductance and capacitance in series as shown in Figure 2. The trap is connected between the ungrounded antenna lead and ground, and tuned to the frequency of the interfering signal. The part numbers of the series traps available from your Du Mont Distributor are shown in Table 1. Also shown are the Teleset models with which each trap should be used. Complete instructions for the installation of the traps are included with the parts.

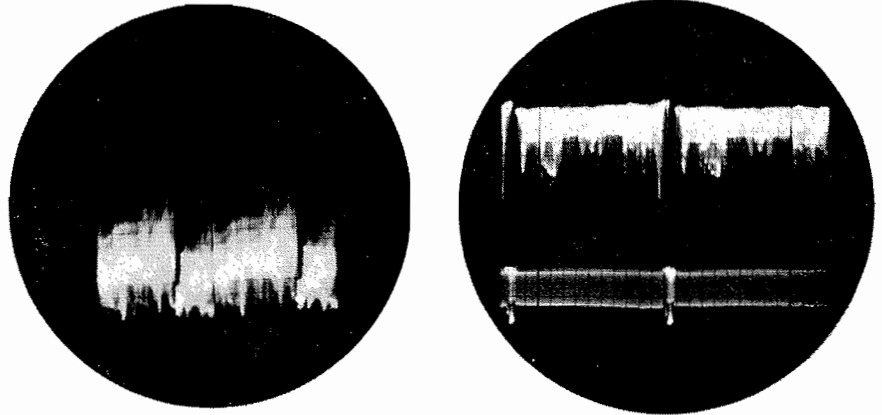
Figure A-2. A, Left—Waveform at NBS transformer distorted by probe loading. B, Right—Normal NBS waveform.

When the probe is connected to a high-Q tuned circuit it loads the circuit, changing its response character-

istics. If this point is not kept in mind, the information appearing on the oscillograph screen can be misleading.

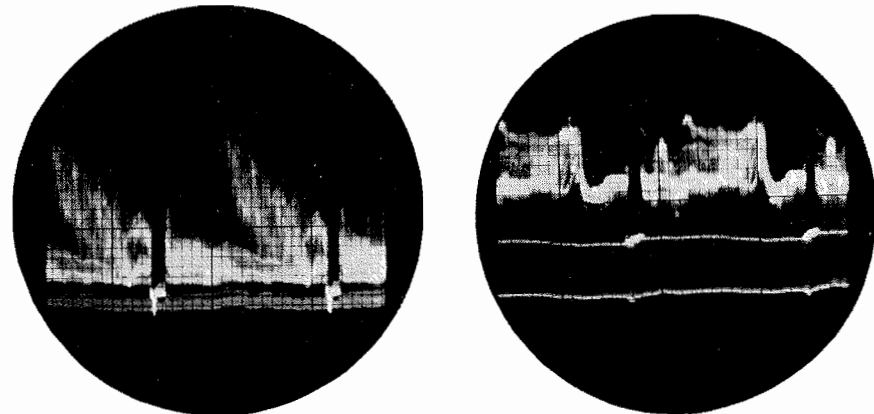
Figure A-7. A, Left—Composite video signal exhibiting sync compression. B, Right—Normal composite video signal.

Compression of the vertical and/or horizontal sync signals can be caused by the following.

1. Improper alignment of one or more video i-f stages.
2. Overload resulting from insufficient a-g-c voltage.
3. Improper adjustment of the narrow-band sync transformer.
4. A defective component affecting the frequency response or ampli-

If sync compression is observed at the output of the sync detector, the stage in which the compression is taking place may be isolated by working toward the front end of the receiver, checking the signal at the plate and grid of each stage. When compression is observed at the plate but not the grid of a stage, the compression is obviously occurring in that stage. Voltage and resistance measurements, and an alignment check in i-f stages, should then be made to determine the exact cause of the trouble.

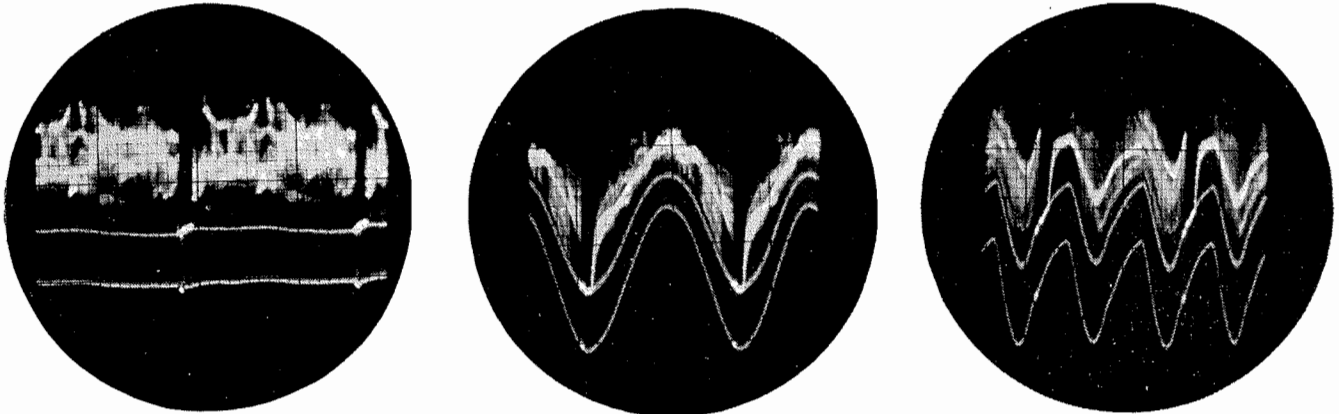
Figure A-8. Left—Normal video signal. Center—Video signal with 60-cycle hum. Right—Video signal with 120-cycle hum.

60-cycle hum is usually the result of coupling between the filament supply and the signal circuits. The most common cause is filament-to-cathode leakage in one of the r-f, video i-f, or video-amplifier tubes, or the picture

120-cycle hum is usually the result of a filter capacitor failure. The B+ lines should be checked using the method described for 60-cycle hum. The amplitude of the hum at various points in the B+ voltage-divider circuit will give some clue as to the location of the faulty component. Voltage, resistance and substitution checks may then be used to identify the defective component.

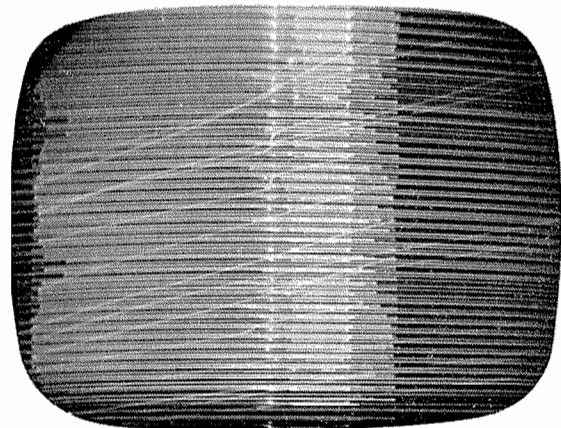
Figure S-1

*Reason:*  
To minimize the Christmas Tree effect illustrated in Figure S-1, which sometimes occurs when a Teleset is turned on. This condition is due to multiple triggering of the horizontal sweep oscillator and is accompanied by audible singing in the flyback transformer. It disappears when the horizontal hold control is reset. In a normal Teleset multiple triggering may occur for a fraction of a second after the Teleset is turned on. In a Teleset in which the BTO transformer is not properly adjusted the Christmas tree effect may last for several minutes or more.

*Procedure:*  
Remove C245 near Z210 and replace with a 220 mmf 5% 500V condenser. Realign Z210.

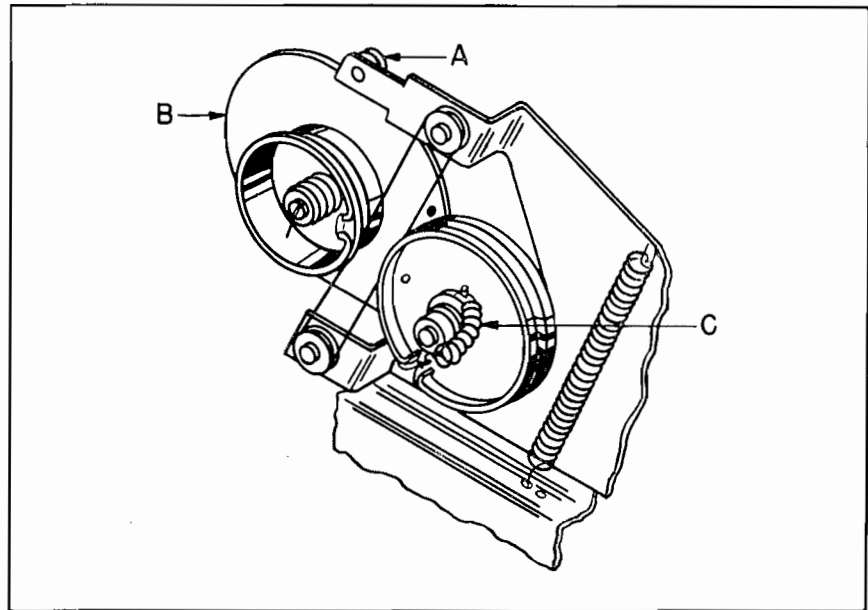
Figure T-1

*Symptom:* The dial pointer jumps across sections of the dial. Observation of the cam follower idler wheel,

A in Figure T-1, shows that it is rising off the cam, B. Proper pointer action requires that the idler wheel be on the cam at all times.

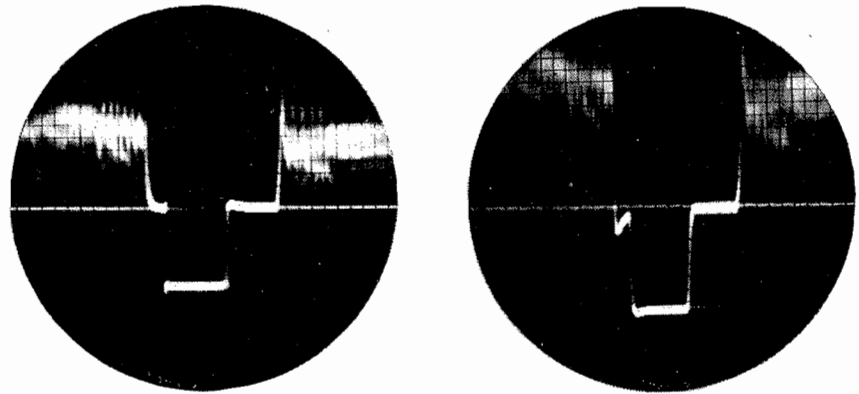
Another transmitter difficulty is the transmission of extraneous signals. A characteristic trouble in the stabilizing amplifiers of some transmitters is the development of a spike on the front porch of the horizontal sync signal, as shown in Figure H-2.

Figure H-2. Left, normal horizontal sync pulse. Right, sync pulse with spike on front porch.

This type of extraneous signal causes the receiver horizontal oscillator to fire prematurely and produces a slight horizontal displacement of the top portion of the picture. Unfortunately this spike is not visible in the video i-f waveform, unless an oscillograph with a vertical-amplifier frequency response of 10 mc or more is used.

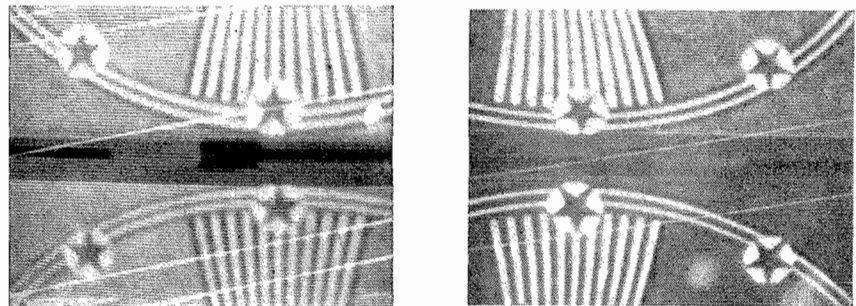
Figure H-4. Left, normal appearance of the vertical blanking interval. Right, vertical blanking interval showing effects of sync compression.

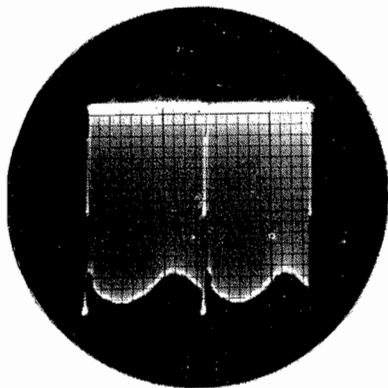
Figure H-1. Output of the first sync clipper showing 60 cycle hum in the sync signal. Normal waveform is shown in Figure H-5.

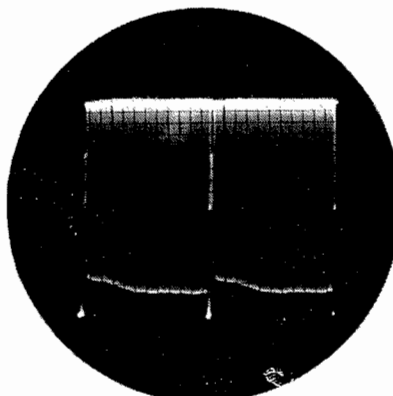
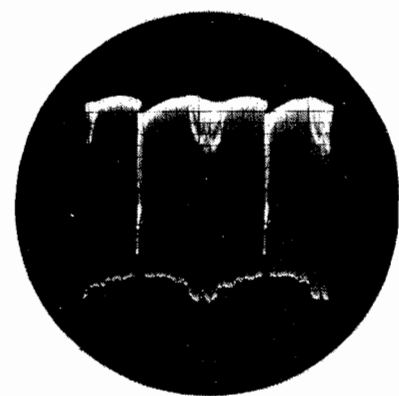
Figure H.5. Left, normal waveform at the plate of the first sync clipper. Right, waveform at plate of first sync clipper showing video in the sync.

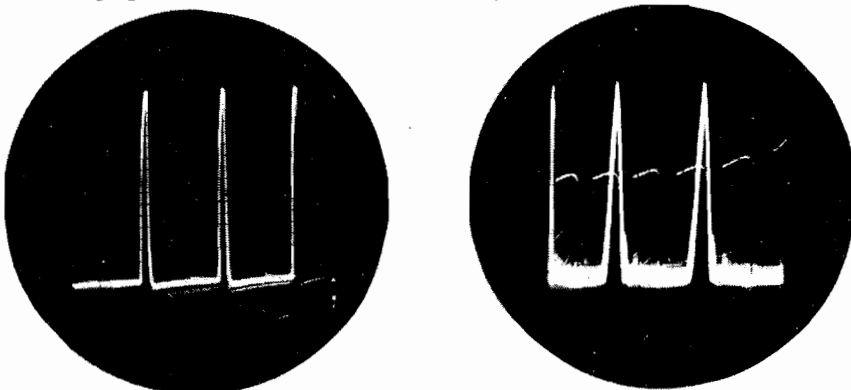
Figure H-7. Left, normal waveform at the plate of the second sync clipper. Right, waveform at the plate of the second sync clipper showing video in the sync due to overloading, loss of gain in earlier stages or misadjustment of the NBS transformer.

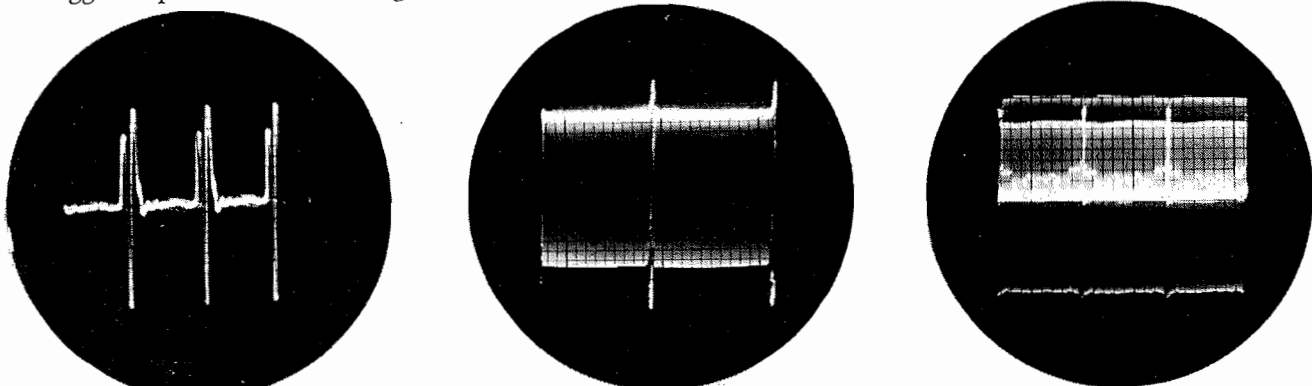
Figure H-9. Waveforms at plate of second sync clipper. Left, effect of hum on the negative supply line, oscillograph adjusted to observe the horizontal sync signal. Normal waveform appears in Figure H-7. Center, normal waveform with oscillograph adjusted to observe two vertical fields. Right, effect of hum, oscillograph adjusted to observe three vertical fields.

the presence of video information or hum, insufficient horizontal sync pulse amplitude and jitter. If the signal is not normal the fault may be isolated by working towards the front of the receiver examining the signal at the input and output of each stage. When hum is encountered check the B+ and negative supply lines.

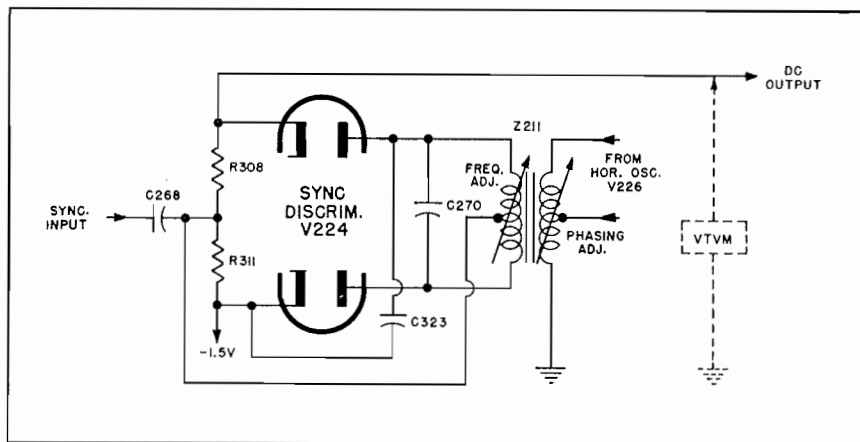
Figure A-3 Simplified circuit diagram of the sync discriminator. A VTVM should be connected as shown to check the operation of the circuit.

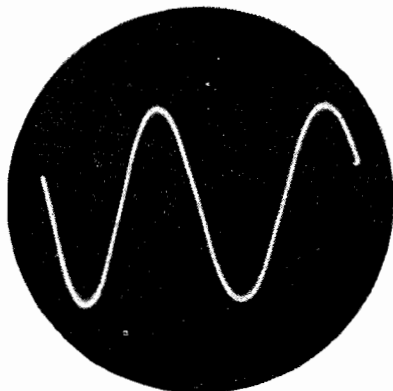
waveform, the vertical input of an oscillograph should be connected between the control grid of the oscillator and ground. The waveform observed should closely resemble the one shown in Figure A-2. If this check indicates that the oscillator is operating properly, the sync discriminator should be checked as described below.

Figure A-2. Sine-wave signal which is produced by the horizontal oscillator and coupled to the sync discriminator where its frequency is compared to that of the incoming sync pulse.

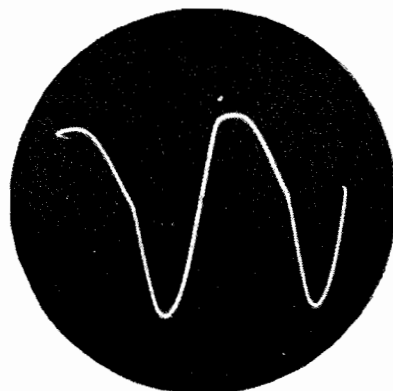
tenna should be disconnected from the receiver and the oscillograph controls set to observe a signal at the horizontal frequency (15,750 Cps). The signal observed at each end of the winding should resemble that shown in Figure A-4.

Figure A-4. Waveform which is present at the ends of the oscillator-transformer discriminator winding when the antenna has been removed from the receiver to eliminate the incoming sync pulse.

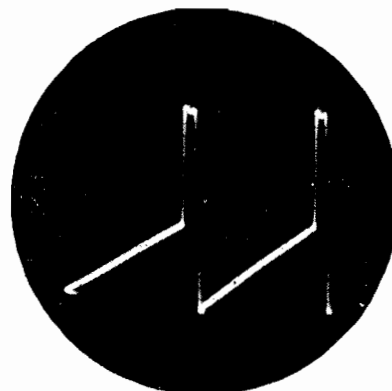
Figure A-5. Waveform which is present at the ends of the oscillator-transformer discriminator winding when a TV signal is being received.

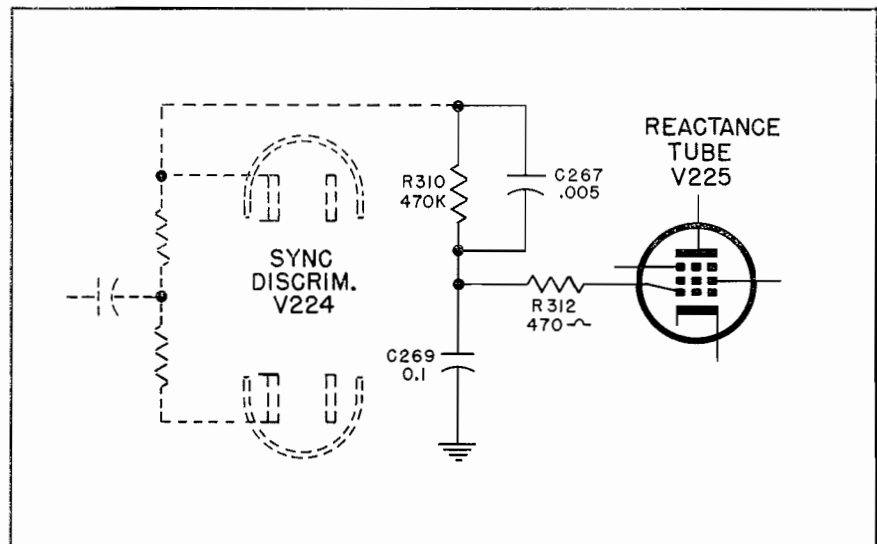
The purpose of the noise-immunity network, shown in Figure A-6, is to prevent rapid changes in the d-c error voltage when noise or vertical-sync pulses enter the discriminator circuit. A check should be made to determine

whether or not the noise-immunity network is coupling the error voltage to the grid of the reactance tube by connecting a VTVM between the grid of the reactance tube and ground, and varying the horizontal-oscillator frequency control. As the oscillator frequency is varied above and below 15,750 cps, the control grid voltage should vary from approximately +1 to approximately -4 volts. If the error voltage is not correct, the components in the noise-immunity network should be checked.

Figure A-6. Partial schematic showing the noise-immunity network components (solid lines).

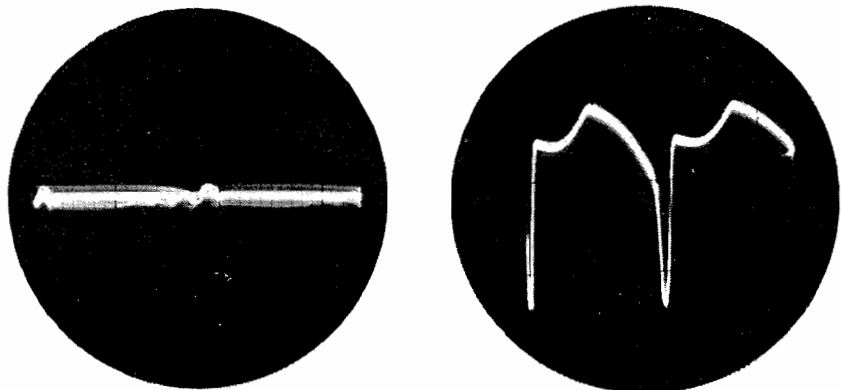
The network should also be checked to determine whether or not it is properly filtering the error voltage. This may be accomplished by connecting an oscillograph between the grid of the reactance tube and ground. The waveform observed should be similar to that shown in Figure A-7A. A typical waveform produced by a defective noise-immunity network is shown in Figure A-7B. This waveform resulted in horizontal tearing in the picture as shown in Figure A-8.

Figure A-7. A—Left, waveform at the grid of the reactance-tube when the noise immunity network is functioning properly. B—Right, waveform at same point when the network is defective.

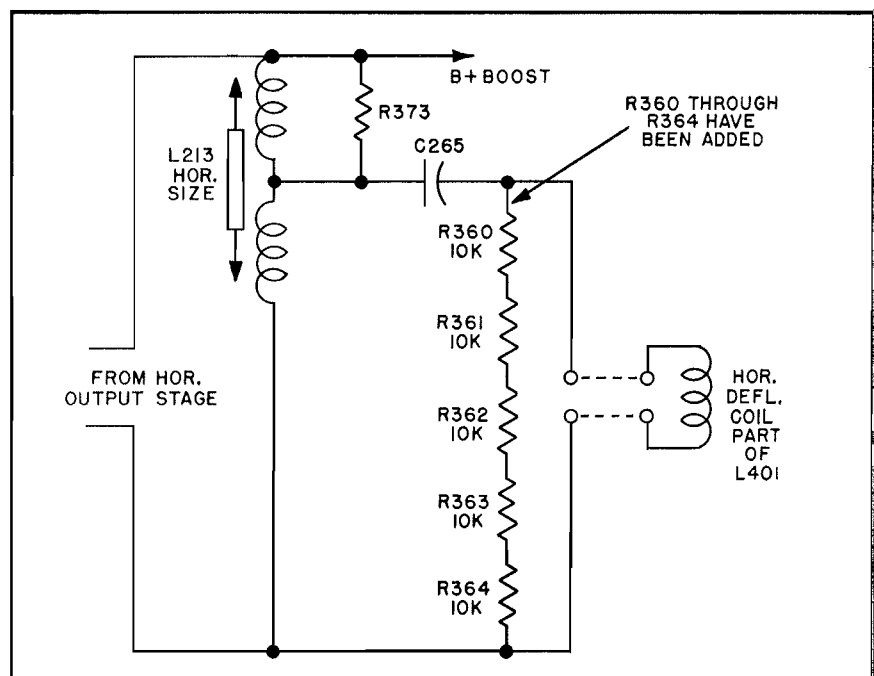
1. Linearity resistors, R360 through R364, are added in parallel with the horizontal-deflection coil, as shown in Figure B-1.
2. An additional decoupling capacitor is added at the B+ terminal of the 3rd video i-f stage, as shown in Figure B-2.
3. A channel-5 beat trap and a noise-immunity switch are added at the

**Figure B-1.** Partial schematic showing the location of the linearity resistors across the horizontal deflection coil winding. These resistors were incorporated in RA-130A Telesets to facilitate horizontal linearity adjustments.

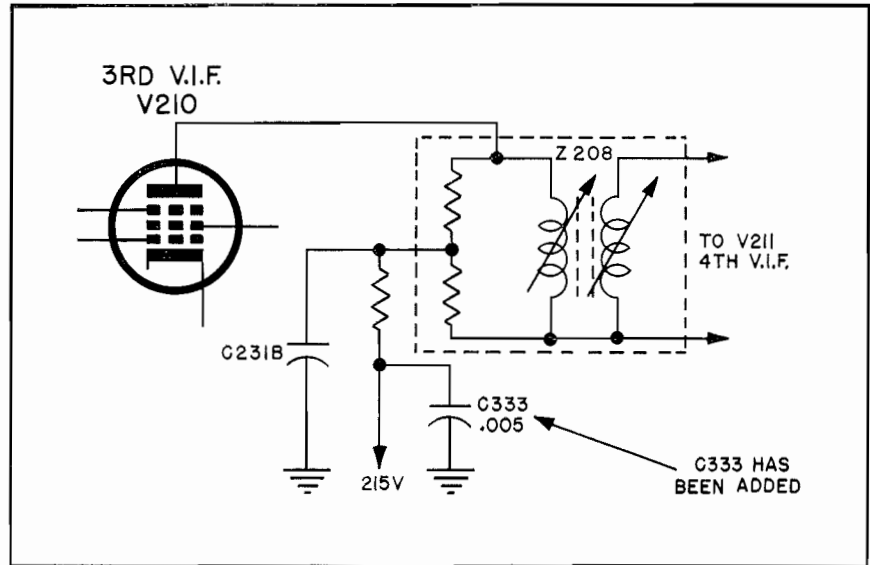
Figure B-2. Partial schematic showing the location of the decoupling capacitor in the 3rd video i-f stage. This capacitor was incorporated in the RA-130A Telesets to prevent sound regeneration.

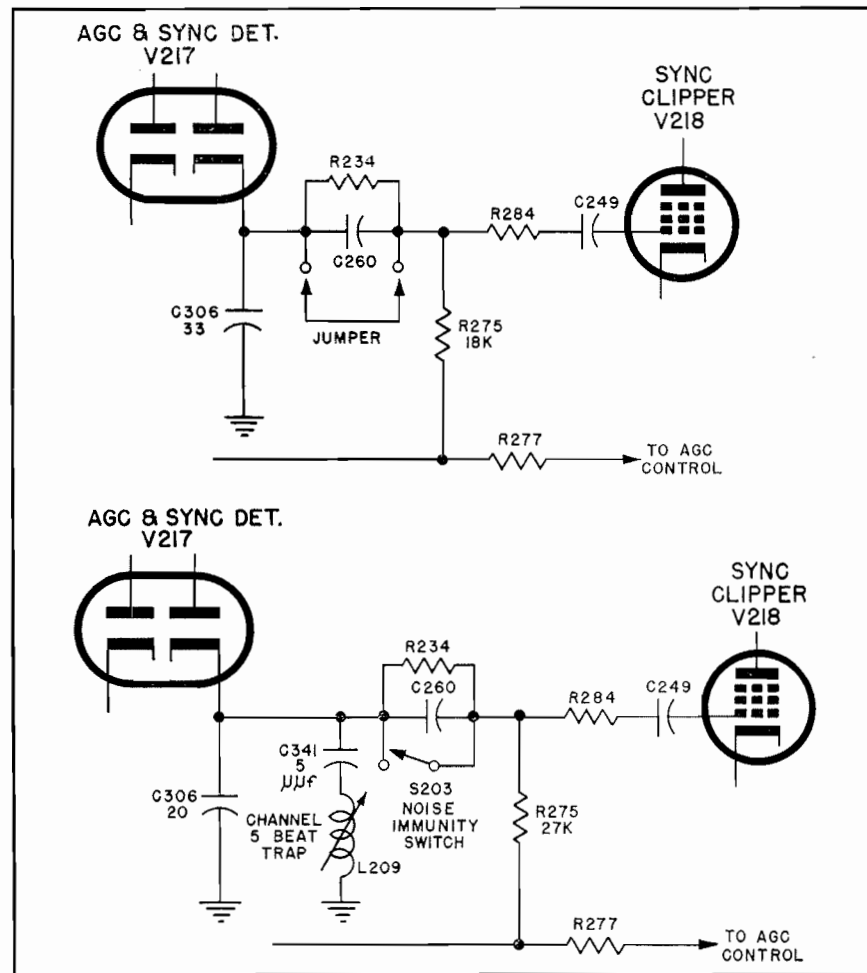
Figure B-3. Upper: Partial schematic of the RA-109A FAS sync-detector output stage. Lower: Partial schematic of the RA-130A sync-detector output stage showing the location of the Channel 5 beat trap and the noise-immunity switch.

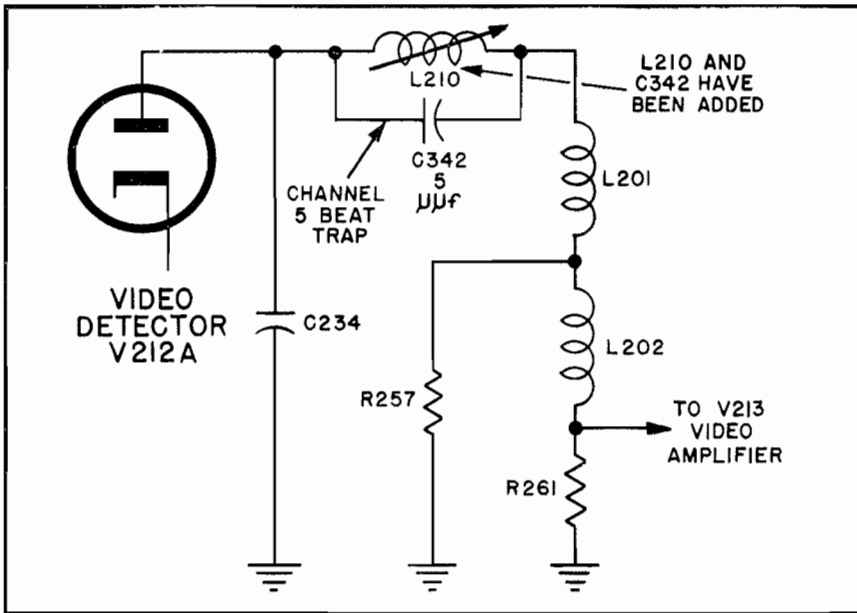
4. A channel-5 beat trap is added at the video-detector output as shown in Figure B-4.
5. Two correction magnets are added to eliminate pincushioning at the top and bottom of the picture.
6. The values of C306 and R275 are changed to increase sync stability. Both components are included in the sync-detector output as shown in Figure B-3.
7. The 21EP4A, a 21-inch, rectangular-type CRT, replaces the 19AP4A.
8. A new horizontal deflection coil is used to provide 70° deflection for the larger CRT.

Figure B-4. Partial schematic of the RA-130A video detector output stage showing the location of the 2nd Channel 5 beat trap, which was incorporated in the above circuit.

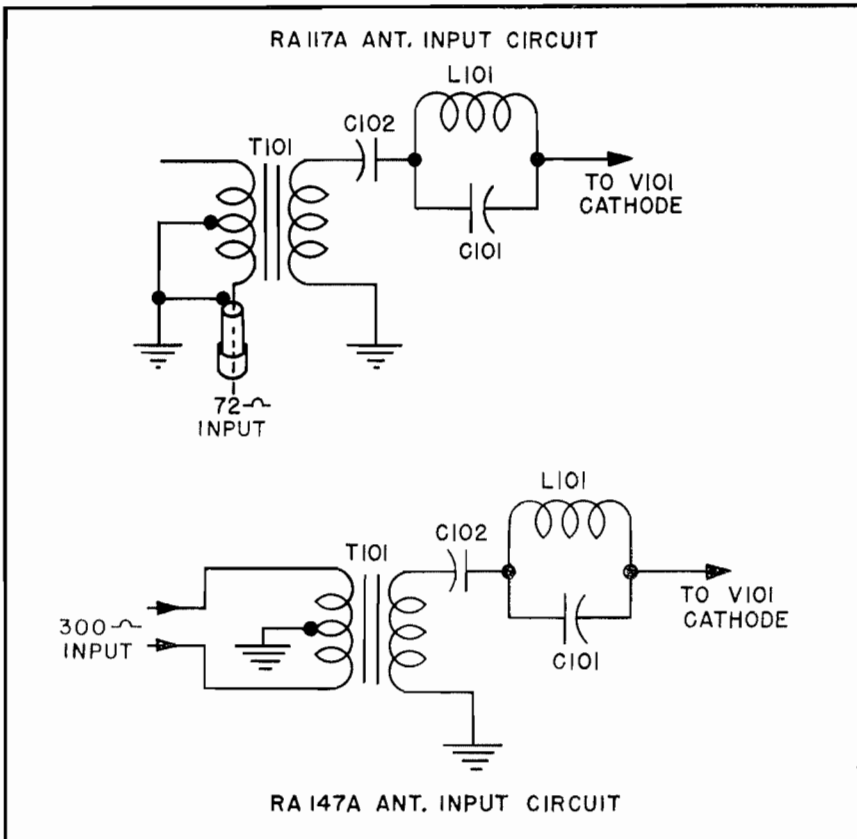
Figure B-5. Upper: Partial schematic of the RA-117A input circuit for use with a 72-ohm coaxial cable. Lower: Partial schematic of the RA-147 input circuit showing the change made to permit the use of 300-ohm transmission line.
