ALLEN B. DU MONT LABORATORIES, INC.

TELESET SERVICE BULLETIN

October 14, 1949

RE-ORGANIZATION OF SERVICE NOTES

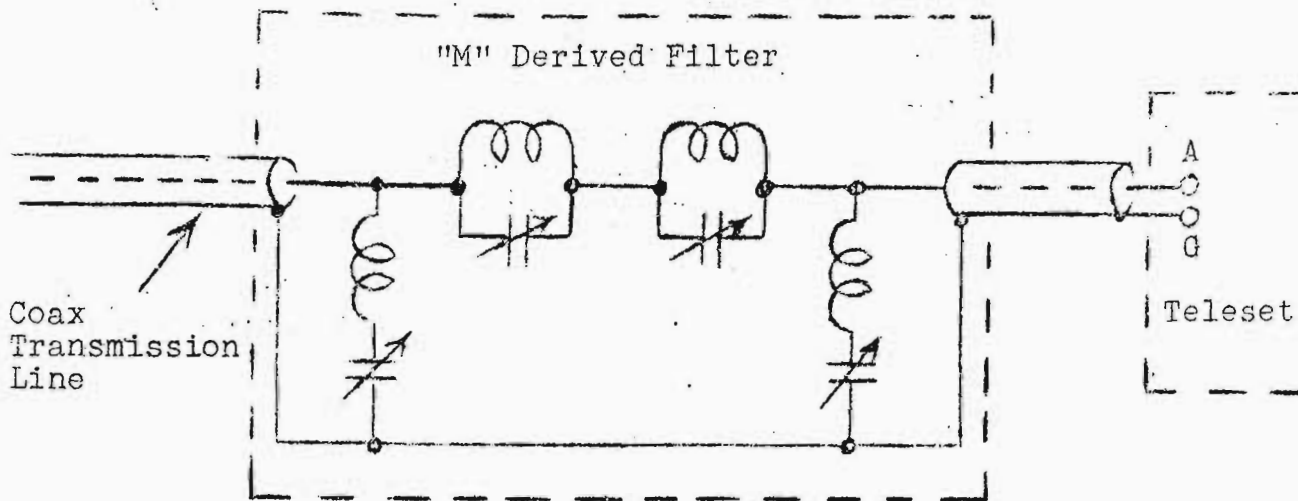
For low signal areas which are affected by FM interference, an "M" derived band elimination filter is recommended because of the low insertion loss requirements. When properly adjusted, adequate attenuation of the entire FM band can be obtained with a minimum loss of video signal thus making this type of filter also very useful in locations where more than one FM station is causing interference. The recommended method for installation of the "M" derived band elimination filter is shown below.

FM band elimination filters may be purchased from the Teleset Service Control Department. For convenience in installation, a 72 ohm coax output lead of sufficient length with male connector and a female input connector are provided. The complete unit can be easily mounted on the back panel of any Teleset model. Instructions for proper adjustment of the FM band elimination filter will be included with each filter.

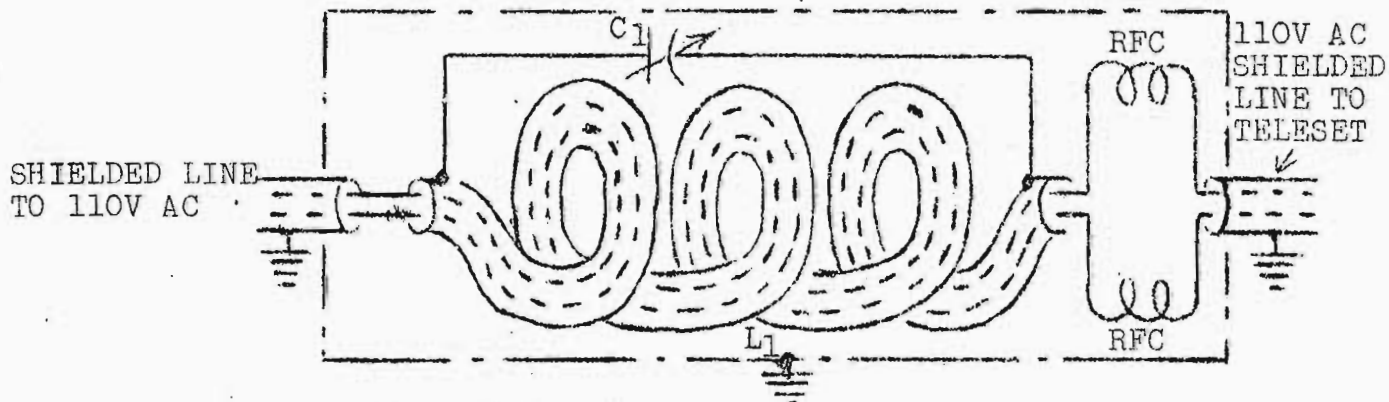
$L_1 = 1 \mu\text{h}$, $4\frac{1}{2}$ turns, $\frac{3}{8}$ " copper tubing, 3" dia.

$C_1 = 200 \mu\text{f}$ var., air dielectric (for 13.56 mc.)
 $50 \mu\text{f}$ var., air dielectric (for 27.12 mc.)

5. If interference is still observed, insert an AC power line filter into the line between the Teleset and the shielded AC line cord. This filter should be tuned to the frequency of the interfering diathermy equipment (13.56 or 27.12 mc.). The circuit of an absorption type filter is as follows:

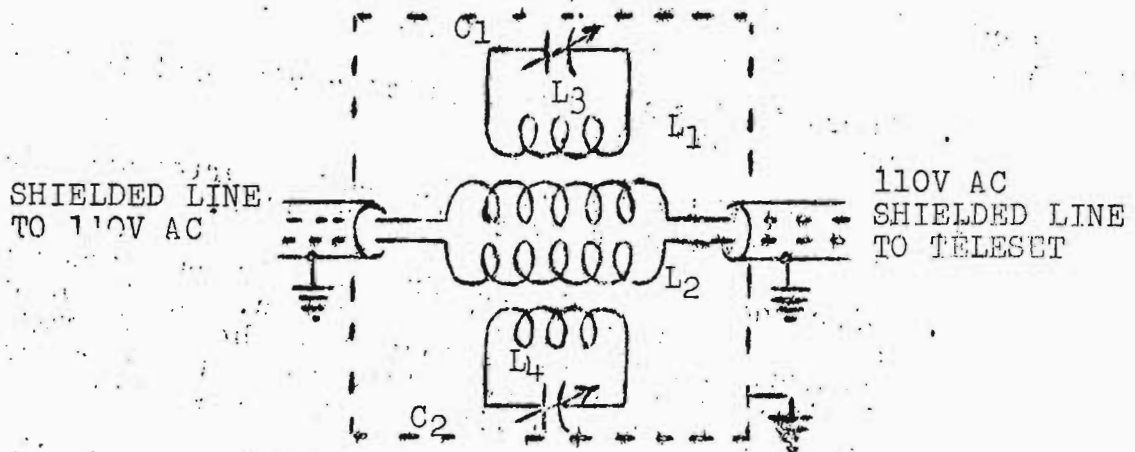
L_1, L_2 = 12 turns #18 insulated wire (O.D. = 3/32")
 L_3, L_4 = 14 turns #12 solid enameled wire.
 C_1, C_2 = 8 - 50 uuf ceramic (part number 03017500)

Note: L_1, L_3 and L_2, L_4 are interwound (bifilar) on $\frac{1}{8}$ " diameter, $2\frac{1}{2}$ " long form.

A more compact power line filter which is suitable for table model Telesets is shown in Figure 3. The circuit for this filter designed for 27.12 mc. is as follows:

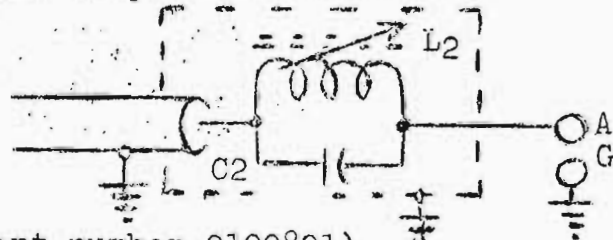
L_2 = 2.5 - 3.8 uh (part number 2100801)
 C_2 = 10 uuf ceramic for 27.12 mc. (part number 03013080)
 = 47 uuf ceramic for 13.56 mc. (part number 03012730)

7. Remove short across antenna input terminals and reconnect the antenna. Check for any remaining interference. If interference is still observed, install a trap (tuned to the frequency of the interfering diathermy equipment) at the antenna input. The trap should be mounted inside of the Teleset if copper screening has been installed. If screening is not used, the trap should be installed in a metal box. The circuit of a parallel resonant trap is as follows:

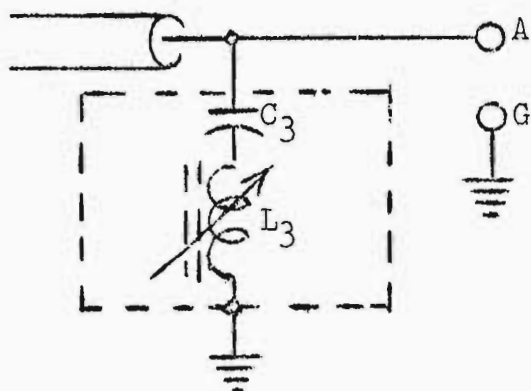
$$\begin{aligned} L_3 &= \text{same as } L_2 \\ C_3 &= \text{same as } C_2 \end{aligned}$$

In some cases a series resonant trap may produce better results than a parallel resonant trap, or vice versa. Experiment will decide which is best in each individual case.

The circuit of a series resonant trap is as follows:

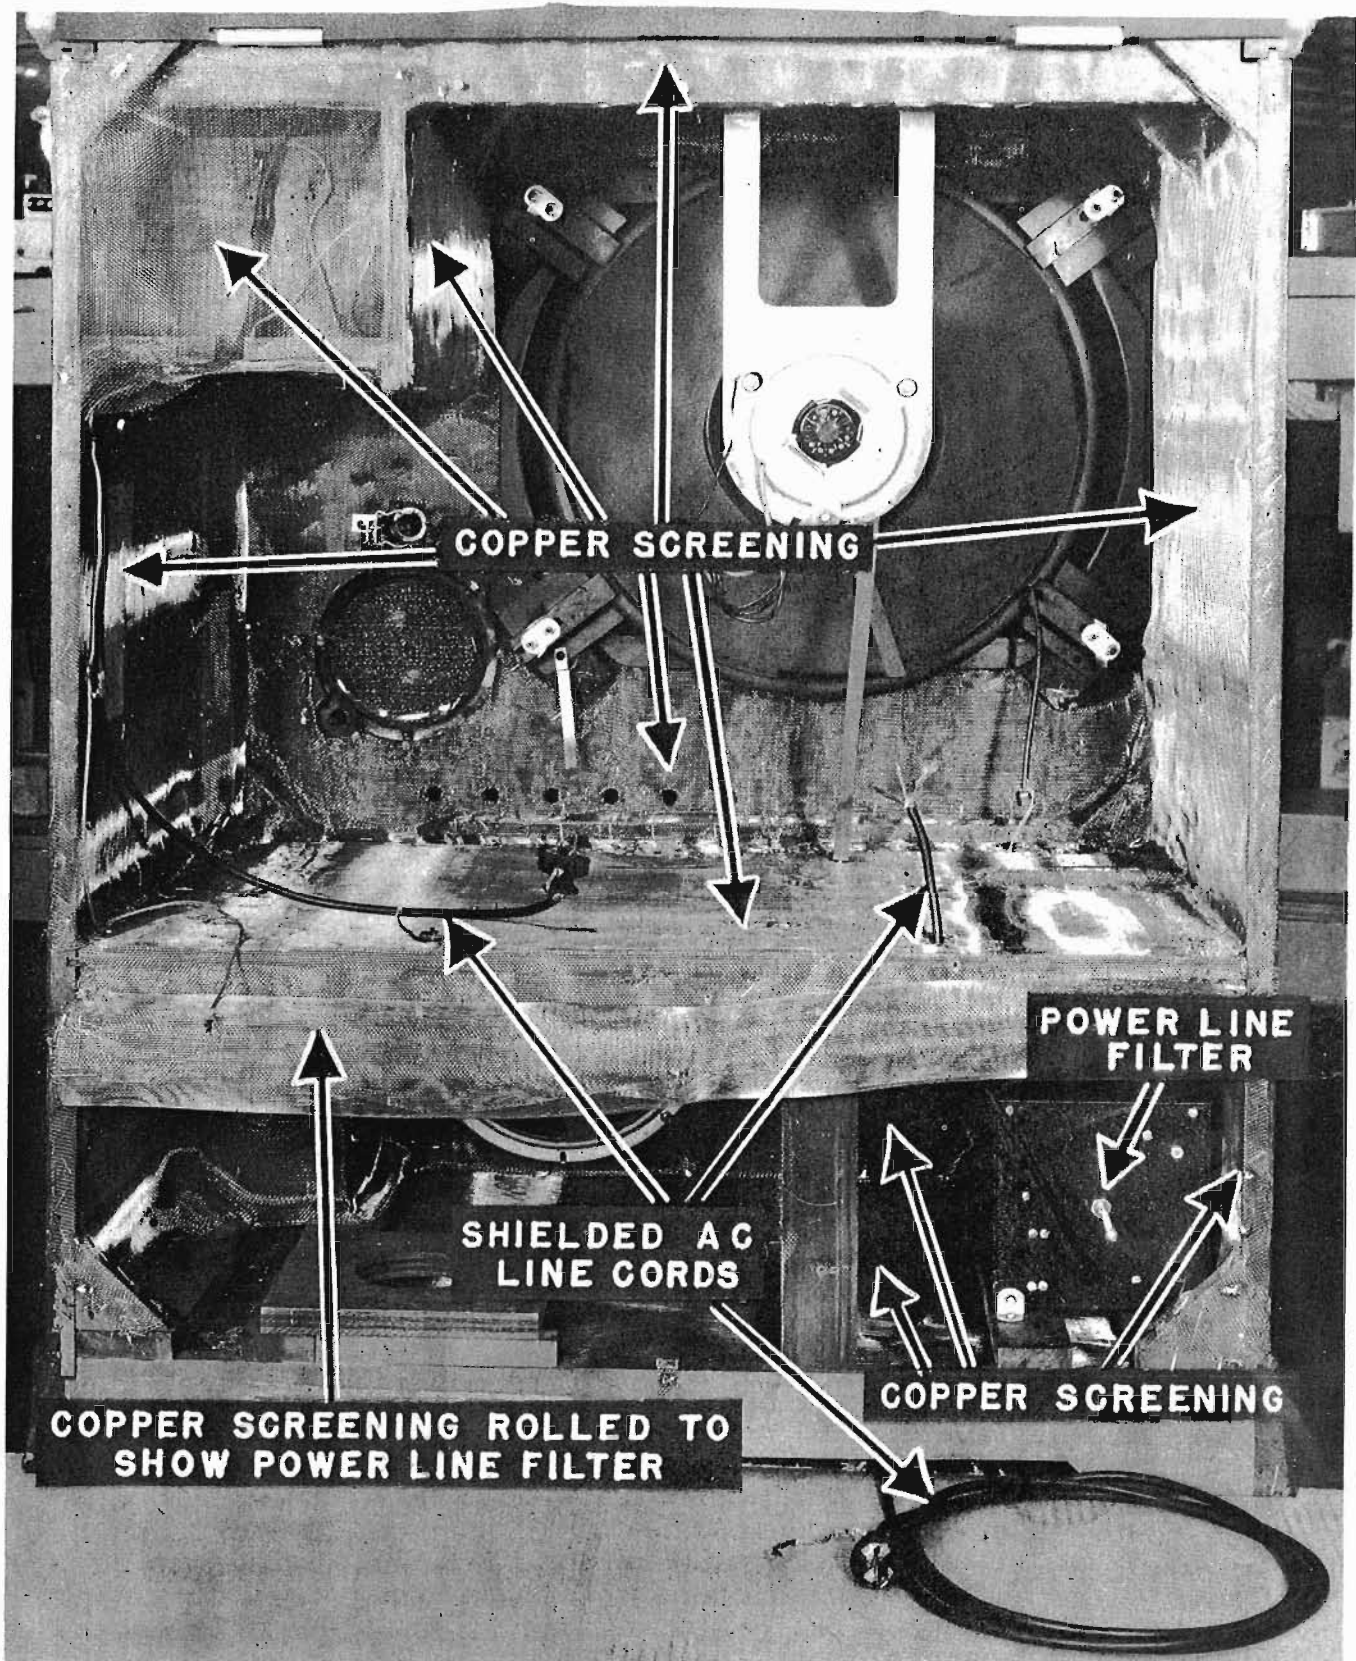
Figure 4

Figures 4 and 5 show an RA-108A Bradford modified in accordance with the complete procedure above. This Teleset was field tested in several adverse locations.

In another case, 8 miles airline from Philadelphia, this Teleset displayed absolutely no interference on any channel in use (3, 6 and 10) within fifteen feet of three diathermy machines operating on 27.12 mc. A similar unmodified Teleset displayed severe interference on all three of these channels when the diathermy equipment was in use.

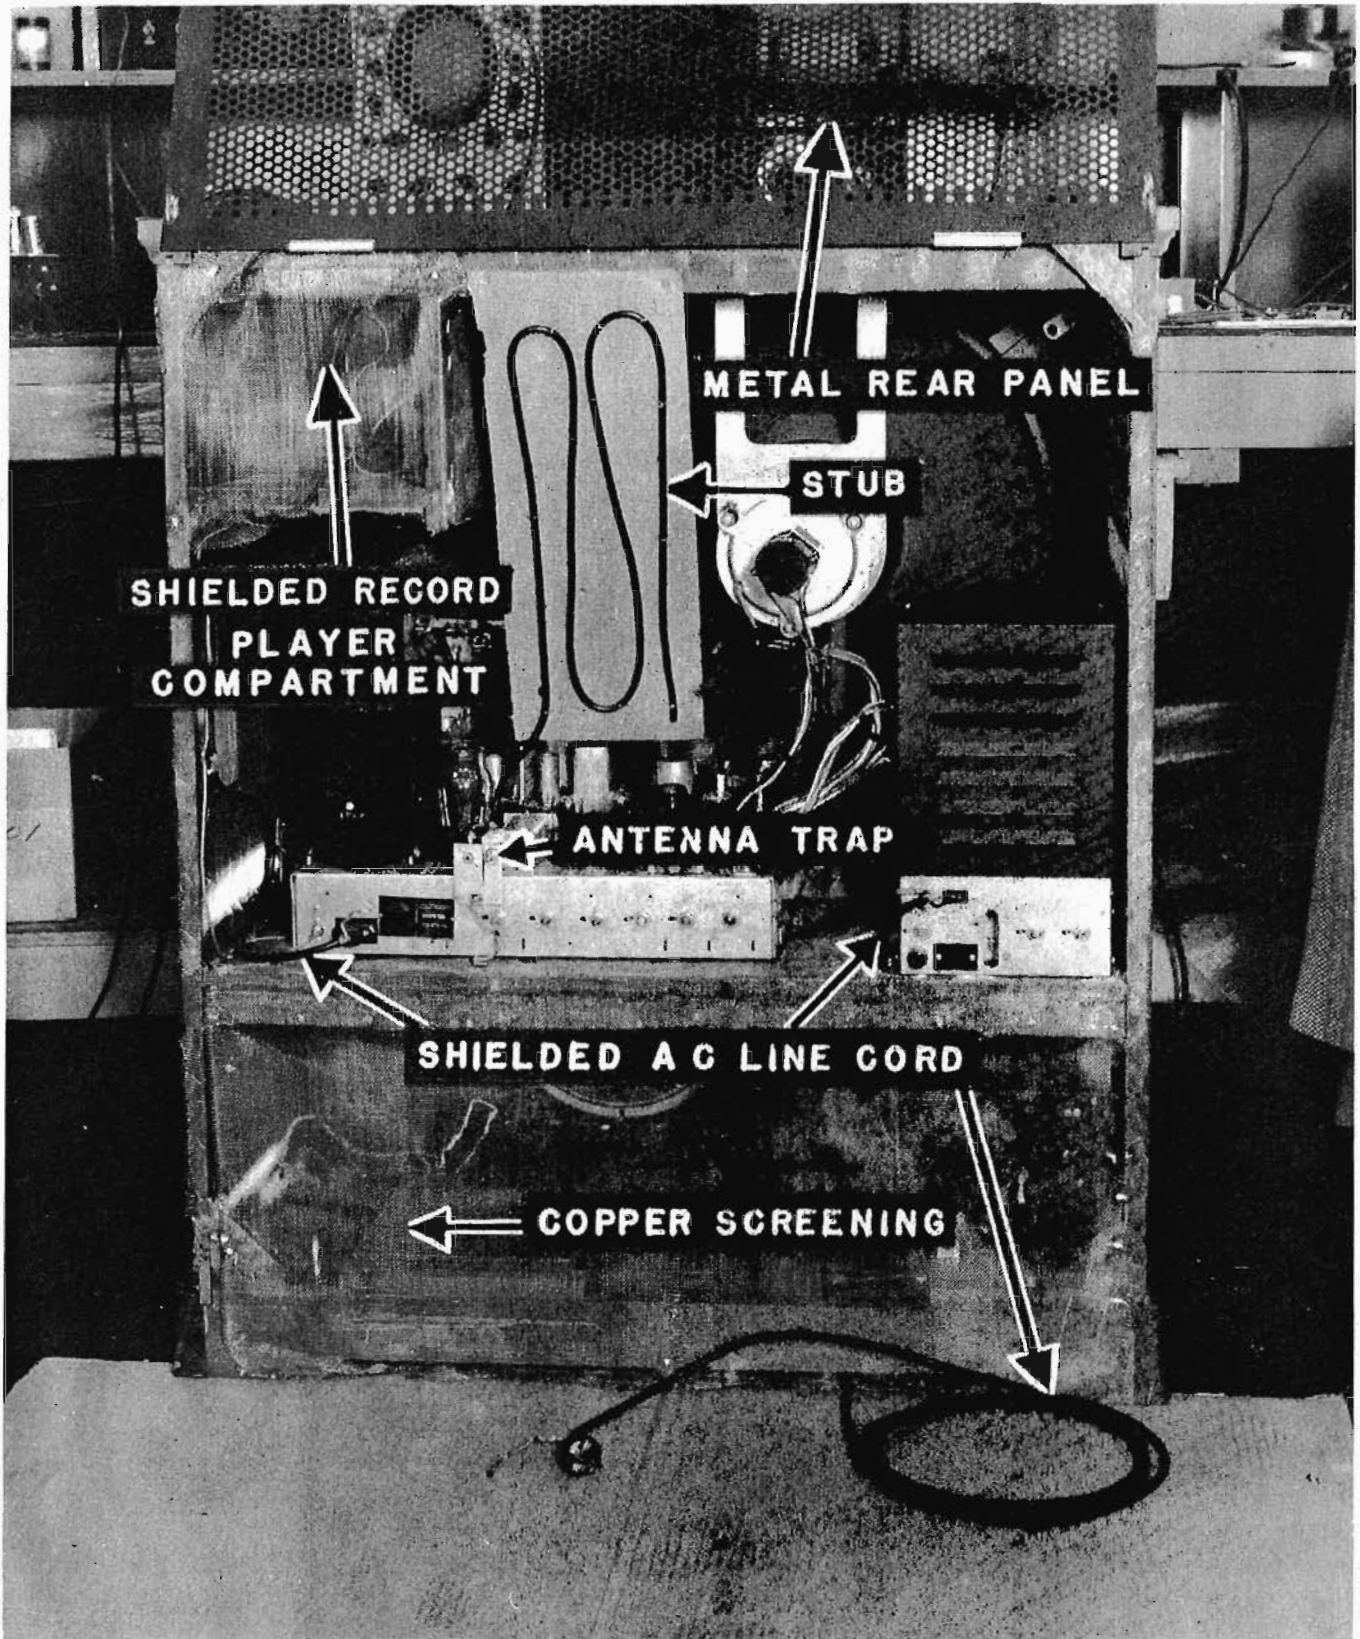
Figure 5

8. If any interference remains, install an open quarter-wave stub of RG-59/U directly across the antenna input terminals. This stub should be fixed in place by stapling to a piece of cardboard, as shown in Figure 5. The length of the stub is approximately as follows:

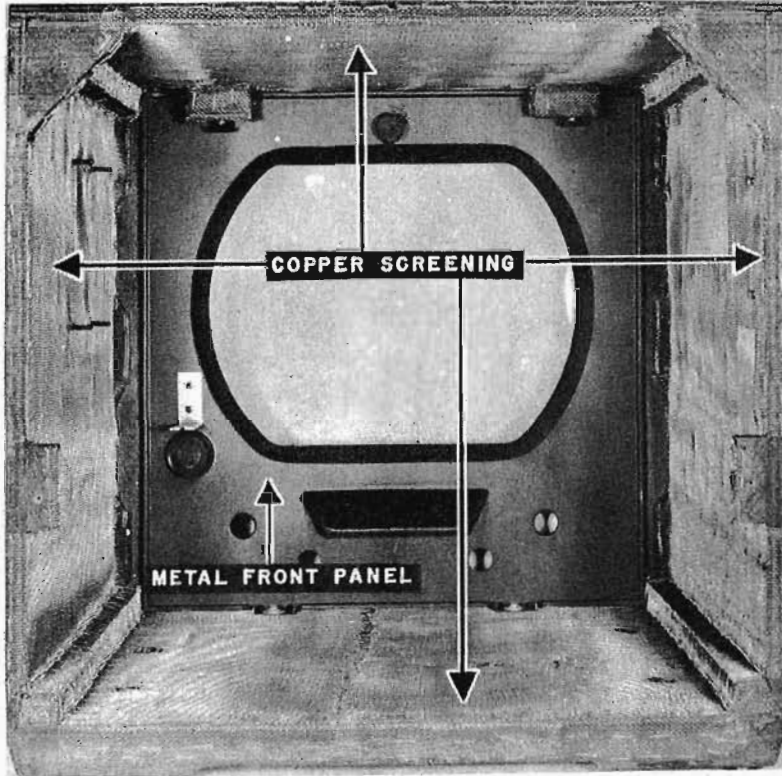
Figure 6

Figures 6 and 7 show an RA-111A Putnam modified in accordance with the above procedure.
