RA-102 SECTION

RA-103C SECTION

RA-103D, RA-104A, RA-110A SECTION

RA-105 -- RA-106 SECTION

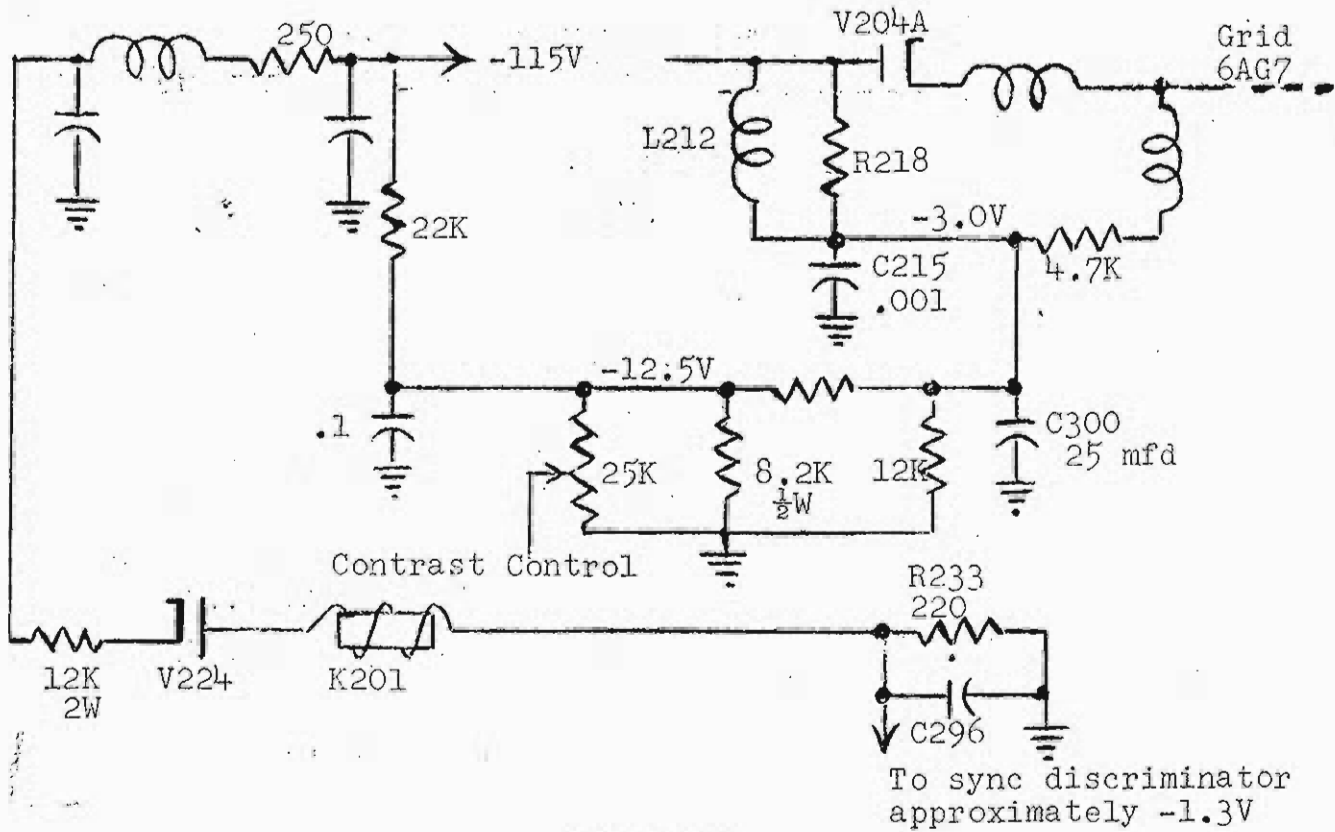
Figure 1

This condition is caused to a major extent, by feedback of the third harmonic of the video IF, from the CRT grid lead back to the antenna and RF section of the tuner. Since the lead to the CRT grid is longer in the RA-104A and RA-110A models, it is obvious why regeneration has been greater in these sets.

Present Bias Circuit

2. Change the bias circuit of the video amplifier V205, from that shown in Fig. 1 to the circuit shown in Fig. 2. In the existing circuit, the bias voltage for the mixer and the video amplifier are taken from the same point. The new bias circuit applies bias to the video amplifier from a different point. The only changes involved follow:

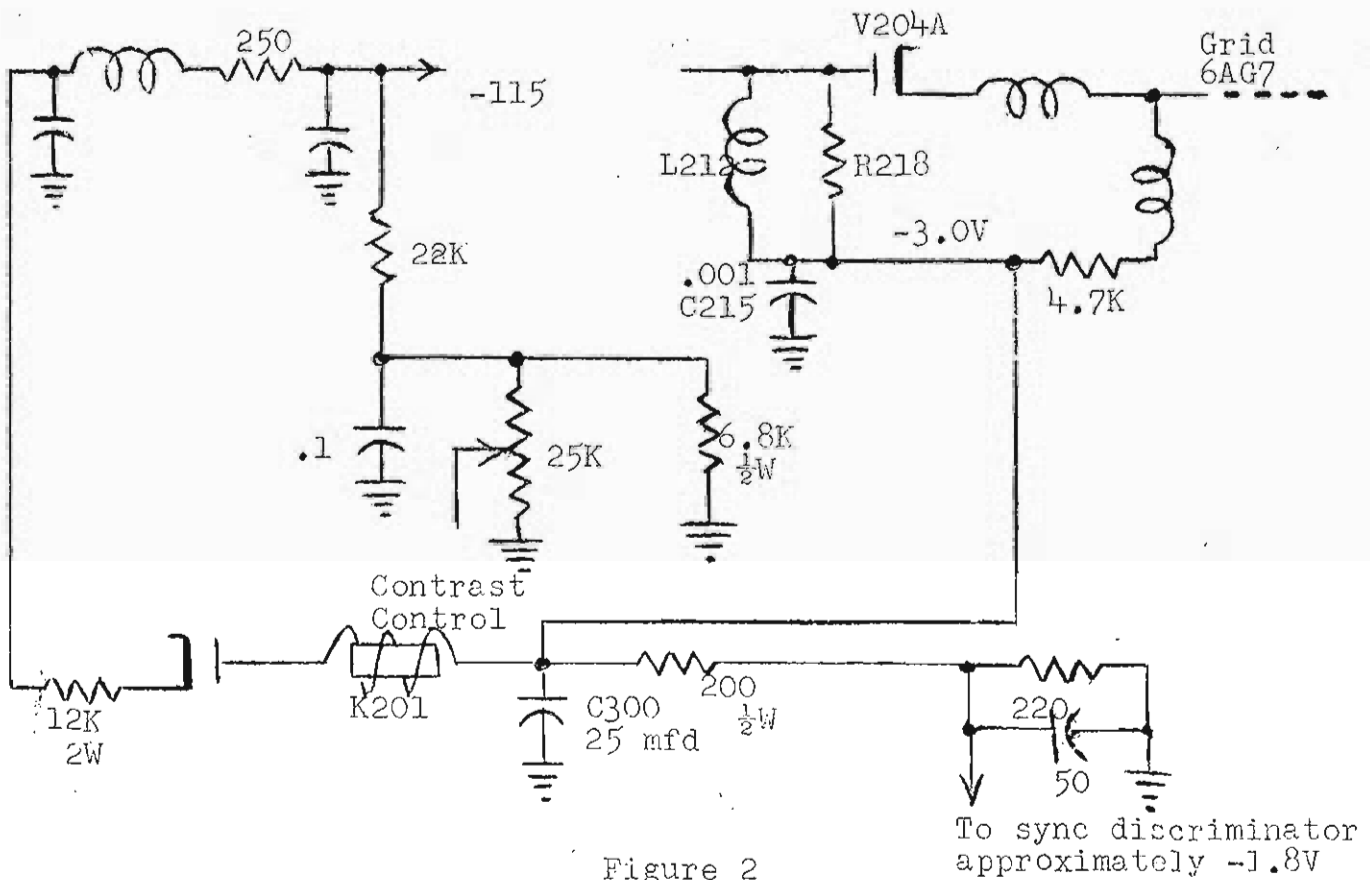
Figure 2

Proposed Bias Circuit

- a. Insert a 200 ohm $\frac{1}{2}$ watt resistor between the relay coil and the junction of R233 and C296.
- b. Remove the connection between C300 and the junction of R337 and R336. Leave C300 connected to the junction of R219, C215, R218 and L212.
- c. Connect the junction of the relay coil and the added 200 ohm resistor to the video amplifier grid circuit at C300.
- d. Remove R216 (8.2K), R336 (27K), and R337 (12K.) Add a 6.8K $\frac{1}{2}$ watt resistor as shown in Fig. 3.

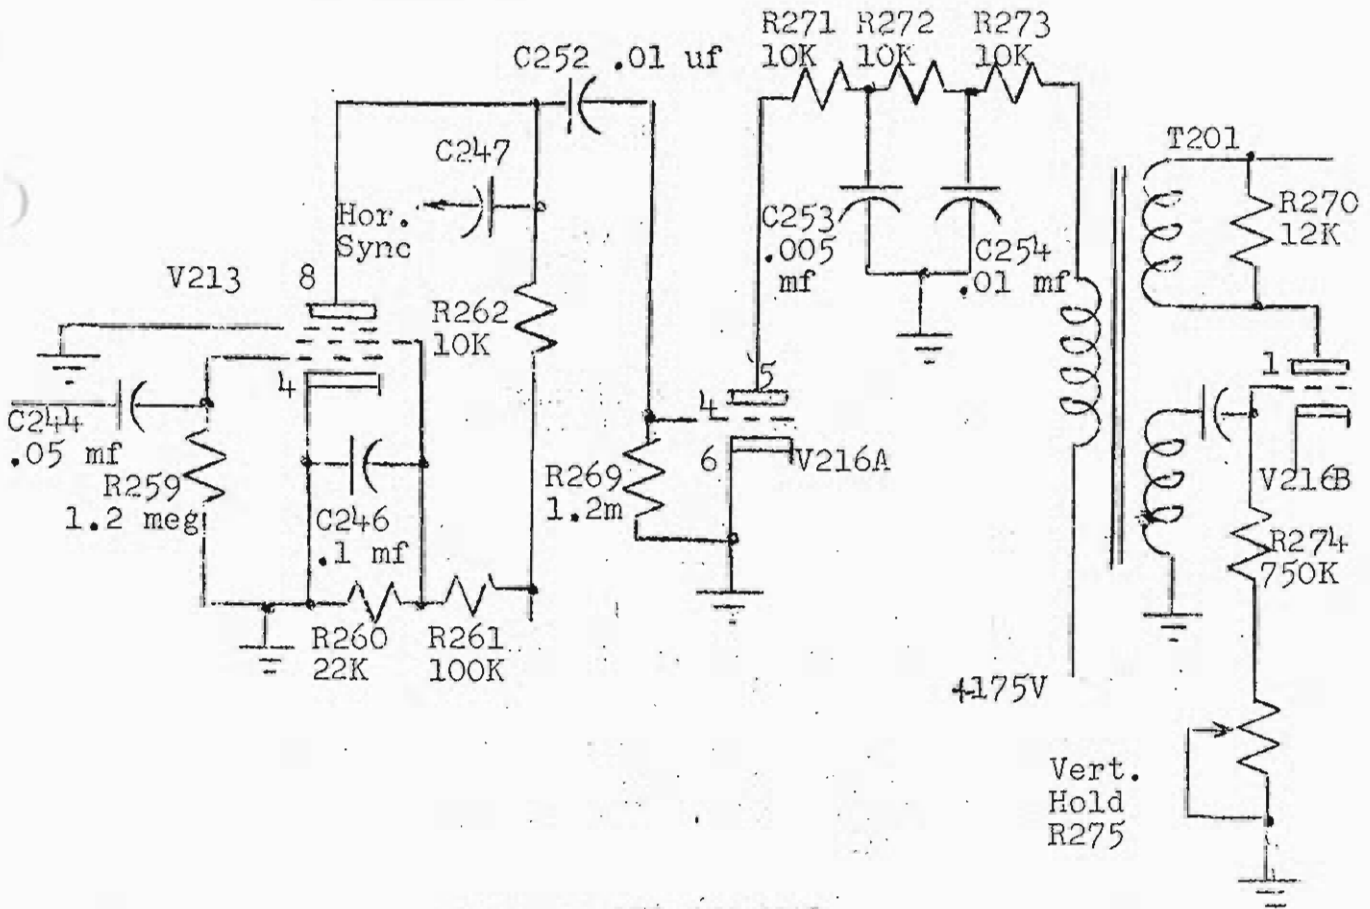
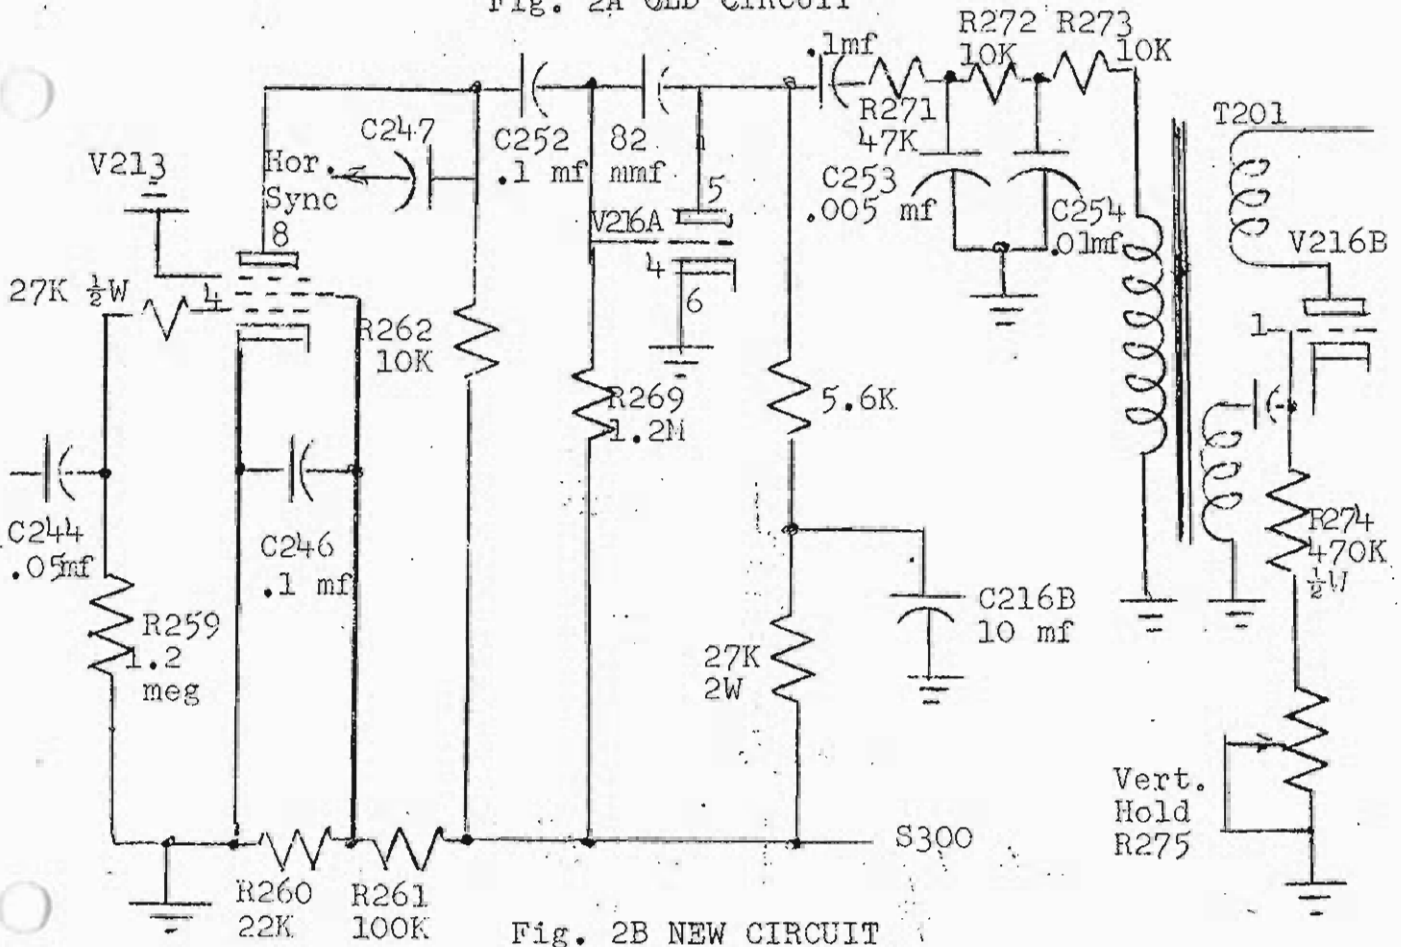
Fig. 2A OLD CIRCUIT

Tests in the laboratory and field have indicated that the following circuit changes give a very substantial improvement in sync noise immunity. These changes are recommended for use in areas where noise causes the Teleset to lose vertical sync. These changes should be especially valuable in weak signal and high noise areas.

Refer to Fig. 2A showing the old or unmodified circuit and Fig. 2B showing the new or modified circuit when making the following changes:

10. Add a 27K $\frac{1}{2}$ watt resistor between the junction of C244 and R259 and pin #4 of V213.
11. Remove capacitor C252 (between pin #8 V213 and pin #4 V216A) and replace with 0.1 mf capacitor.

14. Disconnect R271 (10K) from pin #5 of V216A. (This resistor will be replaced in step #18).
15. Connect a 5.6K $\frac{1}{2}$ watt resistor to pin #5 V216A.

18. Replace R271 with a 47K $\frac{1}{2}$ watt resistor.
19. Connect a .1 mfd capacitor between pin #5 of V216A and the 47K just added.
20. Disconnect the blue lead of the primary of T201 from the +175 volt line and run directly to ground.

21. Remove R270 (the 12K resistor connected across the Brown Black winding of T201)
22. Remove R274, the 750K resistor located between pin #1 of V216B and the vertical hold control and replace with a 470K $\frac{1}{2}$ watt resistor.

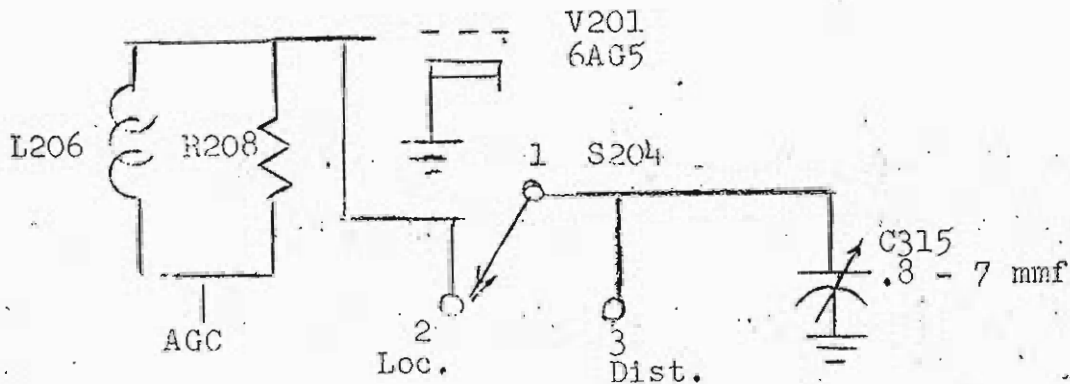
Several errors in the subject schematic recently issued to the field have been brought to our attention. The corrections for these errors follow:

1. The Local-Distance switch connections should be as shown in the following diagram:
