## Introduction

## Volumes

# TV

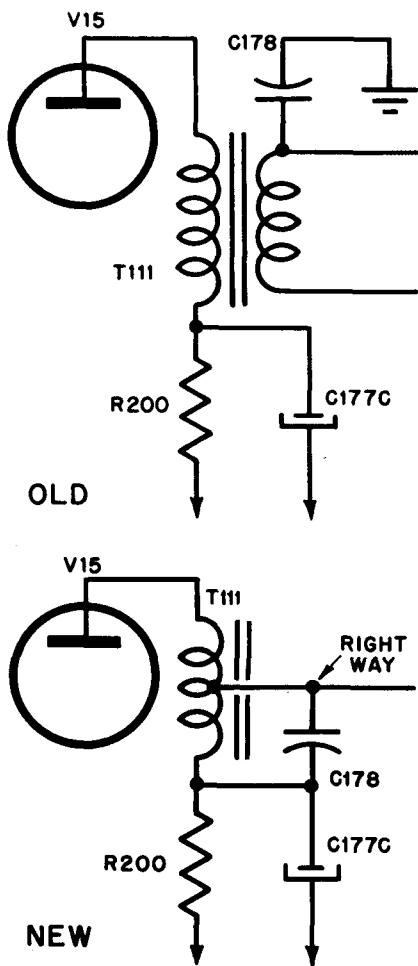
Fig. 9 — Arvin

**Audio buzz at minimum volume setting (see Fig. 9).**

1. The white and orange lead from pin 8 of *V11B*, the video amplifier, being too loose and dressed close to the volume-control terminals. Redress this lead.

2. *C121C*, 80  $\mu$ f, having an undesirable power factor or being leaky. Replace such a capacitor.

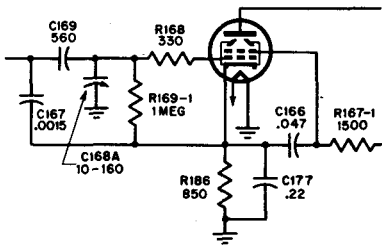
Fig. 11 — Arvin

**Increasing life of V12, 6AV5GT***(see Fig. 11).*

The life of V12 can be increased by making this change:

1. R186 850-ohm, 10-watt resistor added between cathode and ground of 6AV5GT tube.
2. Ground side of C166 capacitor rerouted to cathode of 6AV5GT.

3. *C177*, .22- $\mu$ f, 400-volt capacitor added to cathode circuit of 6AV5GT tube.

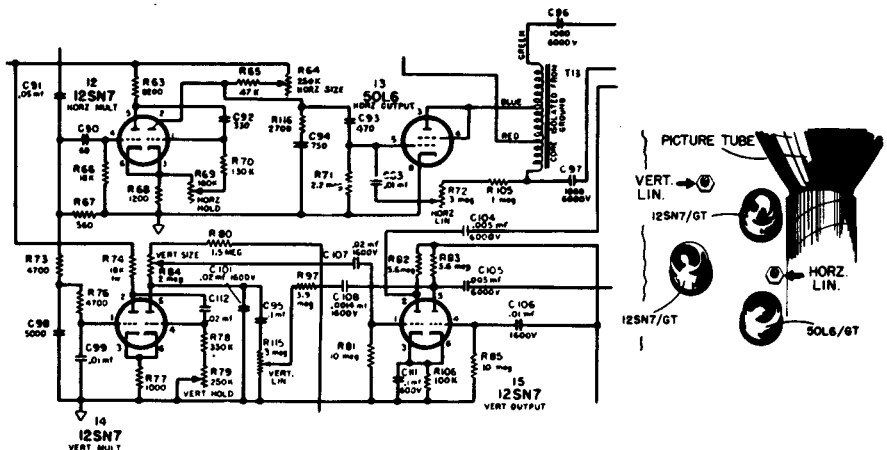
Fig. 12 — Belmont-Raytheon

**Improved horizontal and vertical linearity (see Fig. 12).**

linearity. The wiring instructions used with this kit are as follows:

1. Remove the vertical multivibrator and the output tubes (tubes 14 and 15 both 12SN7).
2. Place the template supplied with the kit over the tube sockets.
3. Center punch and drill two  $\frac{3}{8}$ -inch holes after pushing away the wires under the chassis to prevent damage.
4. Mount the two controls with the hardware provided.
5. Remove resistor R72 and capacitor C95 between pin 8 of tube 13 and B—, and connect pin 8 to B—.
6. Connect capacitor C95 from one end terminal of the vertical-linearity control to pin 5 of tube 14.
7. Connect the other end terminal of the vertical linearity control to B—.
8. Remove the connection of resistor R97 (6.8 megohm) to pin 5 of tube 14. Replace the 6.8-megohm re-

sistor with a 3.9-megohm resistor. Connect the loose end of *R97* to the center-tap of the vertical-linearity control.

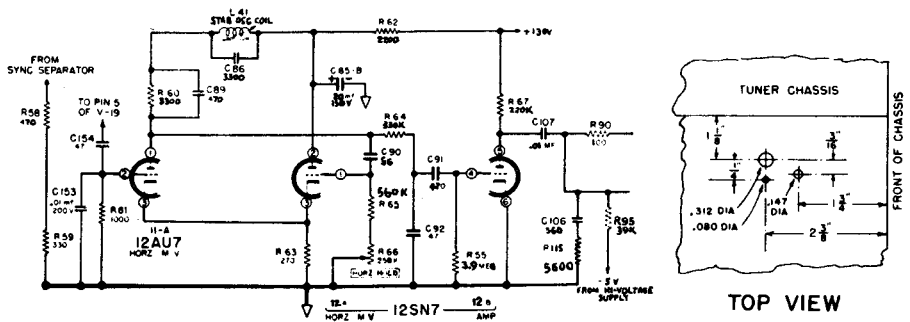
Fig. 13 — Belmont-Raytheon

#### **Stabilized horizontal multivibrator and reduction of picture shift (see Fig. 13).**

The manufacturer supplies modification kit EF to correct the above effects. Since many television broadcasting stations have the practice of locking their sync directly to the 60-cycle line, any phase shift in the transmitter power source may cause side-to-side picture drift. The changes incorporated in this modification reduce the tendency toward picture drift and improve the picture resolution in low-signal areas by providing a flywheel stabilization effect in the horizontal multivibrator.

The wiring changes are primarily located on the sockets of *V11* and *V12* and on the terminal board between the two sockets. They consist mainly of substituting one value of resistor or capacitor for another. For simplicity follow in sequence the wiring instructions below:

1. Change 1,800-ohm resistor on terminal board supplied with modification kit to 3,300 ohms.

2. Remove 470  $\mu\text{f}$  ( $C89$ ) (pin 2 of  $V11$ ) from chassis, and rewire across 3,300-ohm resistor supplied with kit.
3. Remove 33,000-ohm resistor ( $R60$ ) connected from pin 1 of  $V11$  to pin 2 of  $V12$ .
4. Change  $R64$  (pin 1 of  $V11$ ) to 330,000 ohms.
5. Change  $C92$  (pin 6 of  $V12$ ) to 47  $\mu\text{f}$ .
6. Connect blue wire to pin 1 of  $V11$ .

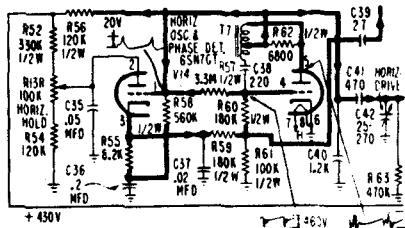
Fig. 14 — Bendix

#### Improving centering (see Fig. 14).

In order to improve electrical centering of the raster and to facili-

tate easier mechanical adjustment of the focus coil, a revision of the horizontal oscillator and phase-detector circuit may be made as shown in the figure.

1. Remove lead of capacitor C39 from the junction of capacitors C40 and C41.

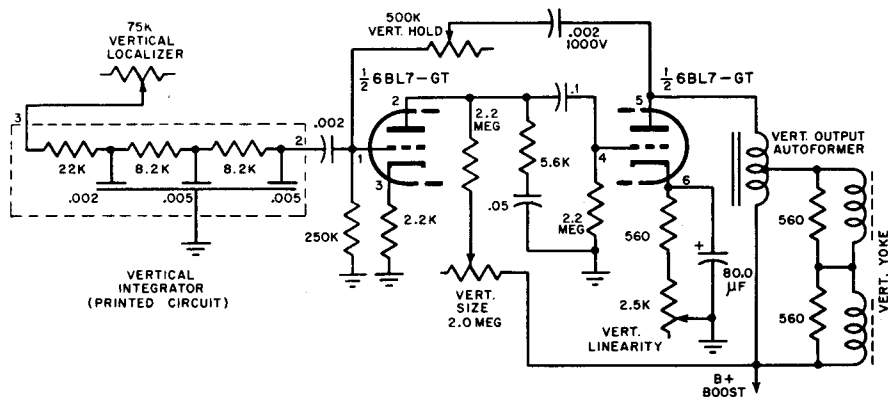
Fig. 15 — Calbest

### *Improved vertical circuit (see Fig. 15).*

In the event foldover at the top of the picture is experienced with the 6BL7-GT, add a resistor whose value is from 22,000 to 47,000 ohms to the 250,000 resistor in the grid circuit.

When making these changes, remove the black heater lead of the picture-tube socket from pin 3 of the 6SN7-GT tube socket, and ground to chassis directly.

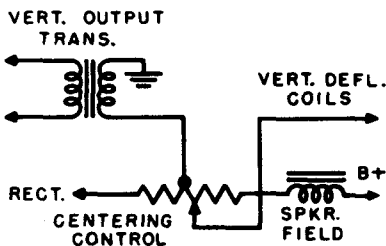
Fig. 16 — Capehart-Farnsworth

#### Adding vertical-centering control (see Fig. 16).

A vertical-centering control may be installed by performing the following operations. The control is a 10-ohm, 2-watt center-tapped potentiometer, part No. 450662A-1. It should be installed in some convenient location on the rear chassis apron.

1. Connect the control in series with the speaker field coil (filter choke), using the end terminals of the control.
2. Open the vertical output transformer yoke lead.
3. Connect the transformer lead to the fixed center tap on the control.
4. Connect the yoke lead to the variable arm on the control.

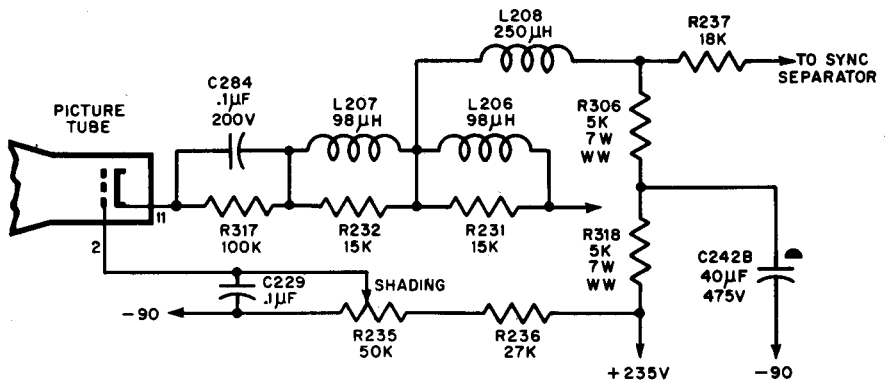
Fig. 22 — Capehart-Farnsworth

#### Preventing blocking on strong signals (see Fig. 22).

Connect in series with the lead to pin 11 (cathode) of the picture tube a parallel combination of a 100,000-ohm resistor and a .1- $\mu$ f 200-volt capacitor. Care should be taken that undue stray capacitance is not introduced between the cathode lead of the picture tube and ground. This change is also shown in the diagram for the previous cure.

circuit and connect to the +235-volt circuit. Remove *R306* from the +135-volt circuit and connect to *C242B*. To provide by-passing at the +135-volt tap, add a 20- $\mu$ f 450-volt tubular capacitor between this point and ground. This capacitor should be connected to the terminal board to the front of the 4.5-mc sound i-f stage and the ground lug of the terminal

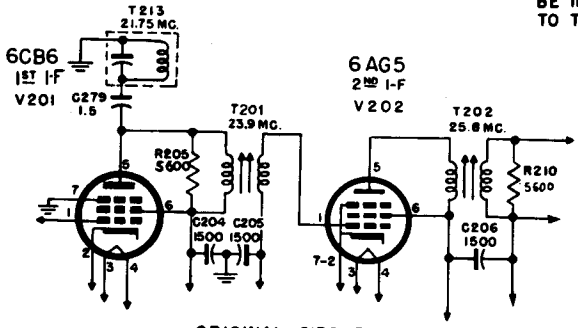
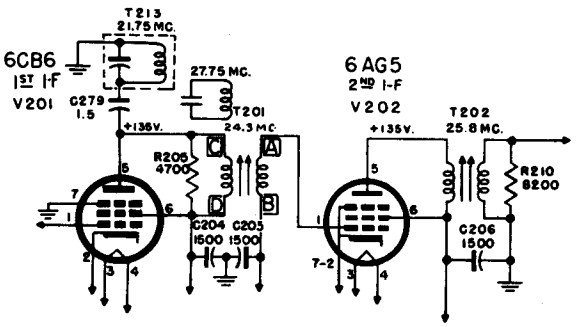
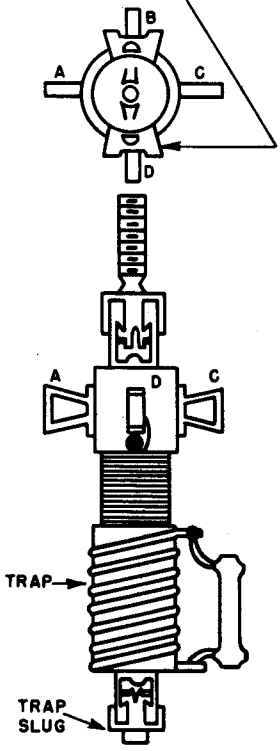
Fig. 23 — Capehart-Farnsworth

#### Adjacent channel trap (see Fig. 23).

For the few areas where severe adjacent-channel interference is encountered, a special trap is available. This trap, part No. 750261A, is a combined first i-f transformer and

trap and replaces the original first i-f transformer.

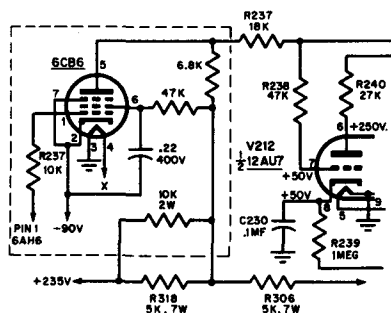
Fig. 24 — Capehart-Farnsworth

### Modification for improved fringe-area operation (see Fig. 24).

It is possible, under particularly severe conditions, that greater range of the contrast control may be required without loss of sync. If so, a

6CB6 sync-amplifier tube may be easily installed on the chassis between the 6AL5 (*V204*) and 12AU7 (*V212*). Using a socket punch, cut a 5/8-inch hole in the chassis. Install socket and wire as shown in the figure.

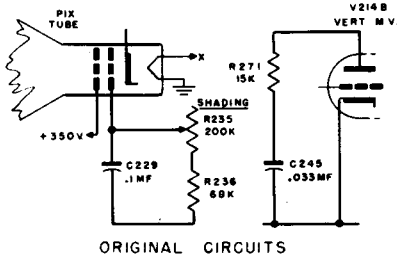
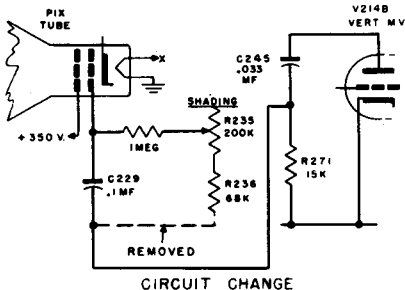
Fig. 25 — Capehart-Farnsworth

### Blanking of vertical-retrace lines (see Fig. 25).

This change will blank out the vertical-retrace lines which may be objectionable. The following changes may be made as shown in the diagrams.

The original circuit has *R271* connected above the capacitor *C245*, and the shading circuit shown with a 200,000-ohm potentiometer, *R235* and *R236* as a 68,000-ohm resistor.

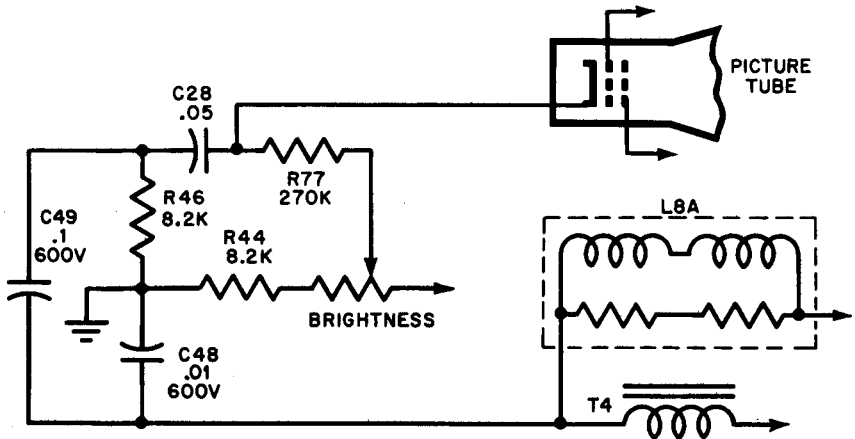
Fig. 28 — CBS-Columbia

**Vertical retrace line elimination**  
(see Fig. 28).

3. Connect *C48* (.01  $\mu$ f at 600 volts) from the junction of *C49*, *T4*, and *L8A* to ground.

The rewired circuit is shown in the figure.

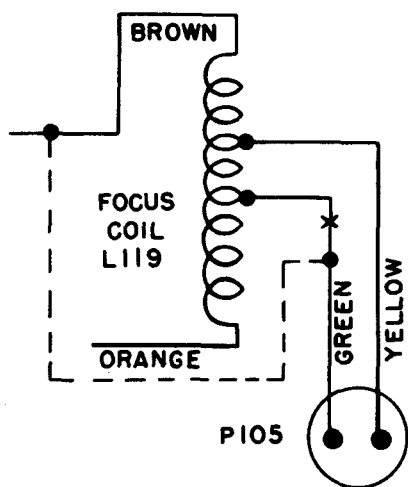
Fig. 31 — Crosley

#### **Increasing range of focus control (see Fig. 31).**

If it becomes necessary to increase the range of the *Focus Control* on the 20- or 21-inch models of 1952, connect the focus coil (*L119*) as shown in sketch and explained below.

1. Cut the green wire at X and tape the bare end of the portion of wire that remains on the focus coil. Be sure to allow enough wire to remain on the coil, just in case it is ever necessary to reconnect it in its original manner, if for any reason the picture tube must be replaced at a later date.

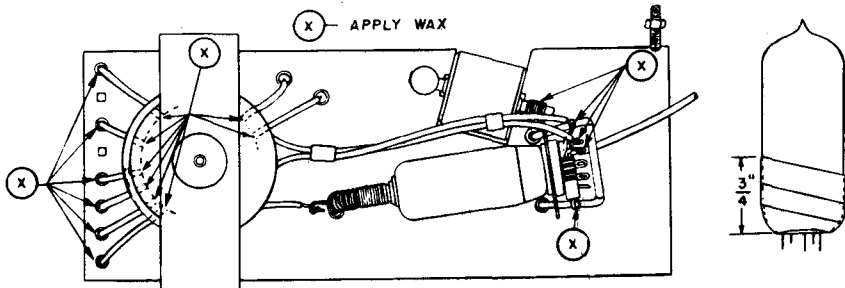
Fig. 33 — Crosley

**Preventing corona and arcing on high-voltage assembly (see Fig. 33).**

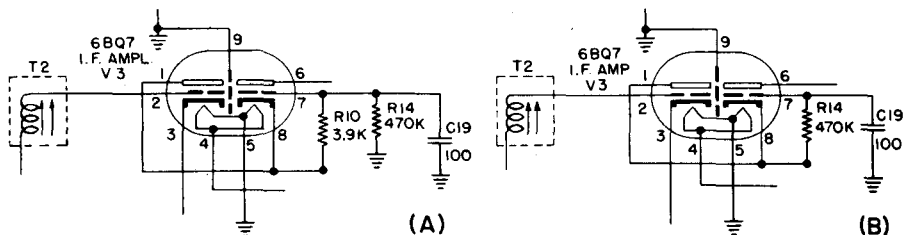
Fig. 35 — Crosley

### **Increasing sensitivity (see Fig. 35).**

Early production sets were wired according to schematic (A) shown in the figure. To increase the sensitivity on later production sets the

resistor *R10* was deleted, and resistor *R14* was removed from chassis ground and wired between pins 7 and 8 of *V3* (6BQ7 tube). See schematic (B).

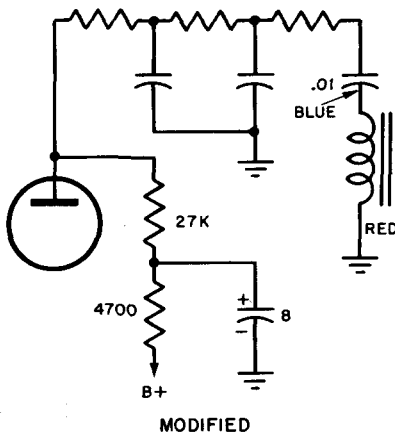
Fig. 36 — DuMont

(see Fig. 36).

6. To the open end of the 27,000-ohm resistor, connect a 4,700-ohm, 1-watt carbon resistor and the positive terminal of an 8- $\mu\text{f}$ , 450v electrolytic capacitor.

7. Ground the negative terminal of the 8- $\mu\text{f}$  capacitor to the chassis.

8. Connect the open end of the 4,700-ohm resistor to the point from which the blue transformer lead was removed in step 1 (above).

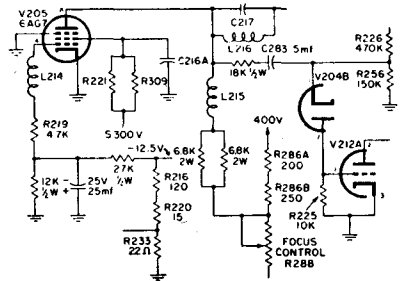
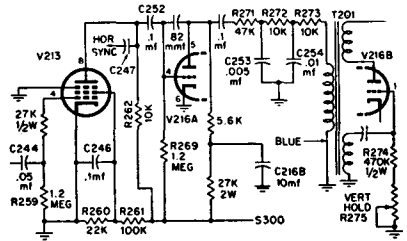
Fig. 37 — DuMont

### Sync noise immunity (see Fig. 37).

8. Remove capacitor *C282*, connected from pin 7 of *V204B* to ground. Remove capacitor *C219*, located between pin 7 of *V204B* and pin 1 of *V212A*, and replace with a short lead, using the pin 7 lug to which *C219* was connected.

9. Remove resistor *R224*, located between pin 1 of *V212A* and ground.

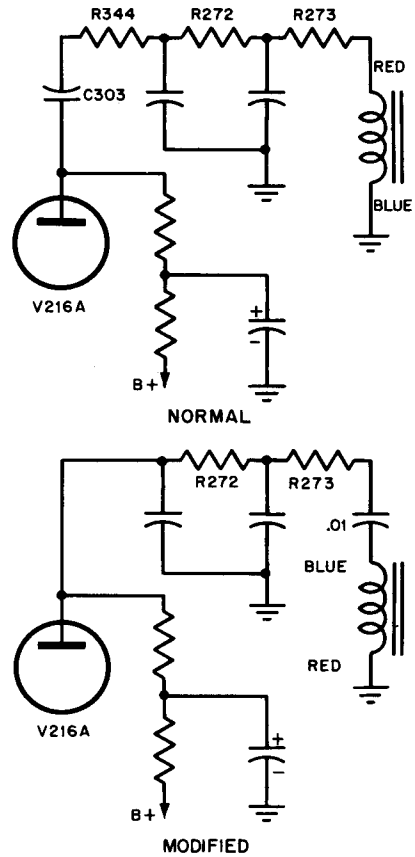
Fig. 39 — DuMont

**Elimination of vertical jitter**  
(see Fig. 39).

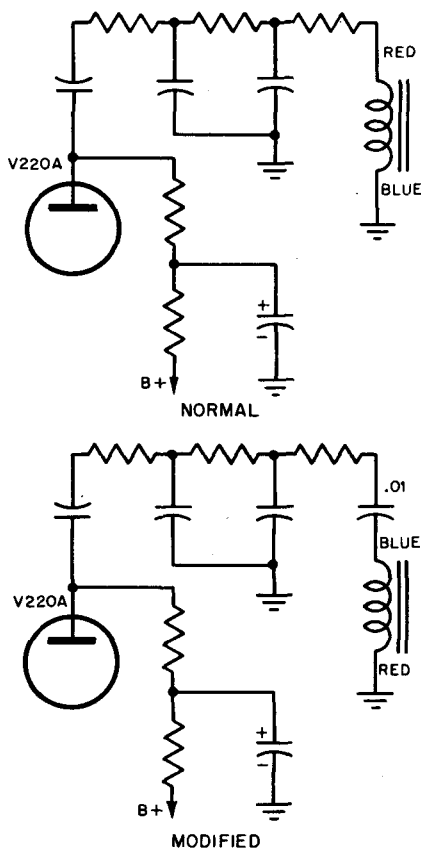
Fig. 42 — DuMont

**Elimination of vertical jitter**  
(see Fig. 42).

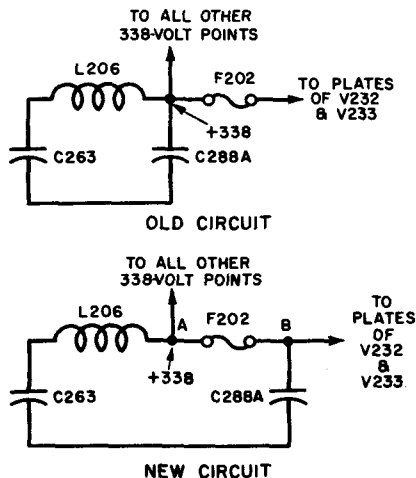
Fig. 46 — DuMont

### Rewiring of fuse (see Fig. 46).

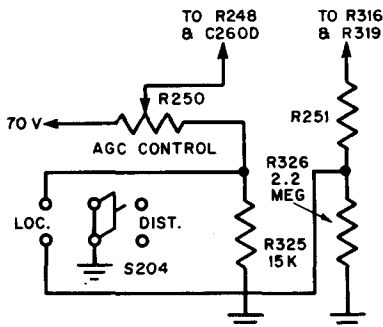
Fig. 48 — DuMont

### Installation of Local-Distance switch (see Fig. 48).

To give increased sensitivity in weak-signal areas, a *Local-Distance* switch may be installed. The switch is used in *Local* position in locations having normally acceptable signal strength. It may be set in *Distance* position for increased sensitivity in weak-signal areas, provided the signal strength on other stations is not excessive. Evidence of such overloading might appear either as a loss in the full range of gray tones or as the presence of sound bars in the picture. In the *Distance* position, the receiver safely handles all signals below a 15,000-microvolt level.
