Introduction

TV

MANUFACTURERS' RECEIVER TROUBLE CURES

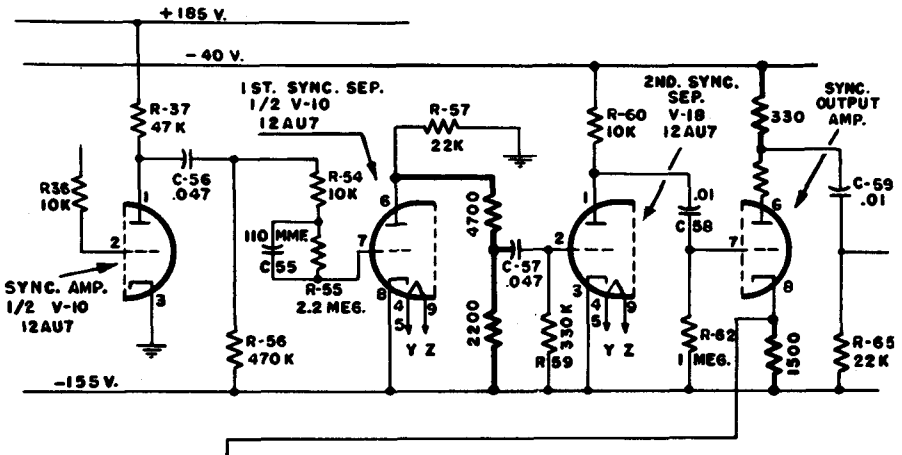
Fig. 4 - Emerson

EMERSON Chassis 120129-B, -D,
 120135-B, -G, -H, 120140-B,
 -G, -H, 120141-B, -G, -H
Improving sync stability in fringe areas (see Fig. 4).

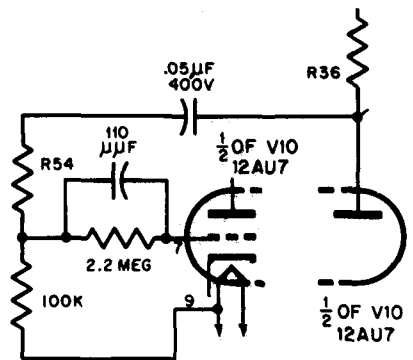
Fig. 6 — Emerson

Improving sync stability in fringe areas (see Fig. 6).

To improve the sync stability in extreme fringe areas, proceed as follows:

1. *R-36* (in plate circuit of sync amplifier) is changed from 10k ohms to 47k ohms.

Note: If the omission of *C-72* causes excessive rippling of the horizontal scanning lines, re-install this capacitor.

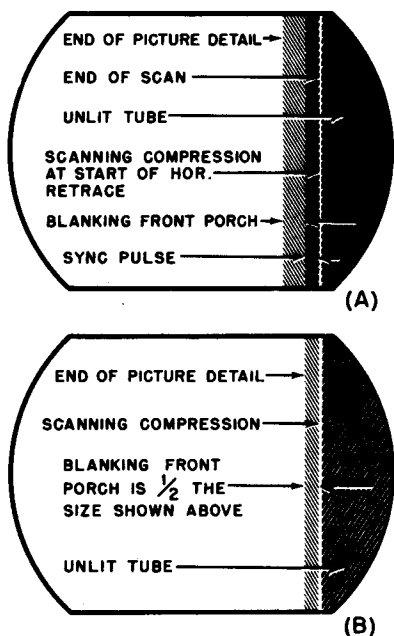
Fig. 9 — Emerson

EMERSON Chassis 120142-B,
120143-B, 120148-B
Reduction of horizontal foldover (see Fig. 9).

1. Replace *R-75* (220 k in afc feedback circuit) with two 100-k, $\frac{1}{2}$ -watt resistors in series.

2. Connect a 25- $\mu\mu\text{f}$ ceramic capacitor from the junction of the two

100-k resistors to chassis, dressing the components away from the horizontal-phase and frequency coils.

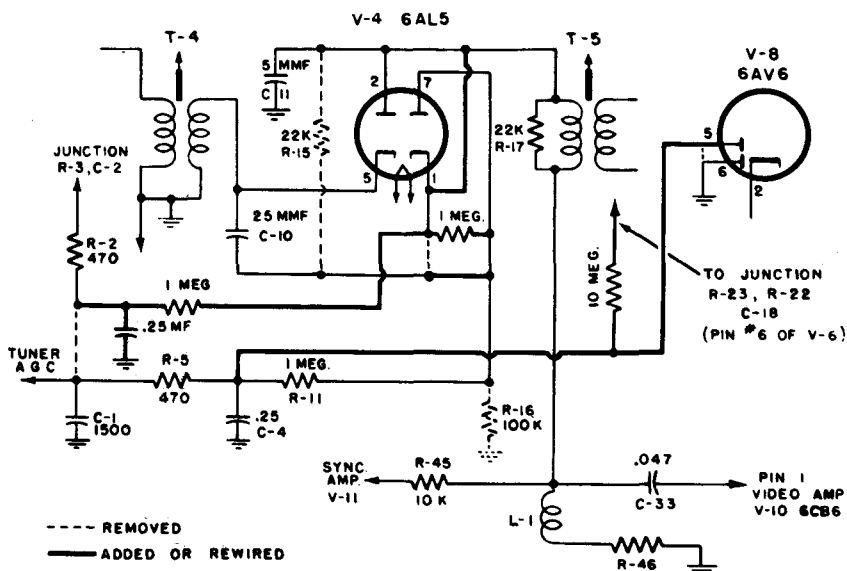
Fig. 10 — Emerson

Modified agc for fringe-area operation (see Fig. 10).

The following changes may be made to improve performance, especially in fringe areas, by modifying the agc system to give a tuner delay. This modification will provide an increase in sensitivity.

1. Remove *R-15* (22k, $1/2$ watt) from pins 1 and 2 of *V-4* (6AL5), replacing it with a jumper wire.
2. Remove *R-16*, 100 k, which is connected from pin 7 of *V-4* to chassis.
3. Remove pigtail of *R-2* (470 ohms) resistor from lug on terminal board and reconnect to empty lug on same terminal strip. This resistor is in the grid circuit of *V-1*.
4. Add a white jumper wire from new position of *R-2* to the empty lug

on the terminal board near sound-output transformer.

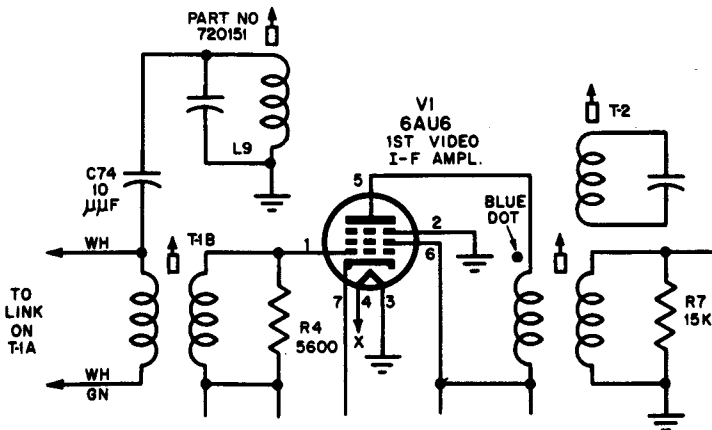
Fig. 11 — Emerson

EMERSON Chassis 120153-B
Addition of sound trap
 (see Fig. 11).

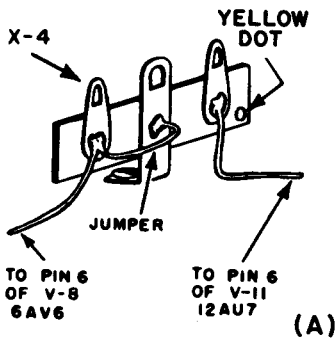
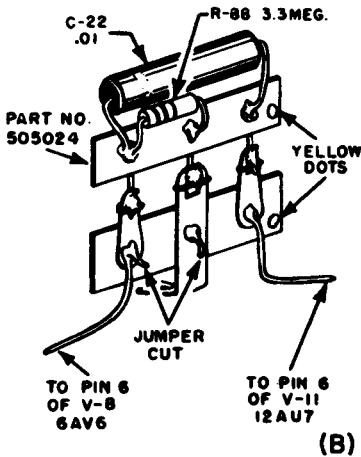
Fig. 12 — Emerson

EMERSON Chassis 120153-B
Preventing jitter in fringe areas
 (see Fig. 12).

In fringe areas where there is a great deal of electrical impulse noise, such as ignition, neon signs, electric motors, etc., the picture might tend to jitter or continuously fall out of sync. To reduce this condition to a minimum this chassis has been incorporated with provisions for connect-

ing a "Fringe Compensator," which effectively limits the amplitude of the noise pulses into the sync separator (*V-12A*, 12AU7) to that of the sync pulses, thus minimizing the effects. This fringe compensator should be connected to the set only when it is obvious that it will be beneficial in a certain locality; it should not be installed in strong-signal areas as vertical jitter or audio buzz may result.

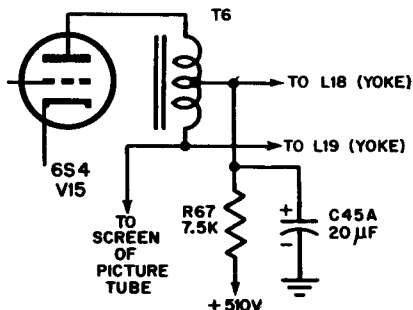
Fig. 15 — Fada

Removing retrace line (see Fig. 15).

To eliminate retrace lines the following circuit changes are necessary:

1. Disconnect screen (pin 10) of picture tube from junction of C-57 and C-58, and reconnect to junction of

L-19 of the yoke and the B+ terminal of *T-6*.

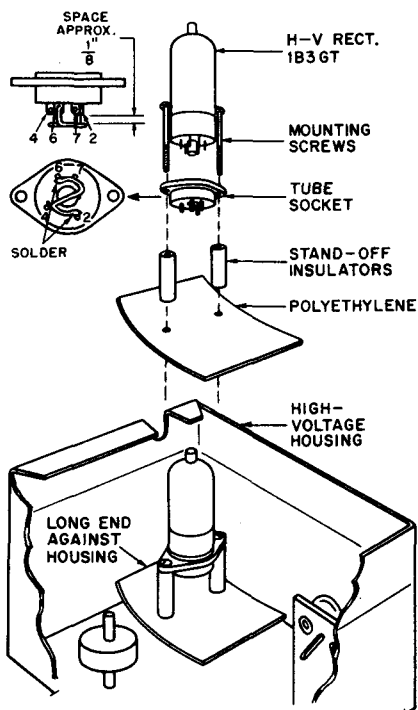
Fig. 16 - Fada

Corona or arcing in h-v cage
(see Fig. 16).

Remove the 1B3 socket assembly from the chassis by removing the two screws that mount the socket assembly on the chassis. Remove the 1B3 tube from its socket and turn the socket over. The socket should be checked for lint, spider webs, and sharp wire or solder points.

Place the plastic insulator strip on the chassis with the long end toward the h-v cage as shown on the sketch. When the socket assembly is remounted, care should be taken that the filament link and leads are kept as far away as possible from the main coil of the horizontal-output transformer, since otherwise corona may result between these two points.

In areas of high humidity an additional change may be necessary if corona still exists under the 1B3 socket. The one megohm resistor mounted on the socket should be replaced with an S-shaped corona ring, constructed of heavy solid wire. The corona ring should be mounted so that all the lugs of the socket are in line with the corona ring, as shown on the attached sketch. In most cases the corona ring will not be necessary; it should be used only when required.

Replace the 1B3 tube and check the leads on the horizontal-output transformer to make sure that their positions have not been changed and that they are not crossing or too close to each other. All of the above

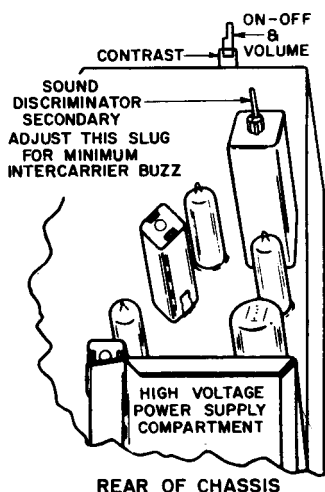
Fig. 17 — Firestone

FIRESTONE Models 13-G-44
through -48, 13-G-51, -52
Reduction of intercarrier buzz
(see Fig. 17).

Slight dynamic unbalance of the discriminator secondary can emphasize intercarrier buzz due to incomplete amplitude modulation rejection. Therefore it is vitally important to obtain an accurate setting of the discriminator secondary slug under actual reception conditions.

Connect an antenna to the receiver to obtain program reception

from a local station. If intercarrier buzz is prominent, a slight readjustment of the discriminator secondary slug should be made to obtain the dip point for the buzzing sound. Note that program sound will be clear and free from distortion at this point. Buzz should now be at an acceptable minimum if station transmission is not at fault.

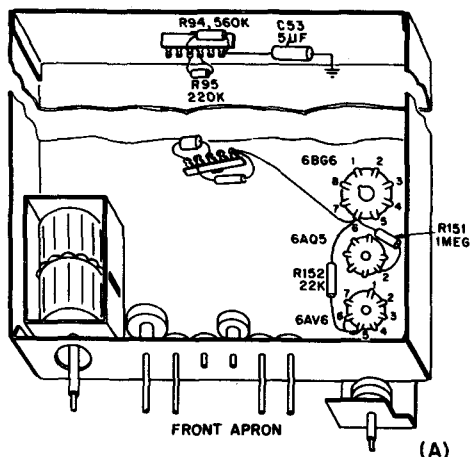
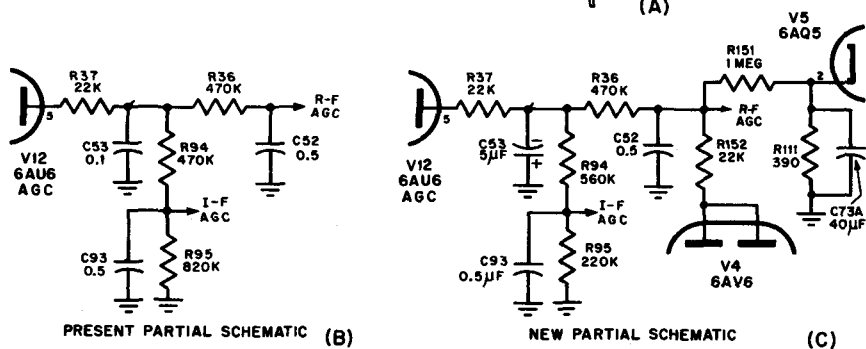
Fig. 18 - Gamble-Skogmo (Coronado)

GAMBLE-SKOGMO (Coronado)Models 05TV2-43-9010B,
15TV2-43-9012A, -9013A**Improving sensitivity in fringe areas (see Fig. 18).**

To improve the signal-to-noise ratio in fringe areas on the models listed above, the changes in the agc circuit shown in the partial schematics are suggested. Part numbers and descriptions of the parts to be removed and added are listed.

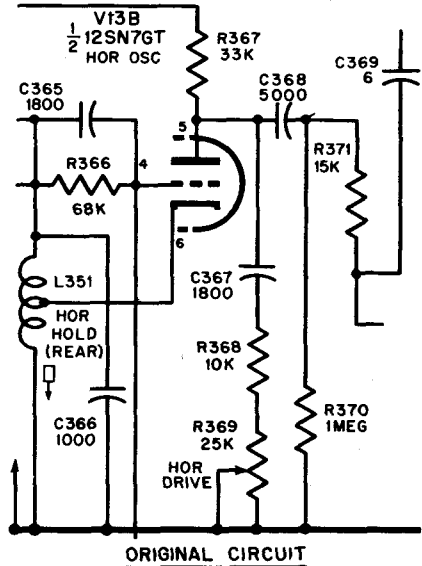
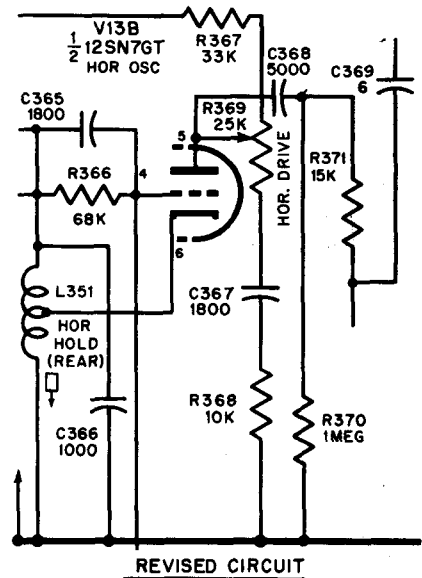
Fig. 23 – General Electric

Drive-control setting affects horizontal pull-in sensitivity (see Fig. 23).

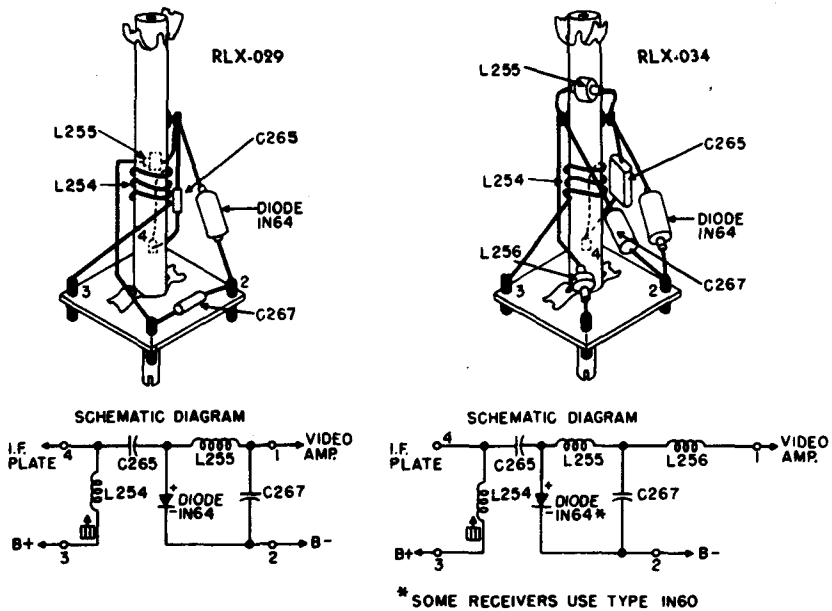
Fig. 27 - General Electric

Reduction of channel-6 "tweet" (see Fig. 27).

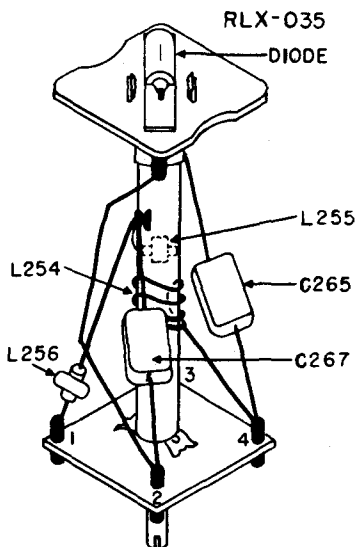
Fig. 28 - General Electric

Replacement of video-detector crystal (see Fig. 28).

To facilitate replacement of the video-detector crystal diode, an improved design of the video-detector assembly (RLX-035, marked with a red dot on top of the assembly) is used to provide top mounting of the diode. It is merely necessary to slip off the cover of the assembly to expose the diode.

In some assemblies a special high efficiency diode is used, marked with a red dot. To maintain the same Q of the circuit and to obtain proper i-f bandwidth a resistor of 12,000

ohms in connected across the diode. In replacing this diode with normal stock do not use this resistor. In case of doubt check for proper bandwidth.

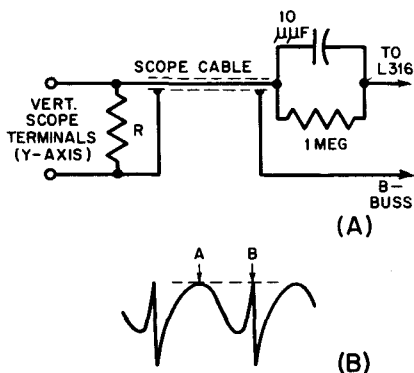
Fig. 29 — General Electric

Horizontal-sync stabilization

On the above production receivers, a tuned circuit is added to the horizontal blocking oscillator circuit to stabilize the sync. The method des-

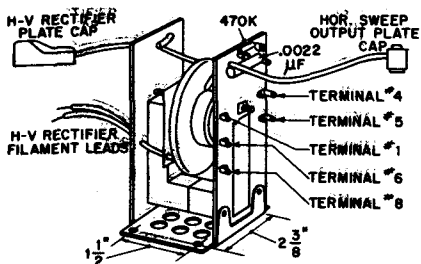
Fig. 30 = General Electric

Improved horizontal-output transformer (see Fig. 30).

A new ceramic-core sweep transformer, stock No. RTO-071, is recommended as a substitute for the original molded horizontal-sweep out-

put transformers for these models. It has several electrical design improvements over the originally specified transformer, among them are higher efficiency and better high-voltage insulation.

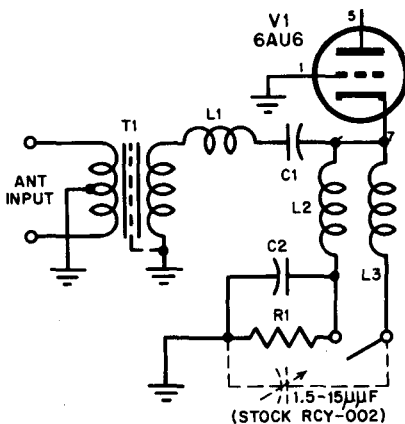
Fig. 31 — General Electric

High-channel interference (see Fig. 31).

The channel selector switch *S-1* is open on low-channel reception connecting the added trimmer in series with *L-3*. This makes a series-resonant circuit of these components which when properly adjusted will effectively reduce the subject interference. On high-channel reception, the trimmer is switched in parallel with *C-2* (1,500 μmf), making the trap circuit inoperative so that it has no effect on the normal high-channel operation.

With the receiver tuned to the low channel and the interfering high channel station operating, two minimum points of interference will be observed when turning the trimmer from the maximum capacitance position. The first minimum indicates that the trap is tuned to attenuate the high-channel fundamental and the second minimum indicates tuning to the second harmonic of the local oscillator. The best point of adjustment for the least interference is the second minimum point or when the trap is tuned to the second harmonic of the local oscillator. Note: The first minimum gives an attenuation of 45 db, while the second minimum gives approximately 83 db attenuation, making it very important to tune for the minimum interference at the lowest capacitance setting of the trimmer.

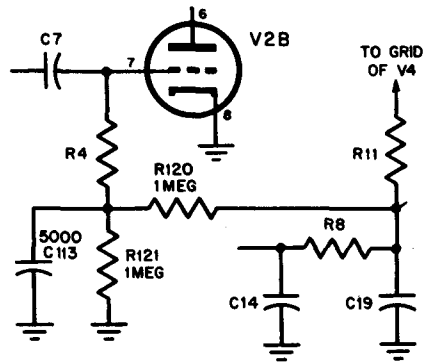
Fig. 32 — General Electric

Audio buzz due to excessive signals (see Fig. 32).

The addition of bias to the converter grid is sometimes necessary when the receiver was used in strong-signal areas, especially on the high-frequency stations. The peaks of the signal, which are the vertical pulses, cause the tube to draw grid current which, in turn, frequency-modulates the oscillator voltage at the vertical-pulse rate (60 cps). This appears in the audio as a buzzing sound.

Bias is added to the converter grid (pin 7 of V-2B) by the addition

of R-120, R-121 and C-113, as shown in the figure. Add a terminal board to the underside of the main chassis near the r-f unit. The board should be mounted so that short leads can be used. Remove R-4 from ground under the oscillator trimmer C-80 and connect to the junction of R-120 and R-121 on the new terminal board. Connect C-113 from junction of R-120 and R-121 to the ground point on the r-f chassis under the oscillator trimmer C-80. Note: Dress C-113 as far away as possible from the oscillator trimmer C-80.

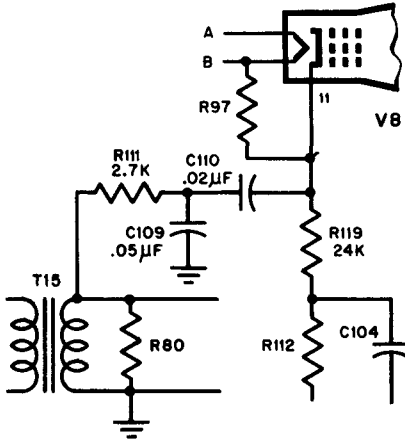
Fig. 33 — General Electric

Removal of vertical-retrace lines (see Fig. 33).

The circuit shown in the figure has been added in late production to remove the vertical-retrace lines which appear when the contrast control is used at a low setting or the brightness control is used at a high

setting. Models not modified may be wired in accordance with the schematic shown with the addition of the following parts: *C-109* (UCC-635) is a .05- μ f, 600-volt capacitor, *C-110* (UCC-631) is a .02- μ f, 600-volt capacitor, *R-118* (URD-059) is a 2,700-ohm, $\frac{1}{2}$ -watt resistor, and *R-119* (URD-1082) is a 24,000-ohm, $\frac{1}{2}$ -watt resistor.

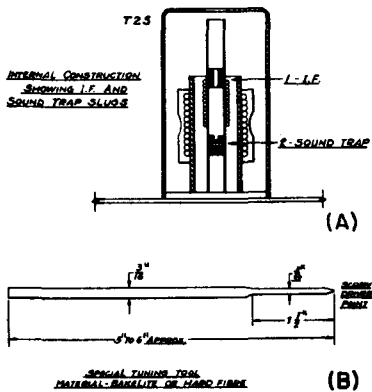
Fig. 34 - Hoffman

Sound bars and/or 4.5-mc beats in the picture (see Fig. 34).

Sound bars appear as alternate light and dark horizontal bars across

the picture which move or vary in synchronization with the received sound. A 4.5-mc beat note appears as a vertical rain-like effect comparable to water running down a window pane. Both phenomena are caused by misalignment of one or more of the absorption wave traps (*T-1*, *T-2*, *T-25*, *T-103*, or *T-105*) in the video i-f circuit. Sound bars indicate the presence of audio frequencies in the video voltage at the picture-tube grid, while the 4.5-mc beat effect in the picture is due to the appearance of a heterodyne signal caused by mixing video i-f carrier and sound i-f carrier. Note: *T-1*, *T-2*, and *T-25* are absorption traps for the sound i-f frequency, while *T-103* and *T-105* affect both the sound i-f interference and the 4.5-mc beat.

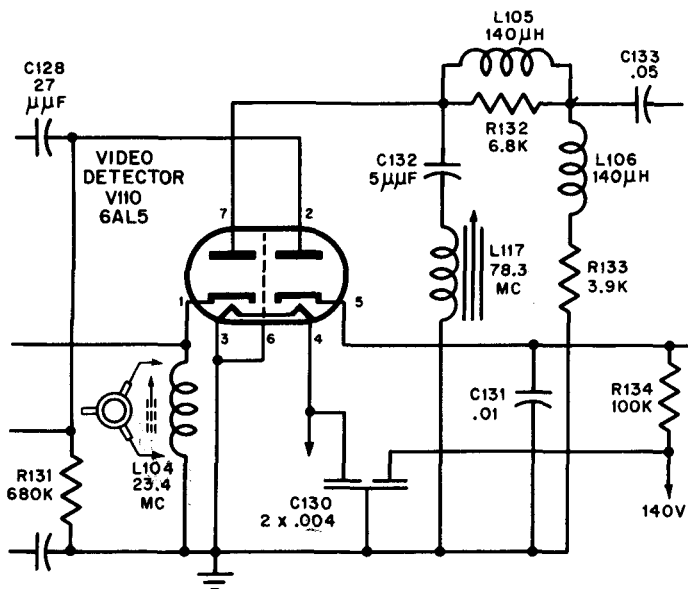
Fig. 35 — Hoffman

Tunable herringbone interference on channel 5 (see Fig. 35).

This internally generated interference appears as a fine herringbone pattern in horizontal bands across the picture. The pattern is tunable with the fine-tuning control. As the fine tuning is varied, the size of the herringbone changes, as well as the number of bands across the picture. The interference is caused by a beat note between the 3rd harmonic of

the picture i-f frequency (26.1 mc) and the channel-5 video-carrier frequency (77.25 mc). When the fine tuning is adjusted for best sound and picture, the interference appears as a herringbone pattern. It is possible to adjust the fine tuning towards a zero beat between the two signals at which time the pattern degenerates to a series of black and white bands across the picture, giving a venetian blind effect.

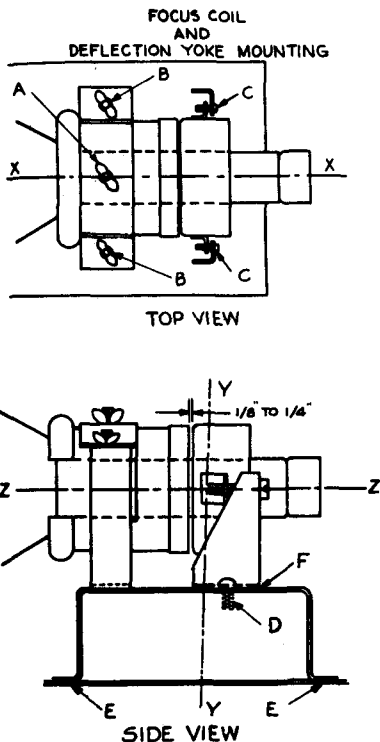
Fig. 36 — Hoffman

**Removing neck shadows (see
Fig. 36).**

A number of remedies are suggested for neck shadows. Any one, or combination of several, may be necessary to clear up the trouble. The primary objective of the remedies is to make certain that the tube is mounted with the neck horizontal, as

compared with the chassis, and exactly centered in the deflection and focus coils. With 15- or 16-inch tubes mounted separately from the chassis, it is generally advantageous and faster to remove the mounting board and tube from the cabinet.

Check the tube mounting. It is imperative that the tube neck axis Z-Z, shown in the side view, be level and concentric with the centers of the deflection and focus coils. The front portion (face) of the tube may be raised by shimming with rubber pads under the front rim where the tube is held in place by the vinyl-resin

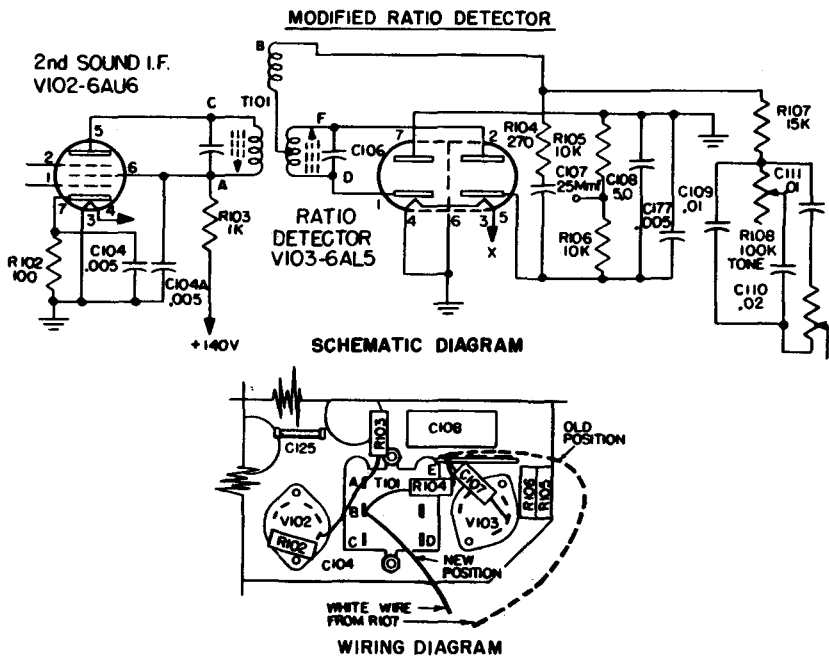
Fig. 38 — Hoffman

Improvement of a-m rejection of ratio detector (see Fig. 38).

Distorted sound may be the result of multipath effects in certain locations which cause random amplitude modulation of the signal. Critical fine-tuning adjustment is required, inasmuch as it is necessary to have the sound ratio detector exactly zeroed to obtain maximum a-m rejection, and least distortion. Certain changes in the detector circuit may be made. These changes reduce the response of the ratio detector to a-m components in the signal, thereby giving better a-m rejection and reducing multipath distortion. In addition, greater audio recovery from the i-f signal gives more audio output, and the response to ignition and other noises is increased. To modify the ratio detector, proceed as follows:

1. Change present ratio-detector transformer (*T-101*) from part No. 5305 to No. 5305-1. This new transformer has reduced primary-to-secondary coupling.

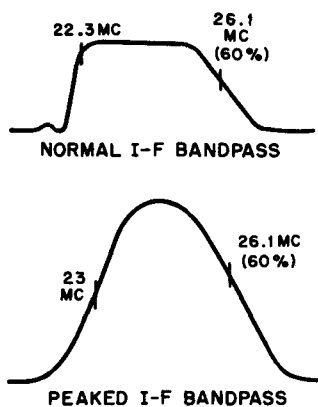
Fig. 39 — Hoffman

HOFFMANChassis 140,
142, 143, 146, 147**Video i-f peaking for fringe-area reception (see Fig. 39).**

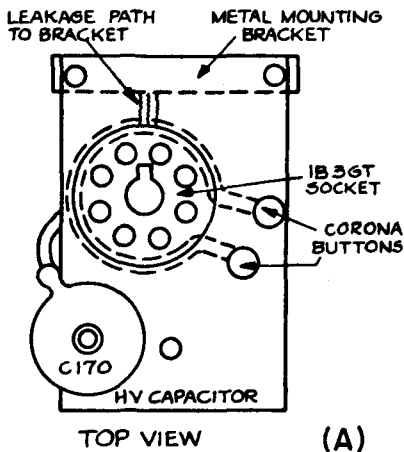
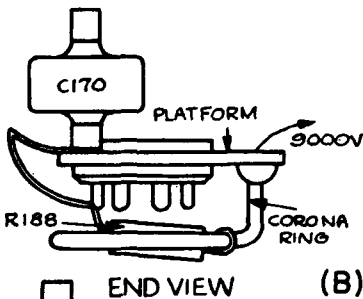
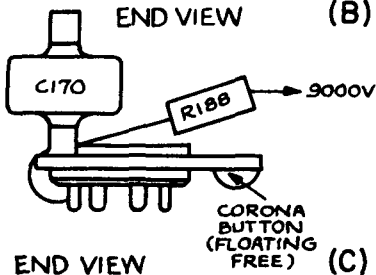
Fig. 40 — Hoffman

HOFFMAN Chassis 140, 142, 146**Arcing at h-v rectifier socket (see Fig. 40).**

1. Remove the 1-meg resistor, *R-188*, (see part (B) of figure) from pin 2 of 1B3GT socket and corona ring.

2. Solder on end of the resistor to the solder lug at the base of the h-v capacitor *C-170* (see part (C) of figure).

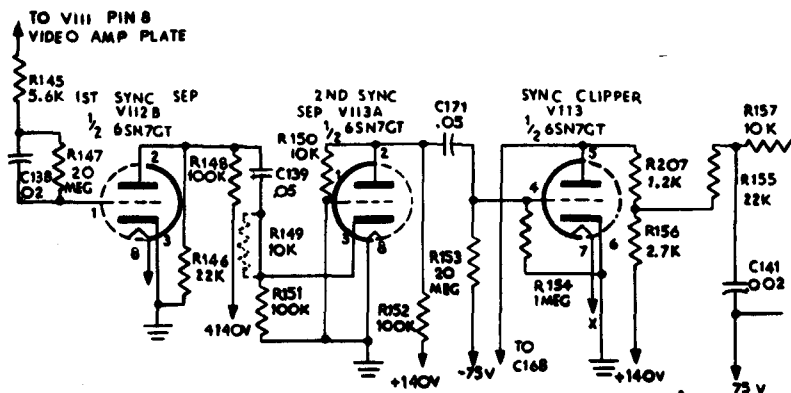
Fig. 41 — Hoffman

HOFFMAN Chassis 140, 142, 146
Unstable vertical sync (see Fig. 41).

Unstable vertical sync is characterized by a picture that tends to jump or bounce in a vertical direction. At times it appears that only part of the picture is affected. Operation of the vertical-lock control is normal, and will hold the picture in sync over a normal range of the control. The vertical bounce caused by noise pulses occur erratically, except when consistent noise conditions are present, and the picture appears to jiggle. Occasionally, the picture will skip one frame vertically. These conditions, in a few cases, are accompanied by spasmodic horizontal tearout of the picture, which is caused by high amplitude noise pulses.

The changes outlined for modification of the sync circuits apply to sets operated in low-signal areas, where the average noise level approaches the signal level. In areas where normal signal and noise conditions exist, no advantage is gained by modifying present sets now in operation.

Conditions of weak signal with very heavy noise or high amplitude noise pulses may exist in a few locations. In these cases, a different time constant for the *R-147-C-138* circuit will give better noise rejection performance. For better noise rejection, use .25 μ f, 600 volts for *C-138* and 1 meg, 1/2 watt for *R-147* in place of the values given above. The circuit wiring will still be the same as shown for either of the alternate sets of components. Better noise rejection is gained at the expense of sync separation, and vertical lines in the picture may exhibit slight waves or curves. The use of this alternate modification is limited to special circumstances best judged by the individual serviceman.

2. Change *R-147* (in above circuit) from 1 meg to 20 megs (part No. 4626).

3. Change wiring of *R-147* which was connected from pin 1 of *V-112* to ground to parallel *C-138*.

4. Change *C-138* (also in above circuit) from .05 μf to .02 μf at 600 volts (part No. 4124).

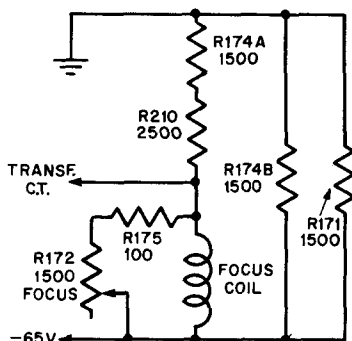
Fig. 42 — Hoffman

HOFFMAN Chassis 142,
146, 149, 150, 154
Increasing range of focus control
(see Fig. 42).

Insufficient adjustment range of the focus control (*R-172*) has occurred in 12-inch chassis using the Dumont 12QP4 picture tube. The 12QP4 tube requires more focusing current through the focus coil than other 12-inch tube types, and maximum counterclockwise rotation of the focus control will not bring the tube to its optimum focus.

Circuit changes to increase the amount of current through the focus coil can be accomplished by changing one resistor and adding another resistor, as shown in the accompanying diagram.

1. Decrease the value of *R-171* from 2,500 ohms to 1,500 ohms, 5 watts (part No. 4715).

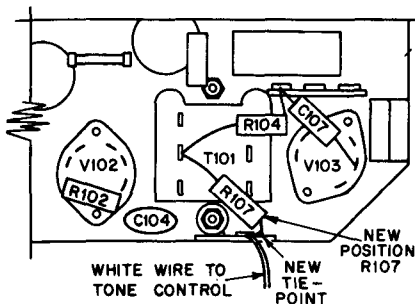
Fig. 44 — Hoffman

HOFFMAN Chassis 146
Elimination of oscillation in sound channel (see Fig. 44).

Under no-signal conditions, the receiver sound system may break into a low-frequency motorboating when the channel selector is set on any of the low-frequency channels. Channel 3 produces the worst condition. When switched to the high-frequency channels, the motorboating gives way to a high frequency rough note that sounds like a bad condition of noise hash. This condition also affects the raster when no video signal is present, appearing as grainy horizontal lines similar to heavy

noise conditions. This oscillation or motorboating disappears when video and sound signals are present. It has appeared only on consolettes with the remote tuning controls. No indications have been observed on any of the other models. This condition should not be confused with audio buzz or oscillation in the audio-output tube, both of which are noticeable whether or not signals are present.

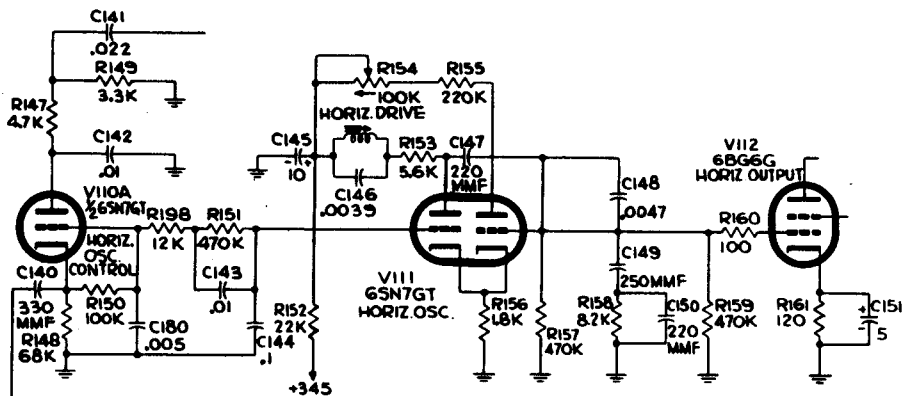
Fig. 47 — Hoffman

Curvature in vertical lines (see Fig. 47).

Curvature in vertical lines in the top portion of the picture is commonly called "hook." This curvature is particularly apparent on a test pattern, or a picture with distinct vertical lines, such as the sides of a door or folds in drapery. The curvature is normally in the form of a bow or a bend to the right in top portion of the picture.

The hook can be materially decreased by addition of a 12k-ohm, 20%, 1/2-watt, composition resistor (*R-198*) and a .005- μ f ceramic capacitor (*C-180*) in the grid circuit of the horizontal oscillator control tube, *V-110A*. Refer to the schematic diagram shown here for location of these components. A further change which will improve the hook is the change of *C-142* from a .0047- μ f to a .01- μ f, 400-v paper type capacitor. However, this change reduces the horizontal sync hold-in range, and it is imperative that *C-146* and *C-149* be changed

to zero temperature coefficient types as described under "Horizontal drift" for chassis 159 and 160 if the change of *C-142* is made.

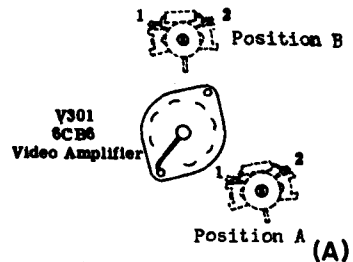
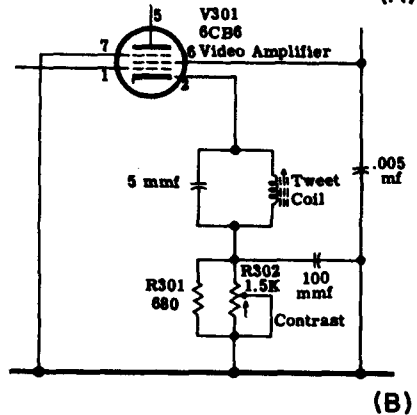
Fig. 49 — Hoffman

Elimination of channel-5 tweet interference (see Fig. 49).

5. Run a short jumper lead between tie-lug 1 of the tweet coil and pin 2 of the video amplifier.

6. Tune in channel 5 for best sound. If receiver is not being operated in a weak-signal area, simulate a weak signal by using an indoor antenna or a balanced H-type resistance pad.

7. Couple 2-wire transmission line to yellow picture tube cathode lead for stronger 3rd harmonic signal by wrapping transmission line about yellow lead.

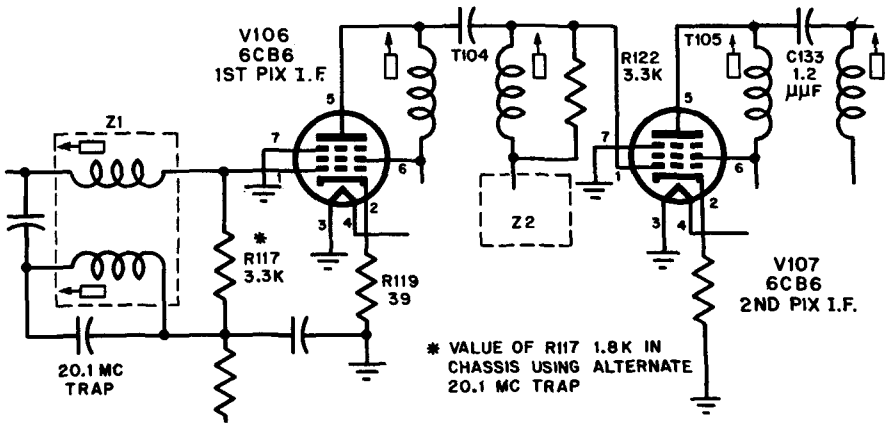
Fig. 52 — Hoffman

Improved video i-f bandpass characteristic (see Fig. 52).

These changes have been made on all sets produced after serial No. G067626.

Note: R-117 should be reduced to 1.8 k in those chassis which employ the alternate adjacent channel sound trap. This alternate trap may be easily identified by ceramic trimmer capacitor mounted on the lip of the i-f subchassis near the 1st video i-f stage.

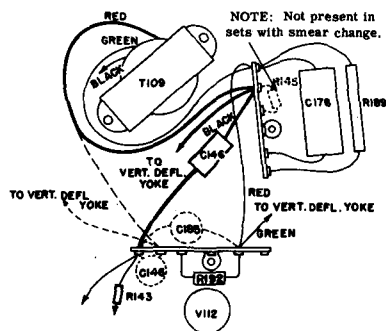
Fig. 53 — Hoffman

HOFFMAN Chassis 170 through 176
Dark shading at top of picture (see Fig. 53).

smear" for chassis 170, 171, 173, 175), remove C-185 and reduce the resistance value of R-143 to 100k ohms. Change C-146 to a higher voltage rating (.0047 μf at 1,000 volts) and rewire as indicated in figure. Dotted lines indicate wiring and components before this change was made. Heavy black lines indicate wiring and components changed.

For sets not containing the smear change, move C-146 leads to other

side of *R-145*, eliminating *R-145* from the circuit. Also, reduce resistance value of *R-143* to 100k ohms.

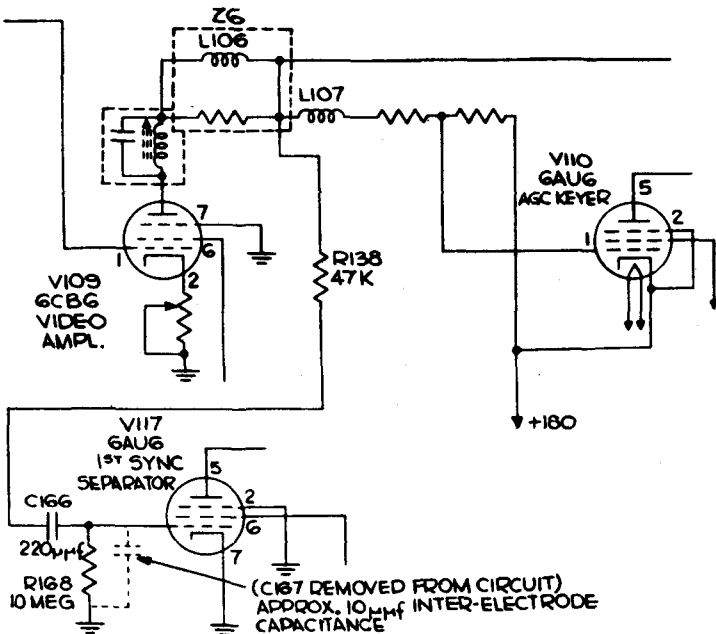
Fig. 54 — Hoffman

Improved picture definition (see Fig. 54).

1. Remove *R-139* (47,000-ohm resistor connected to the grid of the agc keyer tube) and replace it with a short piece of hook-up wire. It is suggested that the leads of *R-139* be kept as long as possible during its removal so that it may be used to replace *R-138*.

2. Remove *R-138* (10,000-ohm resistor between the video amplifier and the sync separator) and connect a 47-k resistor between the junction of *L-106*, *L-107* (plate circuit of video amplifier) and the tie lug

previously used for connecting *R-138* to *C-166*.

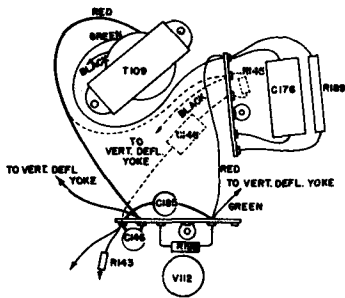
Fig. 55 — Hoffman

Reduction of picture smear (see Fig. 55).

A change concerning the retrace line elimination circuit is made in order to reduce picture smear present when the picture tube draws grid current. A study of the schematic diagram will reveal that retrace-line elimination circuit can act as a grid-leak biasing circuit for the picture-tube grid. When the grid draws grid current, as it will when the cathode is driven by relatively high negative peaks (high contrast levels), a nega-

tive bias is produced which tends to bring the picture grid to its cut-off potential. This negative bias remains on the grid until it has had time to leak off via the RC path of the circuits involved. By reducing the RC time constant of the effective grid leak, the grid is not held near cut-off for so long a time, relatively speaking, and the faster recovery makes it possible for the grid to better follow the transmitted video information.

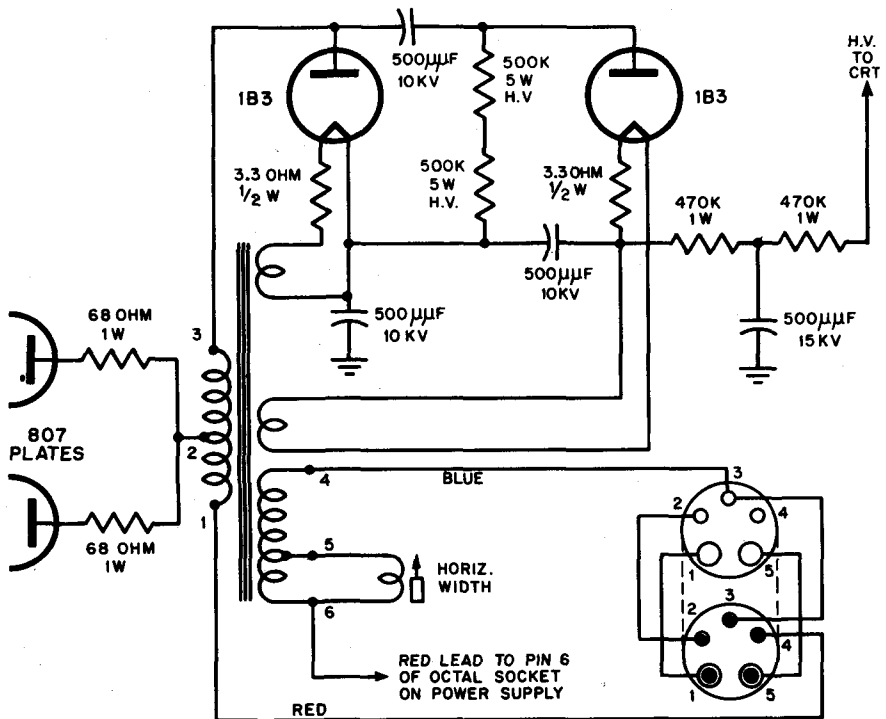
Fig. 60 — Industrial

INDUSTRIAL Chassis IT-1R
Replacement of high-voltage transformer (see Fig. 60).

Due to recurrent failures and breakdown in the 60-cycle high-voltage supply used in the IT-1R (with the 20B-27 h-v transformer), a means has been devised to change over to a fly-back doubler-type supply, such as is used in the IT-3R, 11R, and 13R. This type has proven to be much more dependable, and will greatly reduce, if not eliminate, high-voltage supply failures.

An adapter plate, supporting the necessary components, is supplied. The installation instructions follow:

1. Disconnect all leads from *T-102* (black horizontal-output transformer).

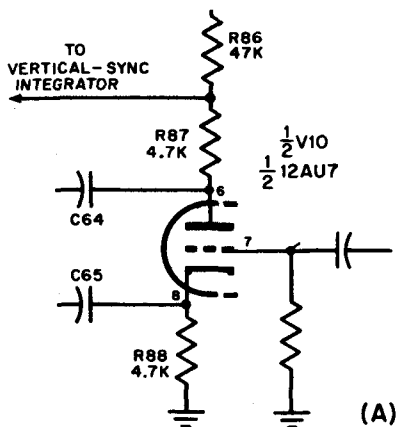
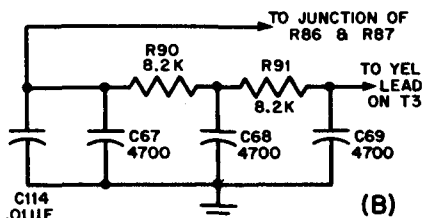
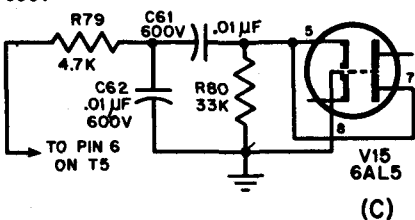
Fig. 62 — Industrial

INDUSTRIAL Chassis IT-21R
Improving sync stability (see Fig. 62).

Alter vertical sync integrator circuit as shown in part (B) of figure.

1. *R-85* is omitted.
2. *C-114*, .01-μf, 300-v mica capacitor is added in parallel with *C-67*.

3. $C-67$ is changed to $4,700\text{-}\mu\mu\text{f}$, 300-v mica.

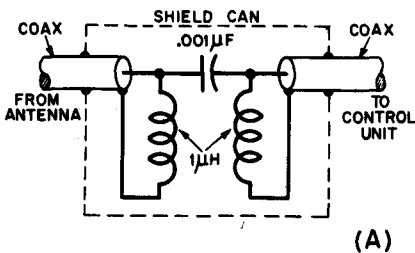
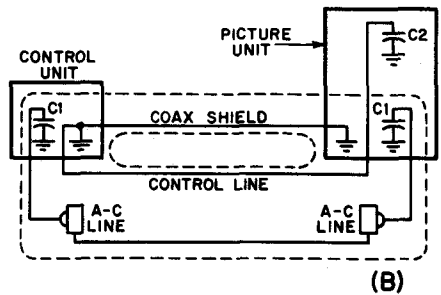
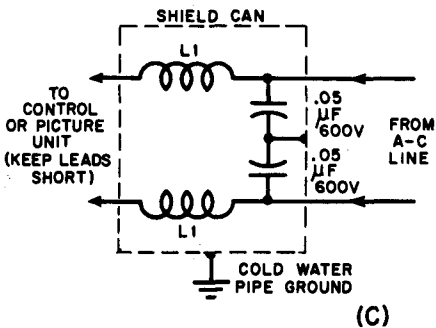
Fig. 64 - Industrial

INDUSTRIAL All chassis
Reduction of a-m interference (see Fig. 64).

cables, the cure may be more involved and difficult. The cause of this interference may be from direct pick-up of the interfering a-m signal by the shield of the coax cable, or it may be introduced by a pick-up loop type of circuit, as shown in part (B). In the figure, *C-1* is the primary-to-ground capacitance of the power transformer, and *C-2* is the coil-to-ground capacitance of control relay. Loops are indicated by dotted lines. The alleviation of the interference may require trying several different techniques. Here are a few which should be tried:

1. If the installation is close to an a-m station, keep the control and picture units as close together as possible and the interconnecting cables as short as possible.
2. The simplest method, which can only be used where a relatively strong

television signal is available, is to reduce the contrast control in the picture unit and bring up the control unit contrast control to compensate. This increases the video signal level on the coax cable and increases the signal-to-interference ratio.

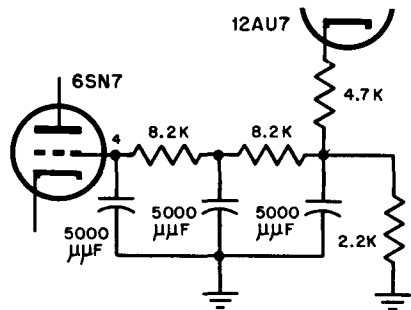
Fig. 65 — Jackson

JACKSON Chassis 114G,
116G, 117G, 120G
Improving vertical sync stability in fringe areas (see Fig. 65).

To improve the vertical-sync stability in weak-signal areas, proceed as follows:

1. Remove vertical-integrator plate.
2. Make up vertical integrating circuit as shown in the the figure.
