Introduction

TV

MANUFACTURERS' RECEIVER TROUBLE CURES

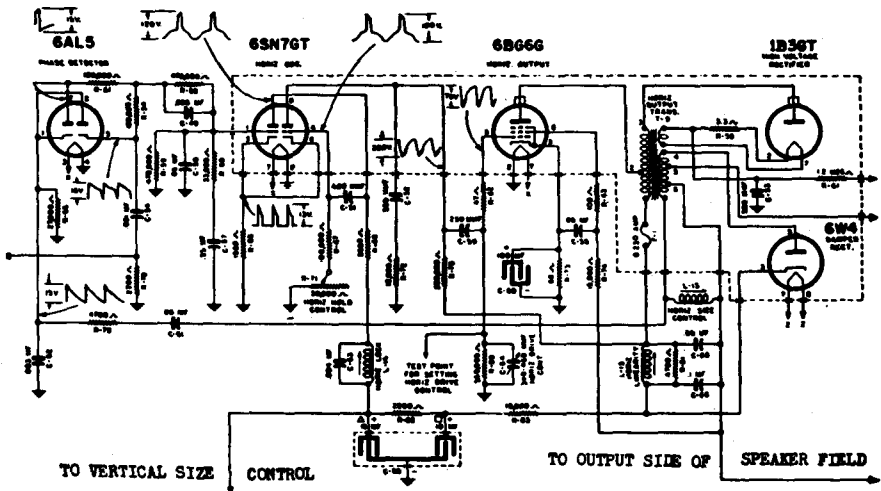
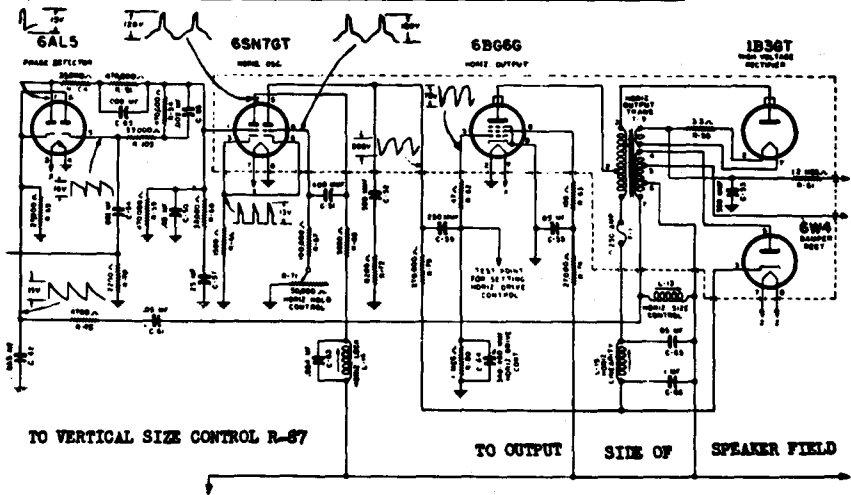
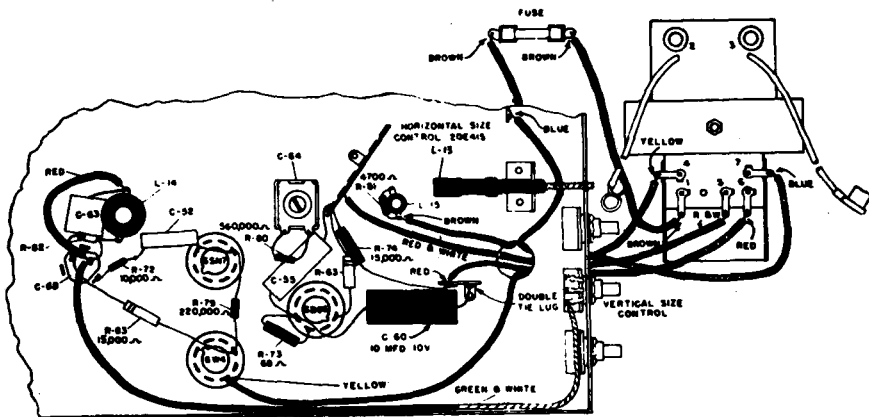
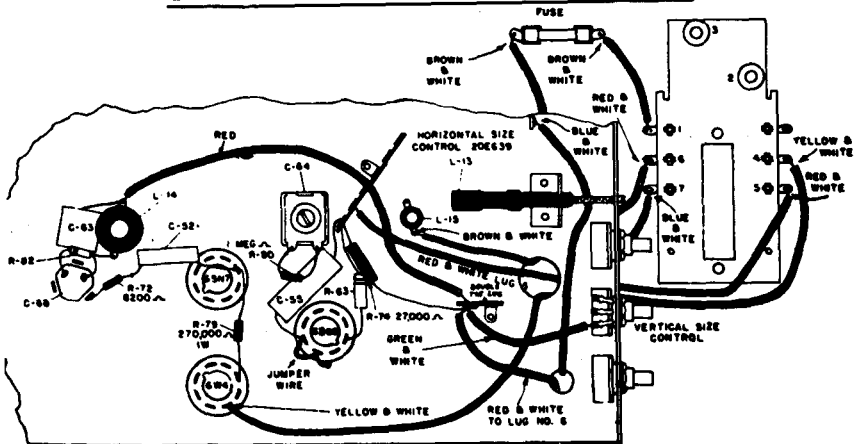
Fig. 8

Replacement of horizontal-output transformer (see Fig. 8).

12. Replace the horizontal-size control (part No. 20E415) coil *L13* with a new coil, part No. 20E639.

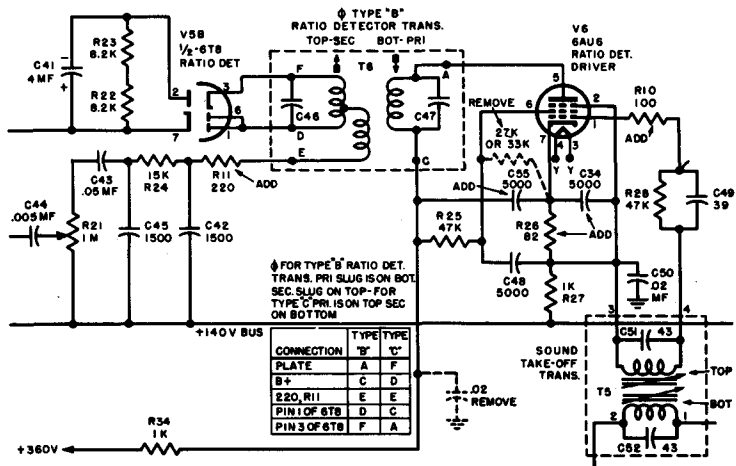
Fig. 10 — Montgomery Ward

Minimizing intercarrier buzz (see Fig. 10).

To minimize intercarrier buzz on earlier receivers, the circuit revision described below is recommended.

6. Insert a 5,000- μ f disc capacitor (*C55*) between junction of 1-k resistor (*R34*) and 47-k resistor (*R25*) located at the ratio-detector transformer and 6AU6 pin 7, keeping leads as short as possible.

7. Remove from 6AU6 pin 1 the leads of 47-k resistor (*R28*) and 39- μ f capacitor (*C49*) and insert from that junction (*R28* and *C49*) a 100-ohm, $\frac{1}{2}$ -watt resistor (*R10*) to 6AU6 pin 1.

8. Remove from a terminal on the ratio-detector transformer the lead of 15-k resistor (*R24*) and 1,500- μ mf capacitor (*C42*) and insert from that junction (*R24* and *C42*) a 220-ohm, ½-watt resistor (*R11*) to the same terminal on the ratio-detector transformer.

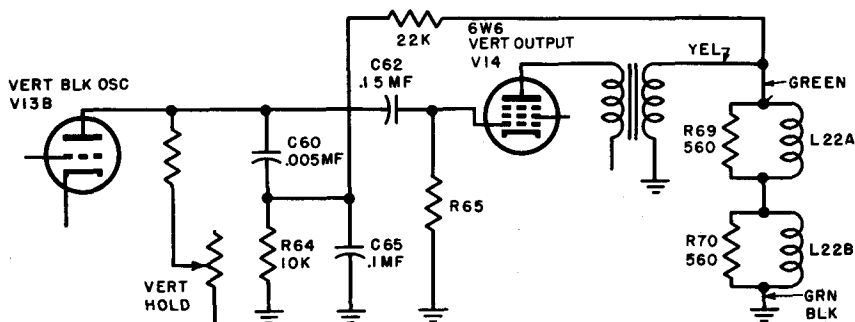
Fig. 19 — Motorola

Improved vertical linearity
(see Fig. 19).

of the peaking resistor R64 will remedy the condition.

In installing this resistor it will be found best to use the terminal strip which serves to effect the junction between the green yoke lead and the yellow transformer lead. The resistor can be connected between this lug and the adjacent lug on the same strip which is at present unused. Then a wire can be run from this point to the terminal strip lug which forms the junction for R64, the peaking resistor, C60, and C61. Care should be taken in making this connection not to break the terminal on the 4.5-mc trap coil, L19, by careless movement of C64, the .1- μ f coupling capacitor to the picture-tube cathode.

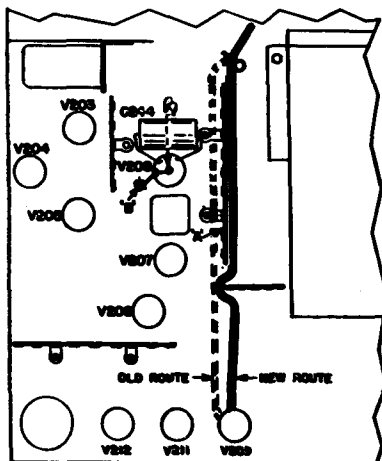
Fig. 22 — Motorola

Audio beat on channel 7 (see Fig. 22).

If you should encounter an audio beat on channel 7, it can be corrected by the following steps:

1. Replace the shielded contrast lead with an unshielded lead.
2. The shielded volume - control lead is originally routed between the terminal strip (A) and the audio i-f strip. Reroute this lead to the other side of the terminal strip to minimize the 4.5-mc pickup in the lead.
3. The ground lead from the center pin of the ratio-detector socket (V208, 6AL5) is originally dressed

over the 10- μ f electrolytic (C244) to a chassis ground kick-out. Move the lead from this kick-out to the kick-out near the tube socket on the video i-f side (B).

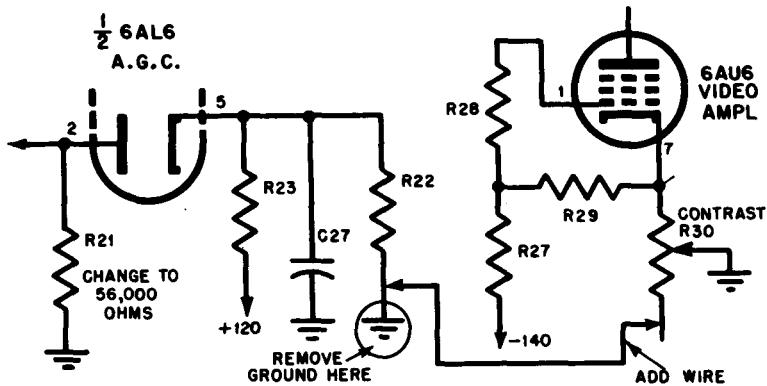
Fig. 31 — National

NATIONAL Model NC-TV-7
Horizontal tearing
(see Fig. 31).

1. Change *R29* (connected to pin 7 of video amplifier) from 3,900 to 8,200 ohms.

2. Change *R21* (from pin 2 of 6AL5 to ground) from 22,000 to 56,000 ohms.

3. Remove ground end of 1,000-ohm resistor on pin 5 of 6AL5 and run a wire from it to unused end of contrast control, as shown. It may be necessary to add a lug for support of the resistor in its new position.

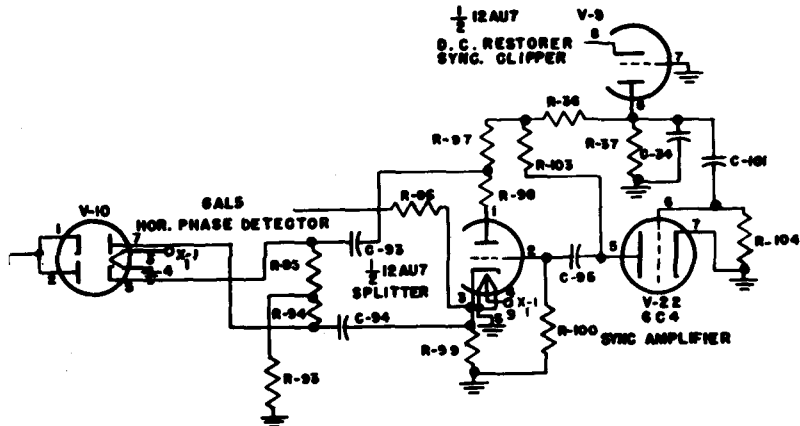
Fig. 32 — National

NATIONAL Model NC-TV-10
Improved sync operation
(see Fig. 32).

Symbol	Part No.	Description
C101	D827-11	Paper capacitor, .1 μ f, 400 volts
R103	J569-49	Resistor, 100,000 ohms $\pm 10\%$, 1/2 watt
R104	J569-57	Resistor, 470,000 ohms $\pm 10\%$, 1/2 watt
V22	6C4	Sync amplifier tube

The affected portion of the schematic diagram is shown in the figure. Note the phase reversal at the horizontal phase detector tube *V10*.

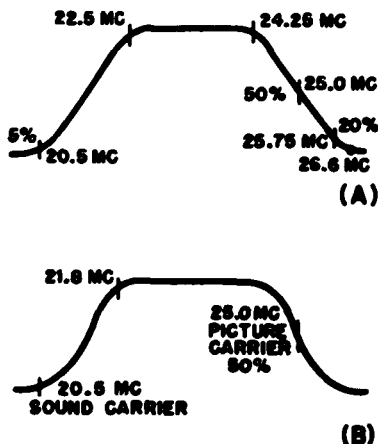
Fig. 35 — Packard Bell

Alignment in fringe areas
 (see Fig. 35).

In order to gain the added sensitivity necessary in some fringe areas, it is recommended that the picture i.f. be aligned as shown in part (A) of the figure. Normal response is shown in part (B).

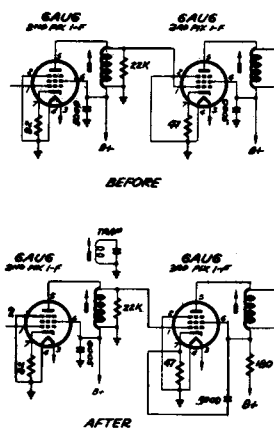
Fig. 36 — Packard Bell

**Improved sensitivity in
fringe areas (see Fig. 36).**

The circuit shown in the figure will provide a marked improvement in overall i-f gain and stability. The

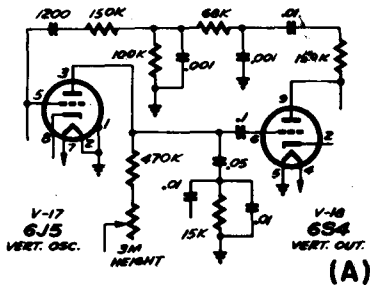
Fig. 38 — Packard Bell

Providing wider tolerance for 6S4 (see Fig. 38).

To provide for wider tolerance of 6S4 (vertical-output tube) characteristics without vertical peaking, the circuit is rewired as shown in part (B) of the figure. The original circuit appears in part (A). Later

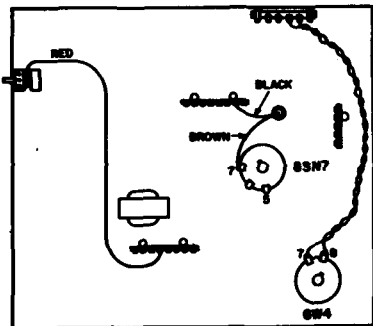
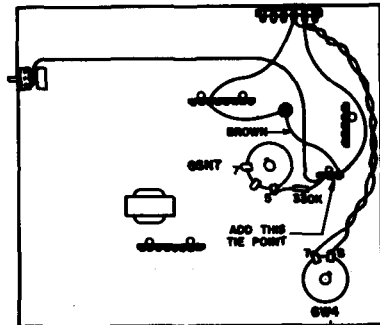
Fig. 39 — Packard Bell

PACKARD BELL
 All early 22-tube chassis
Preventing heater-cathode breakdown in damper and picture tube (see Fig. 39).

To prevent heater-cathode breakdown in damper and picture tubes and to increase the range of the brightness control, it is advisable to make the changes shown in the figure. These changes should be made in all units showing serial numbers below 900.

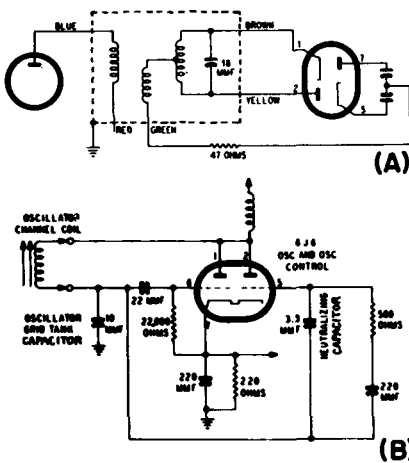
Fig. 40 — Philco

Reducing receiver drift (see Fig. 40).

32-4317 discriminator transformer is used when installing the special 10- μf capacitor.

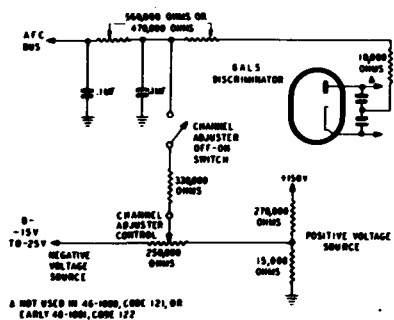
Fig. 41 — Philco

Installation of fine-tuning control (see Fig. 41).

When the Channel Adjuster is installed, a refinement may be made to the oscillator-control circuit to increase the deviation from about .5 mc to at least .75 mc. This refinement consists of changing the 3.3- μf neutralizing capacitor (see figure under "Reducing receiver drift") to a 2.2- μf capacitor, part No. 30-1221-4.

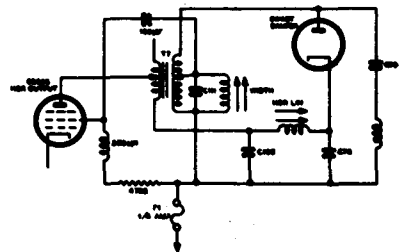
Fig. 47 — Philco

Reducing a-c current through fuse (see Fig. 47).

To reduce the a-c current through the h-v fuse, this fuse (*F1*) is rewired as shown in the figure. In addition, the value is changed from $\frac{3}{8}$ ampere to $\frac{1}{4}$ ampere (part No. 45-2656-8). Increased production is also afforded by this change, already made in production run 4.

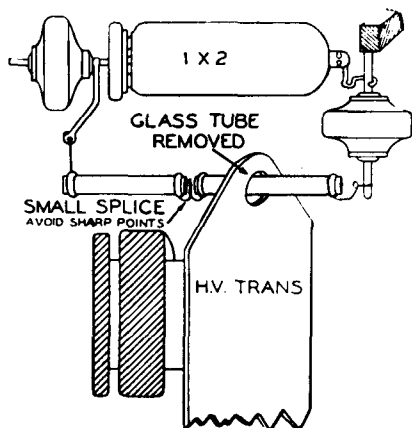
Fig. 50 — Philco

Replacement of high-voltage resistor (see Fig. 50).

High-voltage resistor, part No. 33-1352, is used and has been used for some time in production instead of the older type, part No. 33-1346. The newer resistor has the advantage over the older type, in that it will stand the rough handling which is sometimes encountered in servicing and production of television receivers which resulted in some premature failures of the carbon-filament type.

All field replacements of 2-meg resistors should be made with the newer special carbon mix type. In all of the above series receivers two of these resistors are to be used in series as the d-c return path for the

second stage of the voltage doubler. This statement is true regardless of whether the original wiring of the set used one 2-meg resistor, one 4-meg resistor, or two 2-meg resistors. The newer resistor is color coded red-green-green indicating 2.5 meg nominal value. The resistors under operating conditions are approximately 1.8 meg.

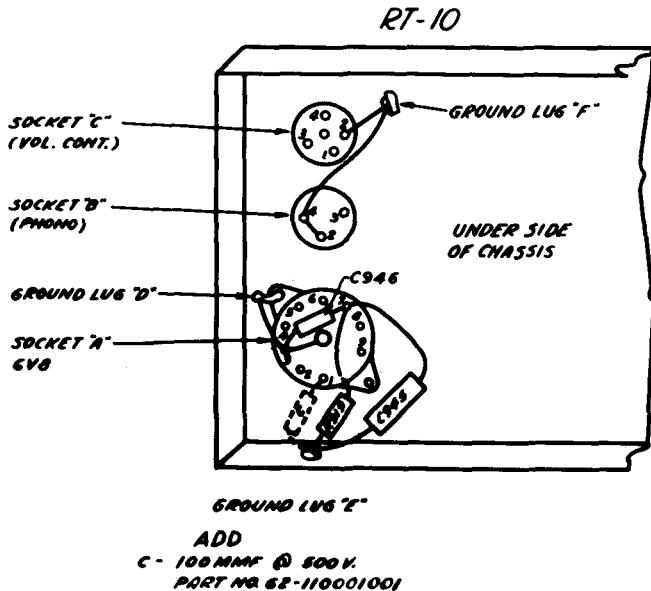
Fig. 51 — Philco

PHILCO Model RT-10
Instability on f.m.
(see Fig. 51).

The following changes will correct the instability of the f-m section of the above model. The changes should be made following a definite procedure which is outlined below:

1. Study the pictorial diagram carefully.
2. Remove bare wire connecting pin 2 of socket B and ground lug D.
3. Remove ground end of C946 from pin 2 of socket B and connect to pin 3 of socket A as shown.

4. Remove ground end of *R919* from pin 2 of socket C and connect to ground lug E as shown.

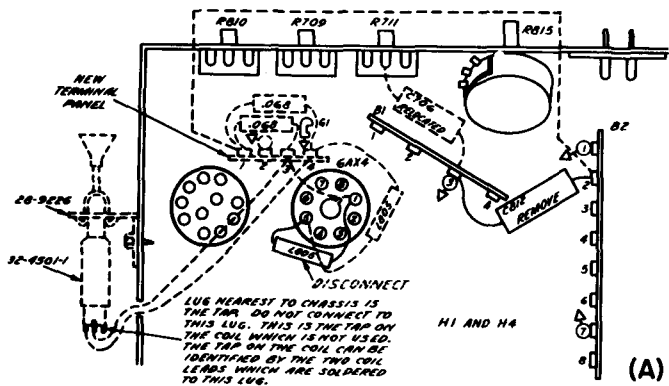
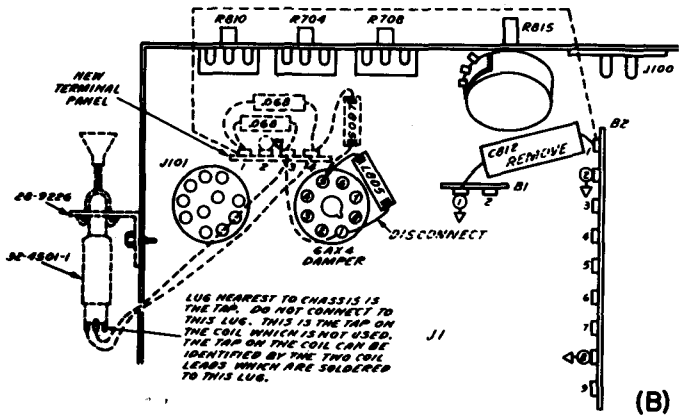
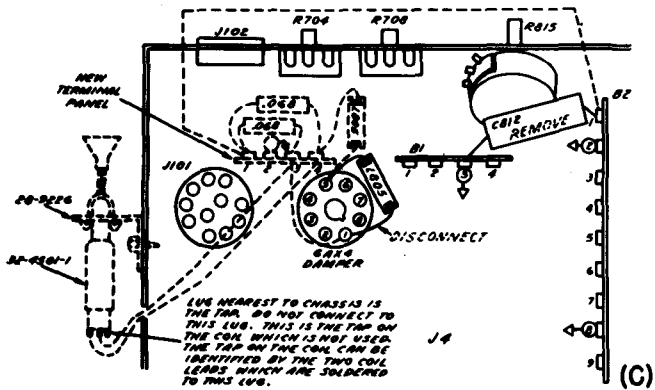
Fig. 52 — Philco

**PHILCO Models TV-80 series,
TV-90 series
Addition of horizontal-linearity
control (see Fig. 52).**

6. Disconnect the r-f choke *L805* from the damper-tube socket pin 1

and connect this end to lug 4 of the new panel, as shown on the wiring layouts.

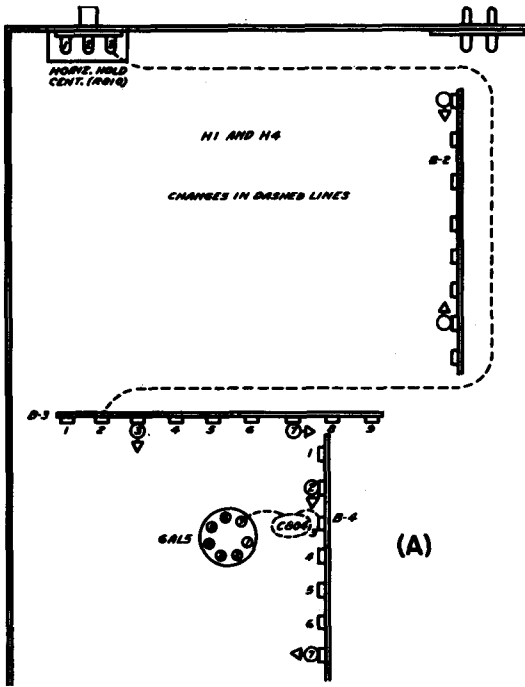
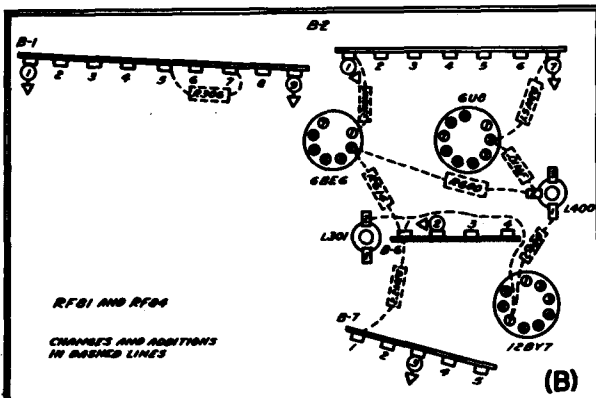
Fig. 53 — Philco

PHILCO Model TV-80 series
Removing bend and wiggle in picture (see Fig. 53).

1. Replace capacitor *C804* (see part A of the figure) with a .001- μ f, 400-v capacitor, part No. 30-4668-35. This capacitor was originally a .01- μ f unit. This has already been changed in later production.

2. Remove lead between lug 2 of terminal panel *B3* and lug 3 of horizontal-centering hold control (*R810*). Refer to part (A) of the figure.

3. Add a longer wire between the points mentioned above, dressing the wire as shown in the figure.

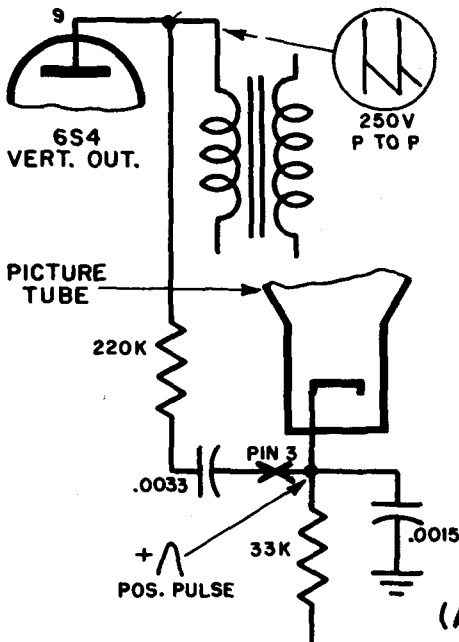
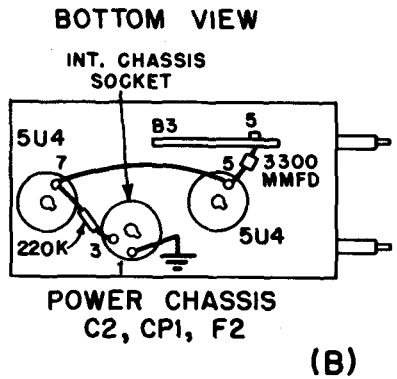
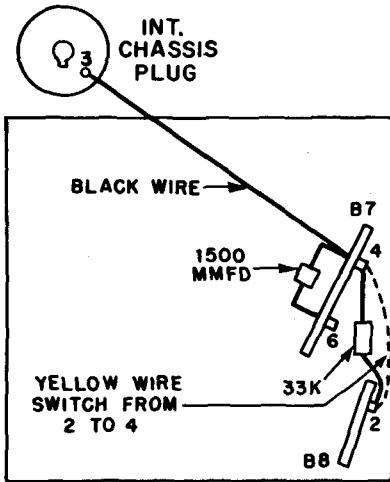
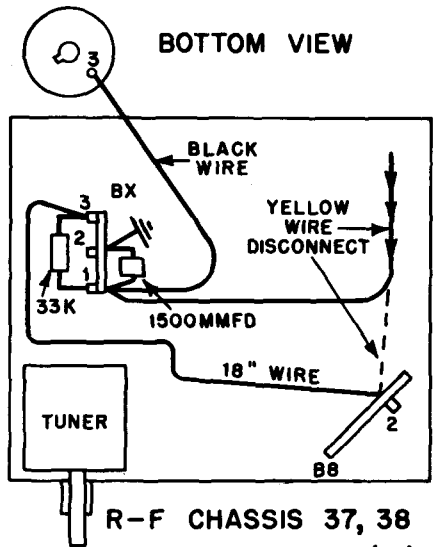
Fig. 56 — Philco

Vertical-retrace suppression (see Fig. 56).

3. Connect a 1,500- μ f, 600-volt capacitor (part No. 30-4650-53) between the terminal strip *B7-4* and ground.

4. Disconnect black wire to pin 3 of chassis interconnecting plug from terminal strip *B4-7* and connect it, adding another length of wire if necessary, to *B7-4*.

If r-f chassis 37 or 38 are used, proceed as follows (see part D of the figure):

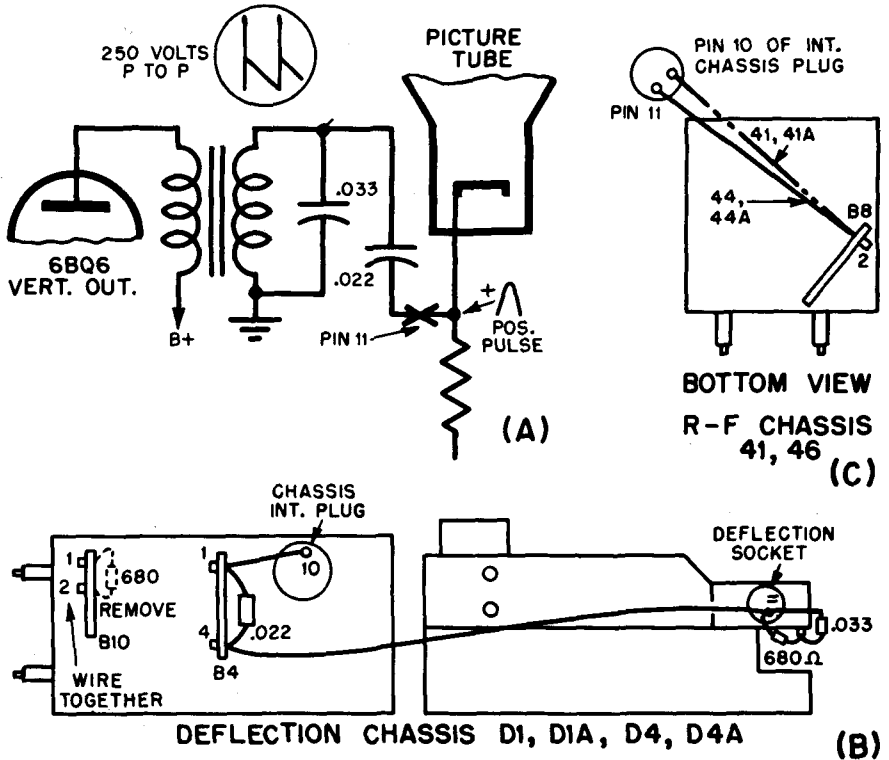
Fig. 57 — Philco

Vertical-retrace suppression
(see Fig. 57).

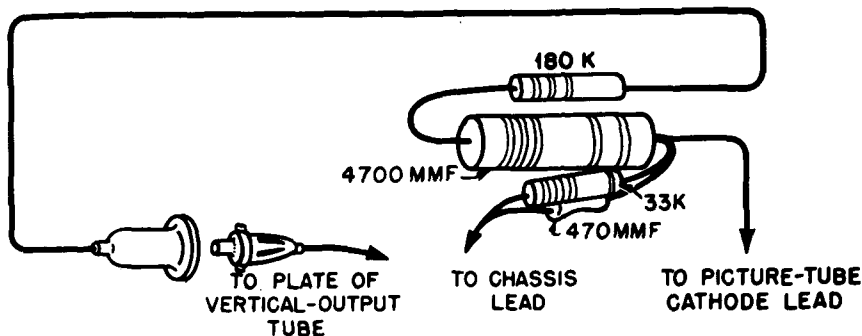
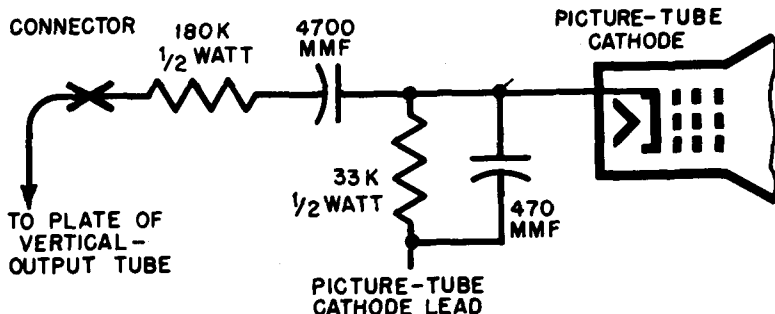
Fig. 58 — Philco

Vertical-retrace suppression (see Fig. 58).

In lieu of the wiring changes described under "Vertical-retrace suppression" for the above chassis, an alternate form of vertical-suppression circuit can be incorporated as follows. An external wiring assembly as shown in the figure is used. The connector provides flexibility in chassis removal.

1. Cut cathode lead in picture-tube cable near socket.

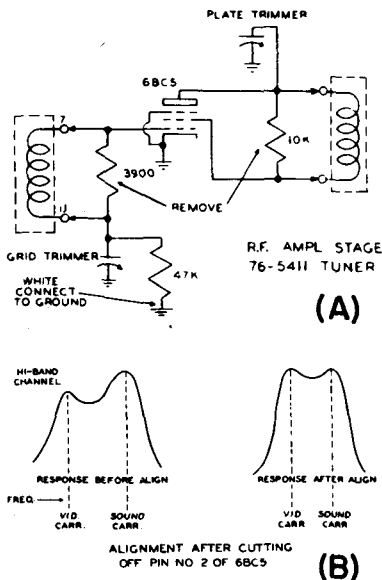
Fig. 60 — Philco

PHILCO Models with 76-5411 tuner
Improving sensitivity of tuner in fringe areas (see Fig. 60).

Changes can be made in the r-f amplifier section of the above tuner by increasing the Q of the grid and plate tuned circuits. This can be accomplished by removing the 3,900-ohm resistor in the grid circuit of the r-f amplifier and the 10,000-ohm resistor in the plate circuit of the r-f amplifier. See part (A) of the figure.

Recently it was found that by introducing a slight amount of regeneration in the r-f amplifier stage, additional gain of another 20 percent may be realized on the high-band channels and especially near the upper end of the high band. This regeneration can be very easily introduced by simply clipping off pin 2 of the r-f amplifier tube. Doing this introduces an impedance common to the suppressor and cathode. This common impedance is the internal cathode tie and the cathode lead. The relatively high capacitance between the plate and suppressor provides a feed-back path which causes some amount of regeneration in the r-f amplifier tube. The circuit actually takes the form of a modified Colpitts oscillator. After pin 2 is clipped off and the tube is reinserted, the tuner should be realigned to complete the modification of the r-f stage for good fringe performance. It is necessary to realign the r-f stage because introducing regeneration tends to produce a definite peak on the sound side (high-frequency side) of the response curve, therefore the r-f stage must be realigned so that the sound and video peaks are equal. It will be found that it is necessary to retune the grid and plate trimmers to give correct response. See part (B) of the figure.

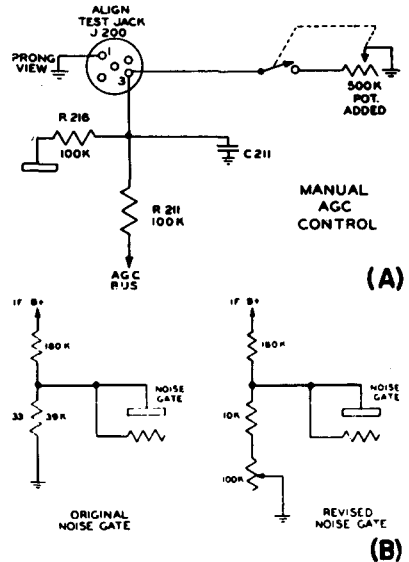
Fig. 64 — Philco

Variable agc and noise-gate
voltages for fringe areas
(see Fig. 64).

The practical limits for reducing the agc voltage in the i-f strip is at the point where sync clipping starts to occur. Part (A) of the figure shows a simplified circuit of the manual agc control.

Under conditions of heavy noise, as would be experienced in some fringe areas, it is advantageous to be able to manually control the bias on the noise-gate diode, thus controlling the clipping level of the tube. A circuit to accomplish this is shown in part (B) of the figure. The 39,000-ohm resistor is replaced by a 10,000-ohm resistor in series with a 100,000-ohm potentiometer.

The dual control does not contain a switch, however, in most fringe areas there is no practical use for a switch since the 1-meg resistance is sufficiently high to cause very little loading of the agc line. The dual control arrangement will also prove valuable for troubleshooting some receivers having sync-clipping problems, since the control affords a manual means of adjusting the agc bias and also the clipping level of the noise-gate tube.

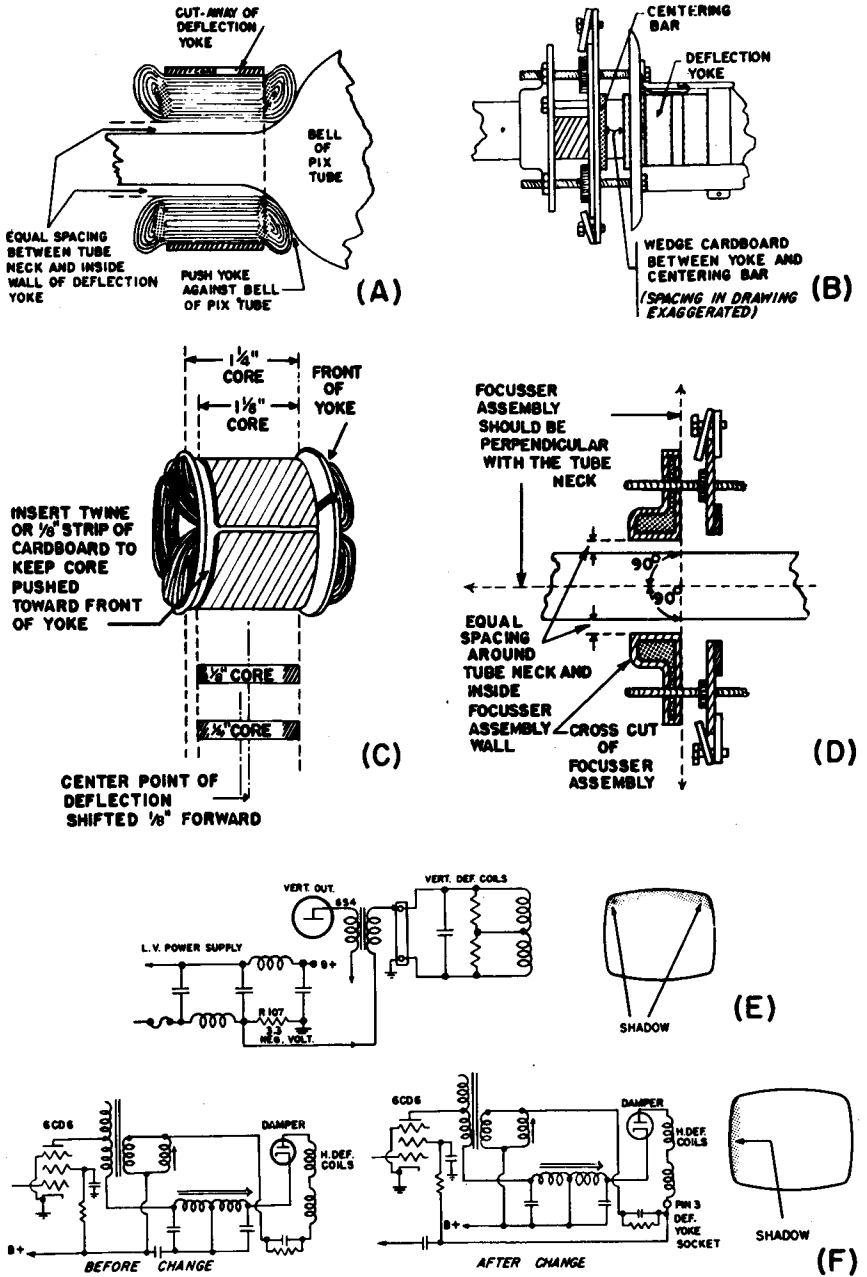
Fig. 65 — Philco

PHILCO All models
Elimination of shadow
(see Fig. 65).

2. Examine the deflection yoke to make sure it is concentric with the neck of the tube and pushed as close to the bell of the picture tube as

possible. See part (A) of the figure. Inserting cardboard wedges between the back of the deflection yoke and centering bar will prevent any tendency for the yoke to spring back away from the bell. It may even be necessary to remove the rubber bumpers to allow the yoke to move closer to the bell of the picture tube. See part (B) of the figure.
