Introduction

This is a series of volumes which deal with specific TV receiver troubles and their cures. These trouble cures are the TV manufacturers' answers to some of the problems that may arise in their particular receivers.

TV

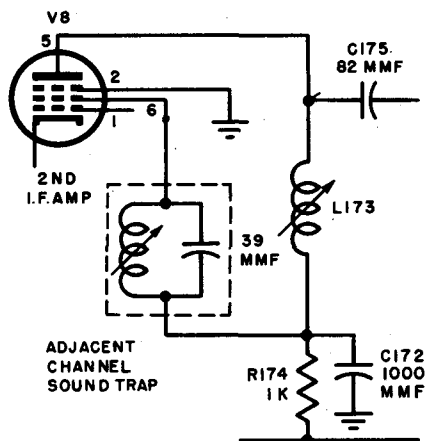
Fig. 26 — Sears Roebuck

Installation of adjacent-channel sound trap (see Fig. 26).

3. Carefully disconnect capacitor *C172* (1,000 μ f) from pin 6 of tube *V8* (6AU6) and from chassis ground.

4. Disconnect the second intermediate-frequency coil *L173* from pin 6 of tube *V8* (6AU6).

5. Connect one terminal of the trap coil directly to pin 6 of tube *V8* (6AU6).

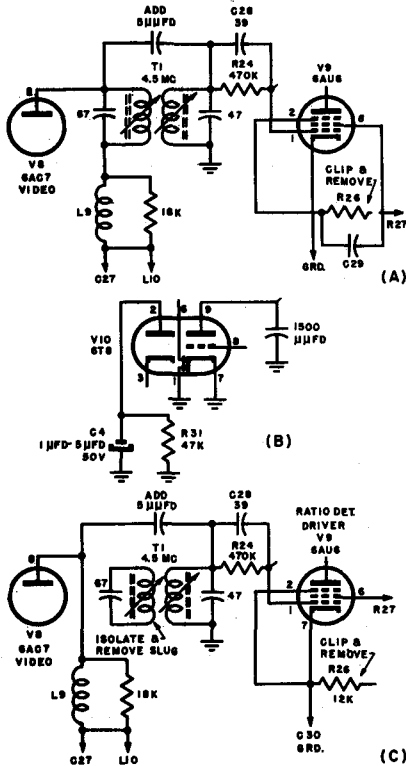
Fig. 31 — Sears Roebuck

SEARS ROEBUCK Chassis 110.499
Reducing intercarrier buzz
(see Fig. 31).

2. Attach a $5\text{-}\mu\text{mf}$ capacitor from pin 8 to the top side of the secondary of $T1$.

3. In addition, completely remove all wires from the primary of $T1$ and remove its slug.

4. Remove *R26* and change *C4* as described previously.

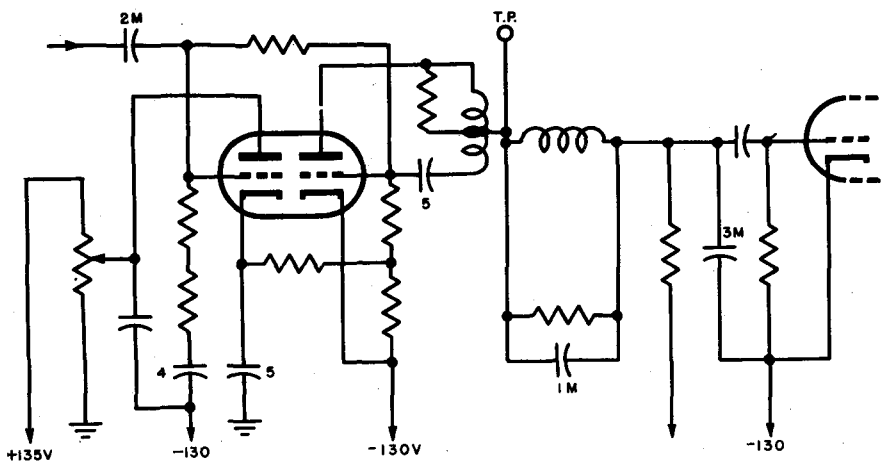
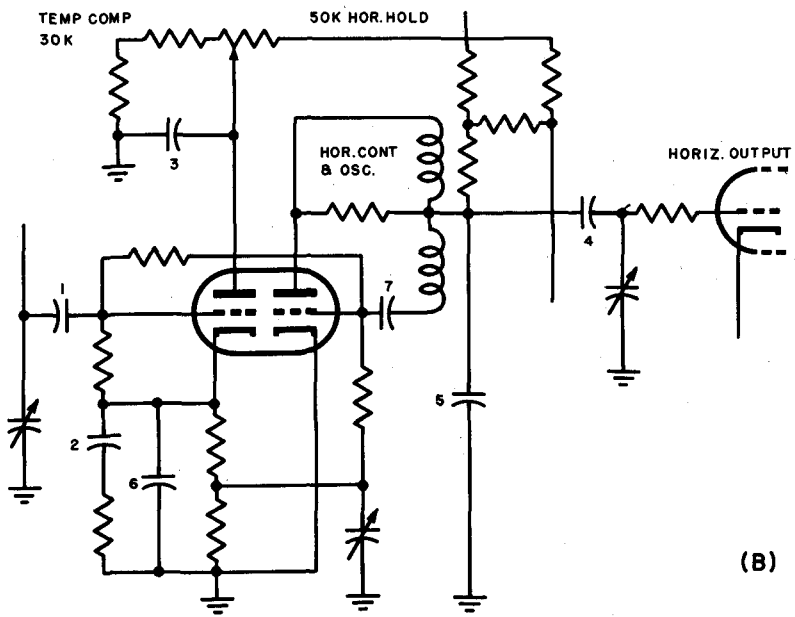
Fig. 37 - Sears Roebuck

Chassis 478 series
Horizontal drift (see Fig. 37).

The second type circuit (see part (B) of the figure) used in model 110 and others does not have a tertiary winding but uses a temperature-compensating resistor as shown.

For drift in this circuit, check the 30-k temperature-compensating resistor. It should be placed parallel to and $\frac{3}{8}$ to $\frac{1}{2}$ inch away from the power transformer. Check the numbered capacitors in the order indicated for leakage and replace only with molded capacitors. The .002- μ f input capacitor to sync-guide grid is especially critical. Leakage of 1 to 5 megohms in any of the above capacitors can cause horizontal drift.

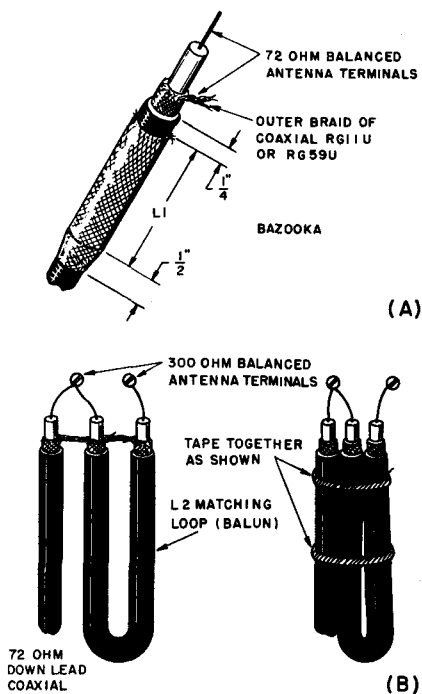
Fig. 42 — Sears Roebuck

SEARS ROEBUCK All chassis
Antenna-matching sections for high-noise area (see Fig. 42).

Television antenna installations in locations having high electrical noise levels require 72-ohm coaxial

cable lead-in to reduce noise pick-up in the down lead. All dipole-type antennas are balanced devices, while coaxial cable is unbalanced. The television set input is usually 300-ohm balanced.

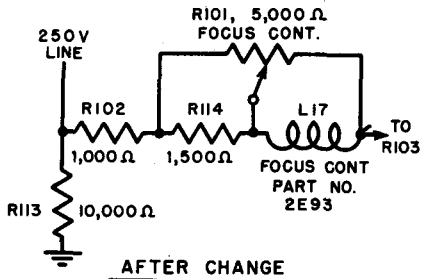
Fig. 45 — Sentinel

Increasing range of focus control (see Fig. 45).

2. The 500- μ f capacitor $C82$ located across the centering control is changed to a 1,000- μ f, 5-volt capacitor, part No. 25E52.

3. The B+ take-off point for the audio section is moved to the variable tap on the horizontal-centering control.

output side of the focus coil, $L17$. Part number of this resistor is 27E1016-11.

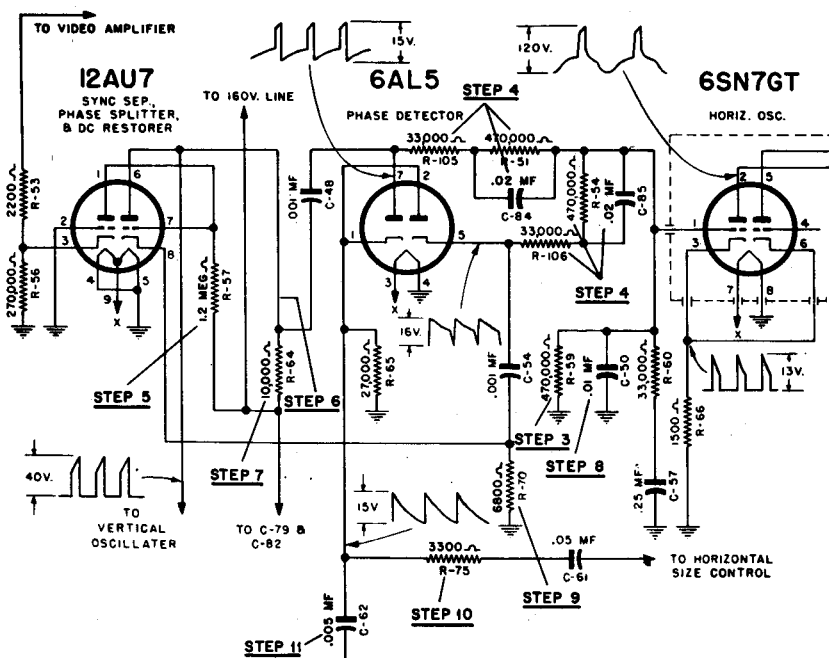
Fig. 46 — Sentinel

SENTINEL Model 416
Improving horizontal stability
 (see Fig. 46).

2. The .005- μ f capacitor *C49*, part of the parallel filter in the output circuit of the phase detector, is removed from the circuit.

3. The 470,000-ohm resistor *R52*, part of the parallel filter, is rewired

to ground to take the place of R59 removed in step 1 above.

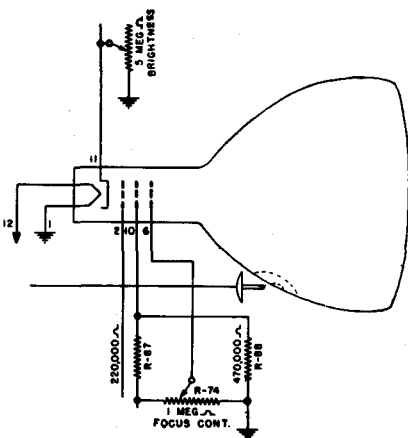
Fig. 50 — Sentinel

Improving contrast range (see Fig. 50).

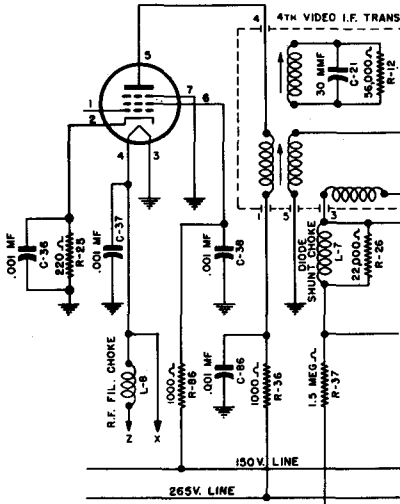
Fig. 51 — Sentinel

Picture rolling and tearing on strong signals (see Fig. 51).

In initial production the screen and plate were tied together to the 150-volt line. If you encounter a set in which the plate is tied to the 150-volt line and the picture tears or rolls on strong signals, the following changes should be made to tie the plate of the 3rd video i-f tube to the 265-volt line:

1. Change the 6CB6 3rd-video i-f amplifier 82-ohm cathode resistor (*R25*) to 220 ohms, $\frac{1}{2}$ watt.

2. Remove the jumper wire that runs from the screen (pin 6) of the 3rd-video i-f tube to terminal 1 of the 4th video i-f transformer. This will leave the screen (pin 6) of the 3rd video i-f tube connected to the 150-volt line through a 1,000-ohm resistor.

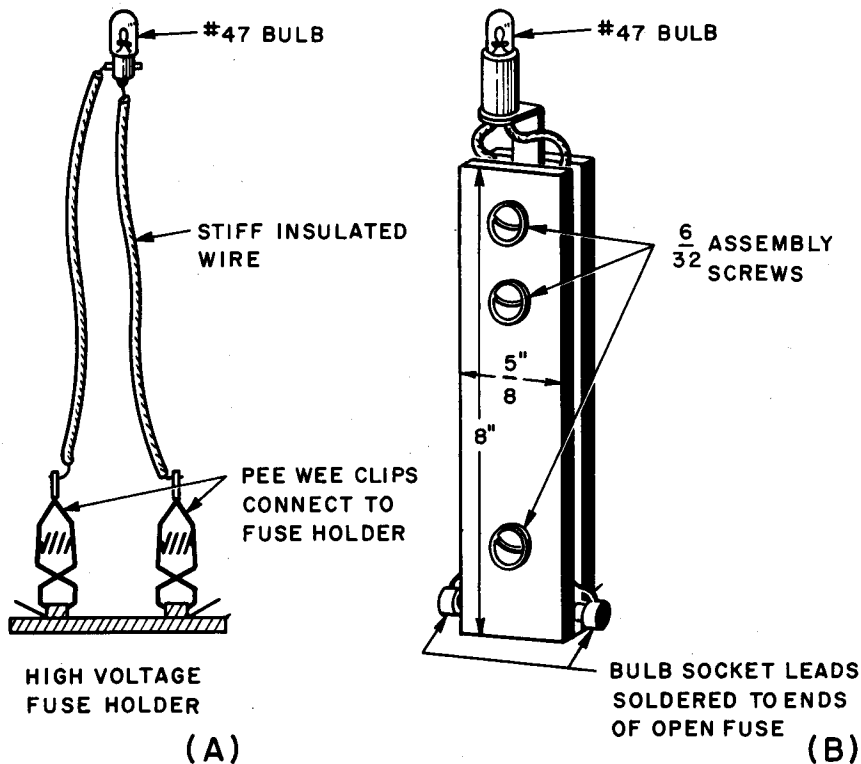
Fig. 52 — Sentinel

SENTINEL All models
Linearity-coil adjustment
 (see Fig. 52).

2. Clip a lead from the pilot light to each terminal of the fuse holder.

3. Adjust the horizontal-linearity control for minimum pilot-light brightness.

The above system is just as accurate as the 150-ma meter method recommended in the latest service notes. Many servicemen feel that the pilot light brightness method is easier to use.

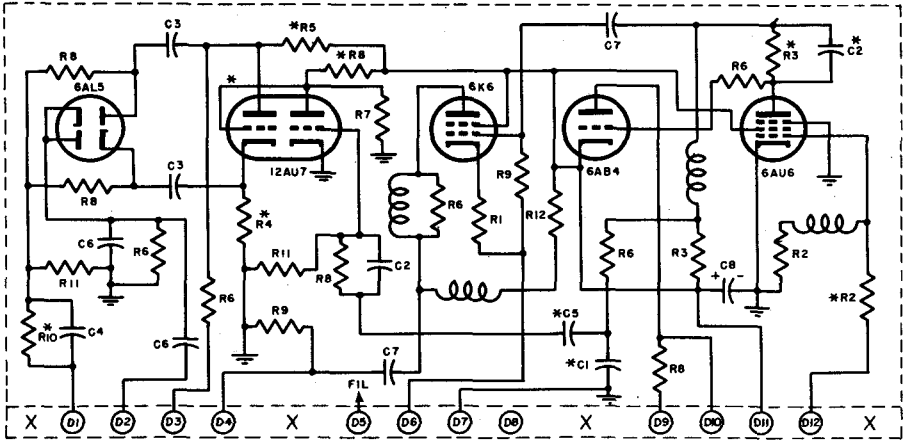
Fig. 53 - Setchell Carlson

Improvement in vertical and horizontal hold (see Fig. 53).

The changes shown in the figure were made in Series 4 of the D unit in order to produce a steadier picture in noisy fringe areas. If an improvement in vertical and horizontal hold is required, these modifications may be made to any earlier Series D

units. Asterisks in the schematic diagram denote component changes from the previous series. Component values are as follows:

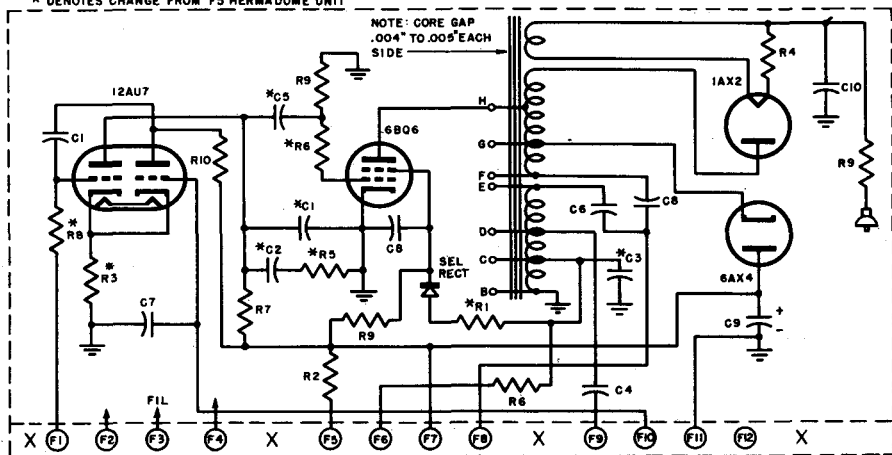
Fig. 54 - Setchell Carlson

Preventing overdrive of horizontal-output tube (see Fig. 54).

An automatic-drive arrangement may be incorporated into Series 5 of the F Hermadome unit. This arrangement, included in Series 6 of the unit, offers a great advantage in that
