## Introduction

# TV

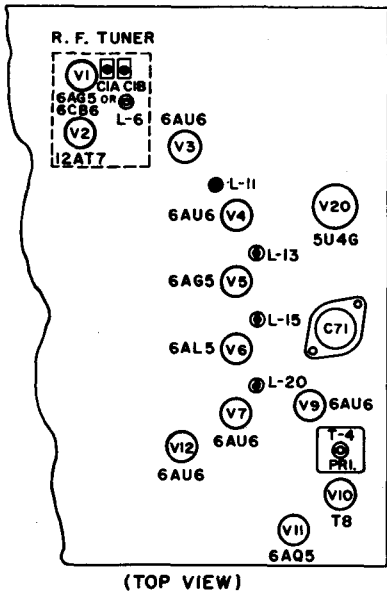
Fig. 2 — Sparton

**Picture i-f instability (see Fig. 2).**

If the picture i-f strip is badly out of alignment, it may become unstable and fall into oscillation. When this condition occurs, a comparatively large voltage is developed across the picture detector load resistor. This voltage is independent of i-f signal input at the converter grid.

8. Replace  $R48$  (1 meg) from pin 6 to +135 volt line with new  $R48$  (4.7 k).

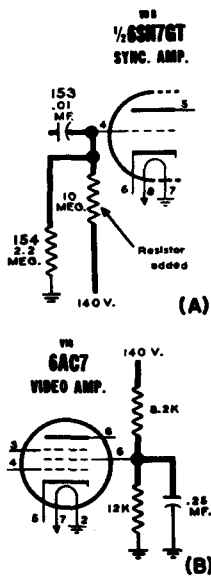
Fig. 5 — Stewart-Warner

1951, 1952 19-tube Models  
**Increased fringe area sync  
stability (see Fig. 5).**

The following circuit changes should be incorporated in all 19-tube models that are being operated in extreme fringe areas. These changes will result in greatly improved sync stability under conditions of weak signal. *Do not* make those modifications on chassis located in *strong* or *moderate* signal areas.

RESISTOR NO.	VALUE	PART NO.	REPLACE WITH
R223	2 meg, 5%, $\frac{1}{2}$ w	510765	510769
R225	100,000 ohms, 10%, $\frac{1}{2}$ w	510172	510766
R226	4.7 meg, 10%, $\frac{1}{2}$ w	510759	510768
R227	1.5 meg, 5%, $\frac{1}{2}$ w	510752	510767

RESISTOR NO.	VALUE	PART NO.	REPLACE WITH
R320	1.5 meg, 5%, $\frac{1}{2}$ w	510721	510767
R322	100,000 ohms, 10%, $\frac{1}{2}$ w	510172	510766
R323	6.8 meg, 20%, $\frac{1}{2}$ w	510196	510771
R324	1.2 meg, 10%, $\frac{1}{2}$ w	510738	510770

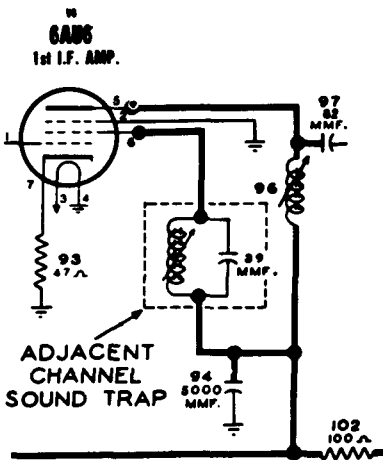
Fig. 6 - Stewart-Warner

### 1951 19-tube Models Installation of adjacent-channel sound trap (see Fig. 6).

Adjacent-channel sound trap, part No. 520131, comprising a slug tuned coil and fixed ceramic capacitor, was designed to minimize interference caused by the sound carrier of the lower frequency adjacent channel.

2. Properly tune receiver for a normal picture by using fine tuning control on front panel of receiver. Do not touch this control during the rest of the adjustment procedure.

3. Connect a standard signal generator through a 330- $\mu\mu\text{f}$  capacitor to

point *Q* on the r-f tuner and a vtvm to the green lead coming from the crystal detector shield can.

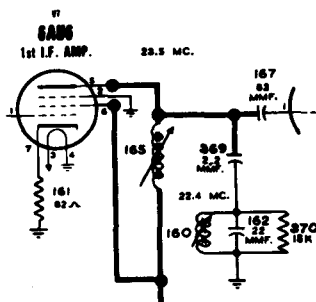
Fig. 7 - Stewart-Warner

1951 26-tube Models  
Improved sensitivity and sync stability (see Fig. 7).

6. The new trap coil should be aligned to the old trap frequency of 22.4 mc.

7. After completing this conversion, the 4th i-f stage should be changed in frequency from 24.75 mc to 24.9 mc.

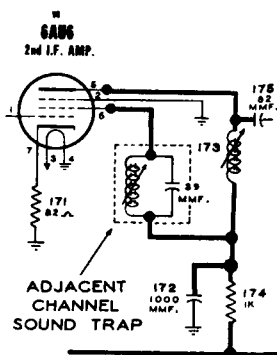
Fig. 8 — Stewart-Warner

### 1951 26-tube Models Installation of adjacent-channel sound trap (see Fig. 8).

Adjacent-channel sound trap, part No. 520131, comprising a slug-tuned coil and fixed ceramic capacitor, was designed to minimize interference caused by the sound carrier of the lower frequency adjacent channel.

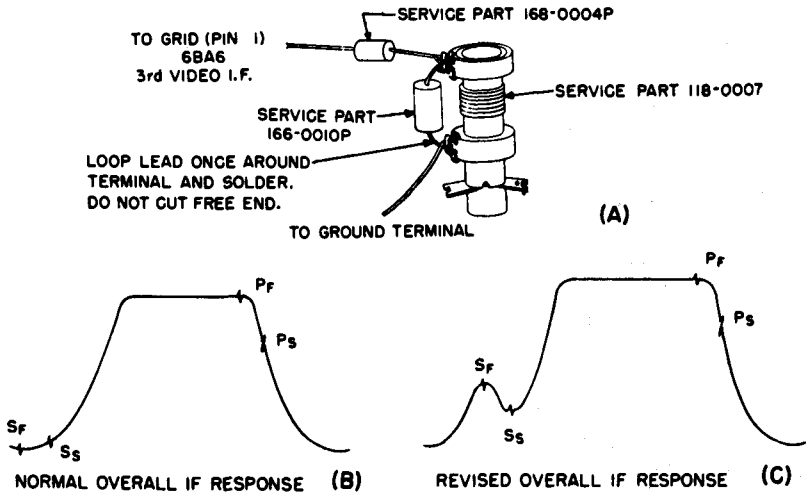
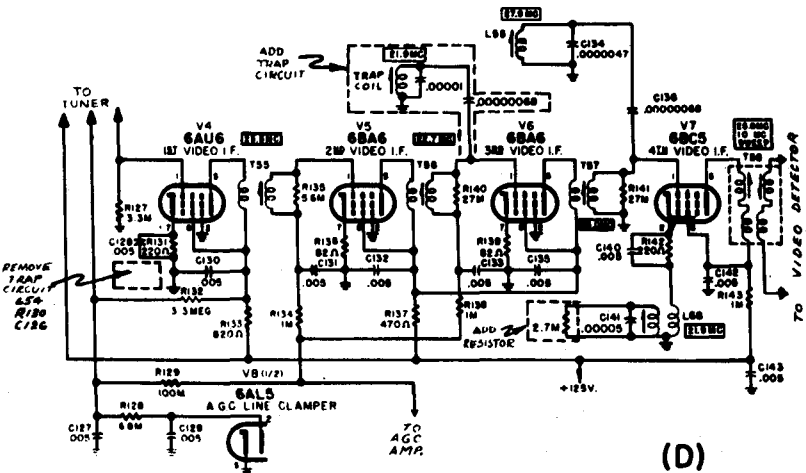
**Improvement in fringe area sound reception (see Fig. 15).**

reception in fringe areas, the following procedure is recommended:

1. Necessary new parts:  
Coil i-f trap, part No. 118-0007.  
Capacitor, ceramic, 10  $\mu\mu\text{f}$  at 500 volts, part No. 166-0010P.  
Capacitor, ceramic, 68  $\mu\mu\text{f}$  at 500 volts, part No. 168-0004P.  
Resistor, 2,700 ohms,  $\frac{1}{2}$  watt, .68  $\mu\mu\text{f}$ , part No. 181-0272.  
(Note: Use 3,900-ohm resistor for chassis 1-387.)
2. Make up an assembly as noted in part (A) of the figure.
3. Remove the following items from the circuit:  
*L54*, trap in 1st i-f cathode circuit.  
*R130*, 33,000 ohms,  $\frac{1}{2}$  watt (same location).  
*C126*, 50  $\mu\mu\text{f}$ , ceramic capacitor (same location).

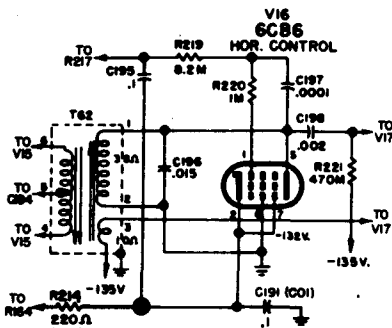
Fig. 21 — Sylvania

**Greater horizontal stability (see Fig. 21).**

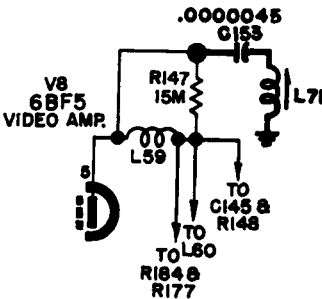
Fig. 22 — Sylvania

**SYLVANIA** Chassis 1-437-3  
**Reducing 4.5-mc sound interference in picture (see Fig. 22).**

To reduce 4.5-mc sound interference in picture, add *C153*, 4.7- $\mu$ f capacitor, and *L71*, 4.5-mc trap coil, in series between the plate of *V8*, 68F5 video amplifier, and ground. The alignment procedure for *L71* is as follows:

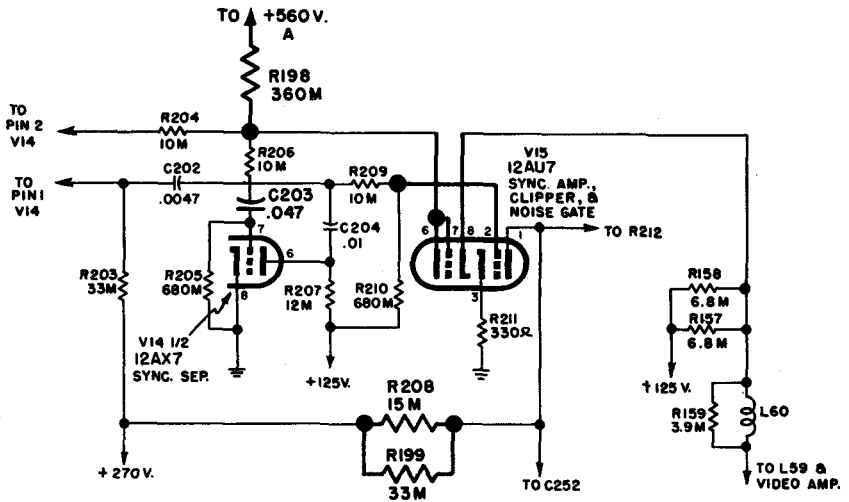
Fig. 24 — Sylvania

**SYLVANIA** Chassis 1-508-1, -2  
**Stabilizing sync and agc under interference conditions**  
 (see Fig. 24).

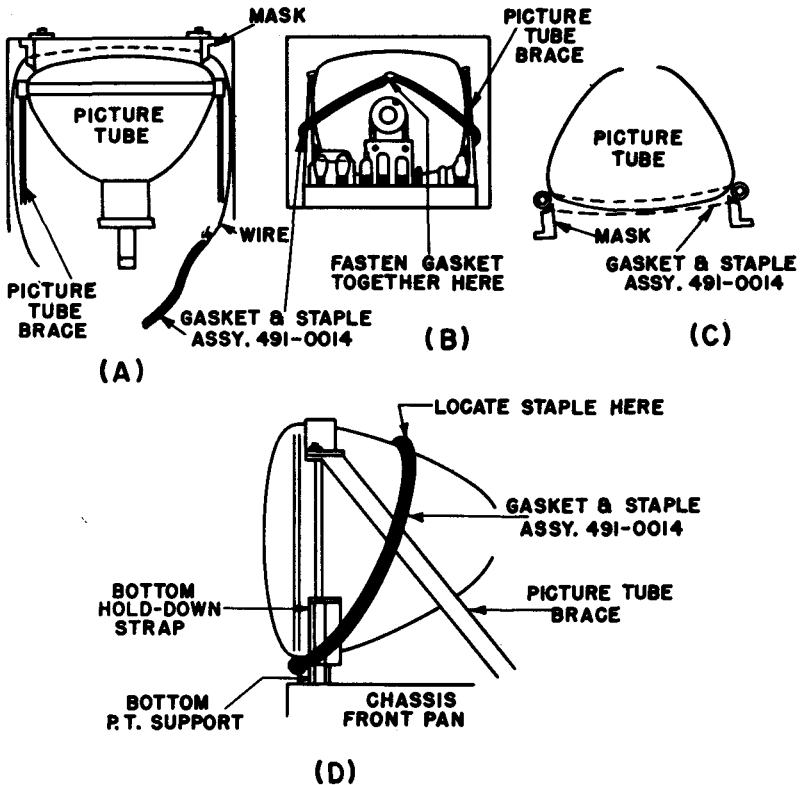
Fig. 25 — Sylvania

**SYLVANIA** All 17-inch chassis **Installation of dust seals for picture tube (see Fig. 25).**

Mask and gasket assembly, part No. 491-0014, may be installed on 17-inch tv models with the chassis either in or out of the cabinet. The methods for each type of installation are given as follows:

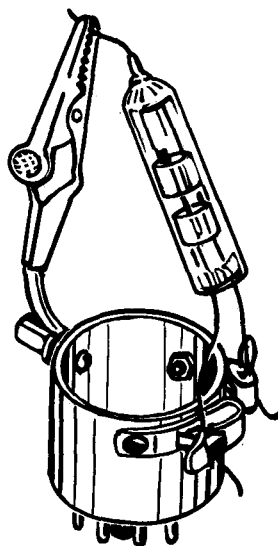
Fig. 27 — Sylvania

**Testing 5642 h-v rectifier tubes (see Fig. 27).**

The 5642 is designed to be soldered in place and therefore is difficult to test without danger of accidental shorts. One way to test these tubes is to make an adapter as shown. Bolt two Fahnestock clips on an octal tube base and connect to the proper pins as required for the particular tube tester used. Bolt a lead with an alligator clip fastened to it to the other side of the base.

This lead does not connect to the base pins, but solder a tube top cap to the bolt so connection may be made with the tester's regular top cap connection, if required.

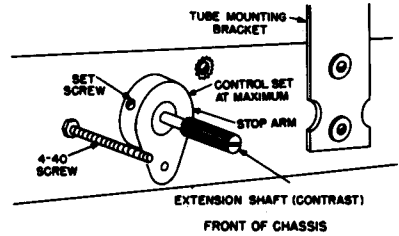
Fig. 30 — Western Auto

#### **Preventing contrast control shaft connector from breaking (see Fig. 30).**

Since the contrast control is located on the video i-f strip assembly, an extension shaft and shaft connector are used to operate the contrast control. The extension shaft can be rotated a full 360 degrees while the contrast control will reach its stop after approximately 280 degrees. If the extension shaft is rotated clockwise after the contrast reaches its stop, the fibre shaft connector will be broken. To prevent the shaft connector from breaking, simply follow the instructions below:

1. Remove the chassis from the cabinet.
2. Remove the lower screw and lockwasher holding the contrast shaft bracket to the front of the chassis.

3. Insert the small 4-40 screw through the hole in the contrast shaft bracket so the screw head is inside the chassis. Tighten to the chassis with the lock-washer and nut provided.
4. Place the stop-arm assembly over the contrast control extension shaft so the stop-arm is away from the chassis.
5. Set the contrast control to maximum (clockwise).
6. Rotate the stop-arm clockwise until it reaches its stop (the 4-40 screw).
7. Tighten the two stop-arm assembly set screws.
8. Replace the chassis in the cabinet.

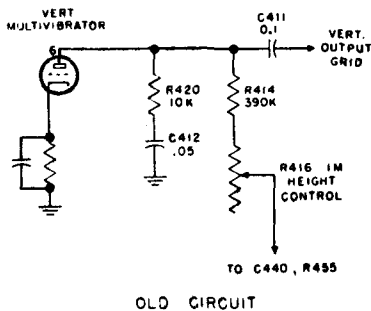
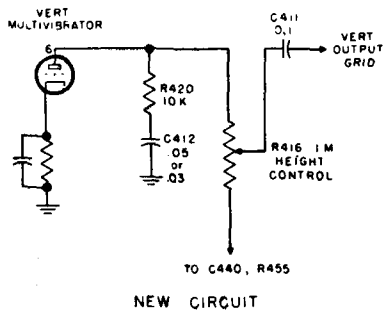
**Fig. 36 — Westinghouse**

**WESTINGHOUSE** Models  
H-626T16, H-630T14  
**Increased control of height (see Fig. 36).**

Due to variations between 6K6GT vertical output tubes, it was found desirable in later production to provide increased control over the picture height. Accordingly the circuit was altered as shown. *R414* is removed from the circuit, and the height control connections are changed. In later production, *C412* is changed to .03  $\mu\text{f}$  in the V-2172 chassis only.

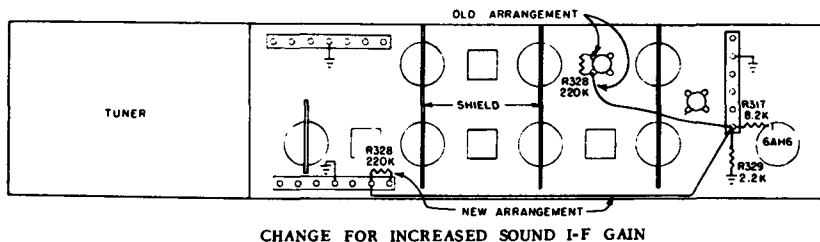
Fig. 38 — Westinghouse

**Increasing contrast range and sound output (see Fig. 38).**

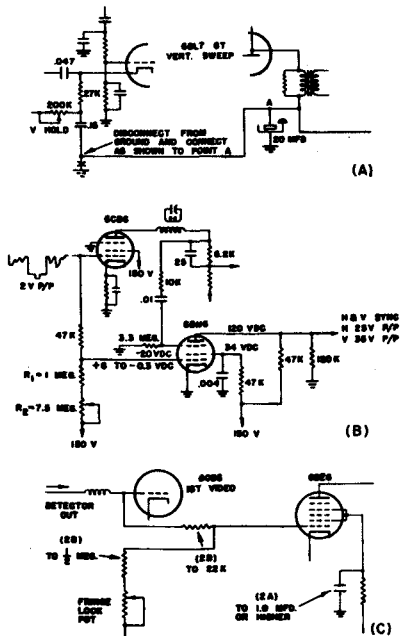
Fig. 42 — Zenith

**Sync Improvement in fringe areas (see Fig. 42).**

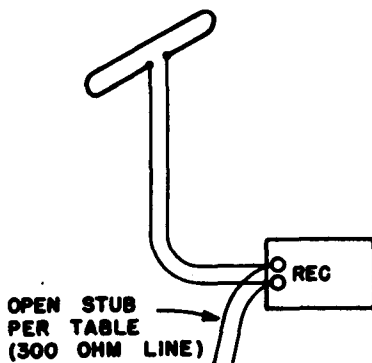
Fig. 44 — Zenith

### Improving overall fringe performance (see Fig. 44).

#### 1. Grounding Turret AGC.

This procedure consists of removing the turret agc lead from the agc string and returning it to ground through a resistor of 500-k to 1-meg

Strong Local Channel	Stub Length (Inches)	
2	43	(Will also attenuate 7, 8)
3	39	(Will also attenuate 7, 8, 9, 10)
4	35½	(Will also attenuate 10, 11, 12, 13)
5	31	(May attenuate 13)
6	28½	
7	14	
8	13½	
9	13	
10	12½	
11	12	
12	11¾	
13	11½
