TV

MANUFACTURERS' RECEIVER TROUBLE CURES

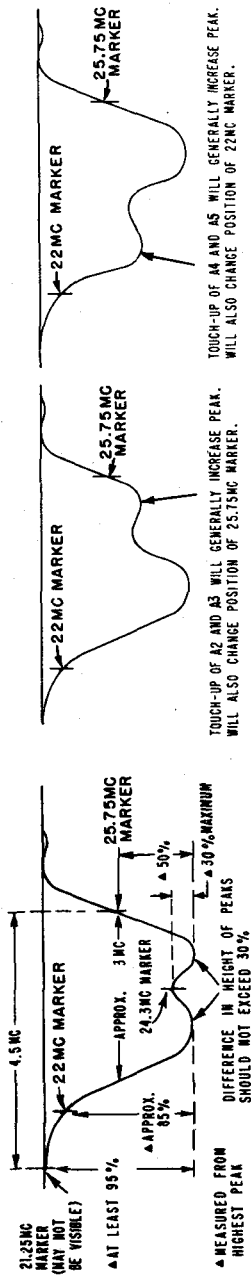
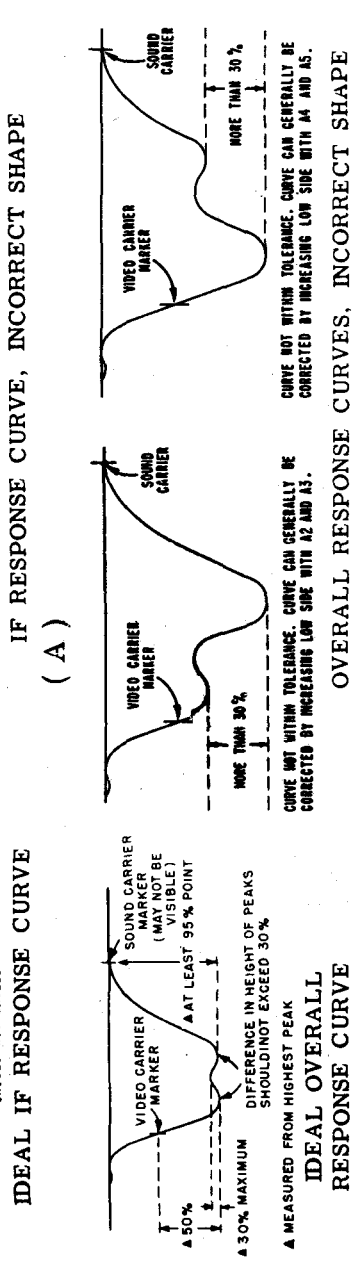
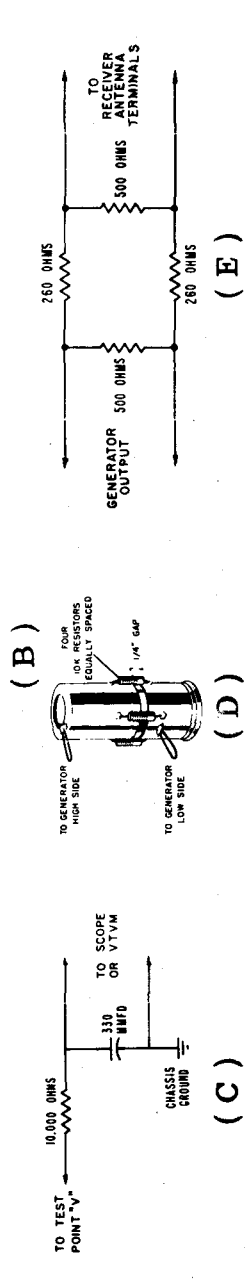
Fig. 1 - Admiral

3. Due to the high sensitivity of the 19-series chassis, it is necessary to use caution when performing the i-f amplifier alignment. When adjusting *A2*, hand capacitance may cause oscillation. This condition will cause the i-f response curve to appear unstable when viewed with an oscilloscope. To minimize the effects of hand capacitance, the following suggestions should be followed:

When checking the overall response curve, it is very easy to overload the receiver, which results in a distorted curve. If the overall response curve changes shape when the generator attenuator is advanced, the receiver is being overloaded. Some generators have a built-in pad as part of the output cable that can be used to reduce the signal. Check the instruction book on the instrument for details. If the built-in pad is unsatisfactory, or if the generator is used without such a pad, it is recommended that a 12-db pad be made up and connected between the generator output leads and the receiver antenna. Part (E) of the figure shows such a pad. Always be sure the termination of the generator output cable is correct. Consult the instruction book of the instrument for details.

Improving alignment procedure (see Fig. 1).

1. Instead of the original i-f response curves shown in the service notes, use the curves shown in part (A) of the figure. If it is necessary to adjust for approximate equal peaks and marker location, carefully adjust alignment slugs as instructed under the above figures. It should not be necessary to turn the slugs more than one turn in either direction. Note: Slug *A2* is the output transformer of 3rd i-f amplifier, slug *A3* is the input transformer of 2nd i-f amplifier, slug *A4* is the output transformer of 2nd i-f amplifier, and slug *A5* is the input tuned circuit of 1st i-f amplifier.

If the curve cannot be made to resemble the response curve shown, repeat all steps under "I-F Amplifier and Trap Alignment" making sure that generator frequencies are accurate and adjustments are carefully made. If a satisfactory curve cannot be obtained after repeating these steps, it may be necessary to change i-f amplifier tubes or check for a defective circuit component to

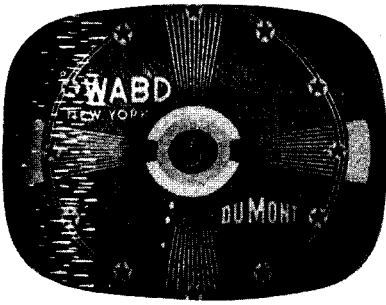
Fig. 47 — Dumont

To eliminate the possibility of parasitic oscillation in the filament supply wiring, the following change is made. This condition causes a series of white streaks to appear on the left-hand side of the picture when the set is tuned to channels 9, 10, or 11. It also results in a loss of horizontal sync stability.

Eliminating parasitic oscillations in the filament supply (see Fig. 47).

1. Disconnect the filament lead running from pin 4 of *V213*, the sec-

ond vertical sync clipper, to pin 8 of *V214*, the horizontal sync clipper, at pin 4 of *V213*.

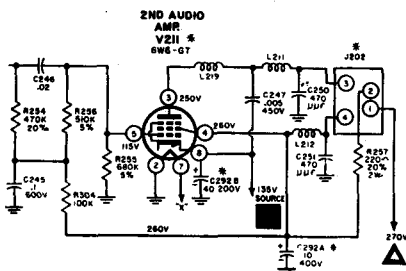
Fig. 55 — Dumont

Preventing audio in picture and beats on channels 5, 7 and 11 (see Fig. 55).

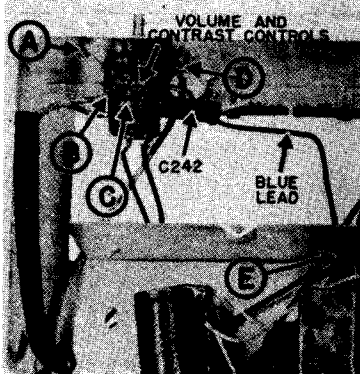
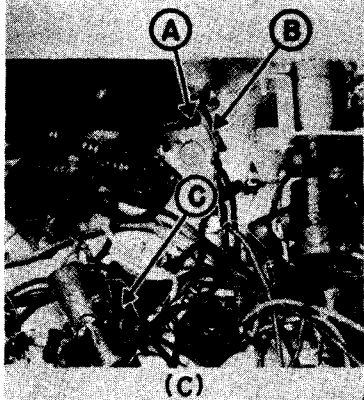
Fig. 56 — Dumont

**Eliminating audio buzz,
minimizing residual hum and
improving sound quality (see
Fig. 56).**

may be used as direct replacements if *L220* is removed from the circuit.

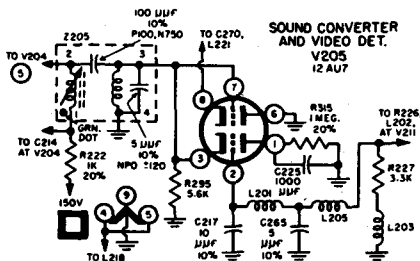
Fig. 57 — Dumont

Preventing i-f harmonic interference in picture (see Fig. 57).

To reduce radiation of harmonics of the sound and video i-f signals, generated in the video detector and sound converter, V205, proceed as follows. Under some conditions these harmonic signals enter the tuner causing interference in the picture.

1. Remove the 6AL5 and its socket. Replace the socket with a 9-pin miniature socket. Rewire the circuit as shown in the figure.

2. Remove R265, a 1k-ohm resistor connected between the junction of C219 (6.8-μμf coupling capacitor to sound i-f amplifier), L221 (coil originally tied to the cathode of the sound converter) and ground. Connect R265, 2.7k-ohm, 10%, 1/2-w resistor, from the junction of L221, C270 (10-μμf capacitor to ground) and pin 8 of V205, to ground.

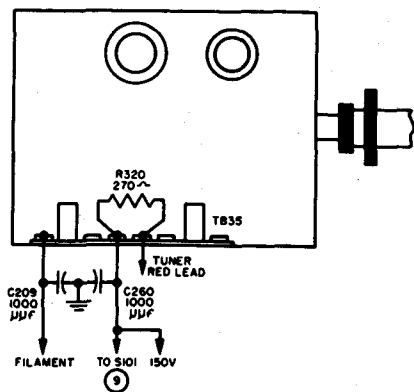
Fig. 58 — Dumont

Preventing regeneration on uhf models (see Fig. 58).

1. Mount S204, a single-pole three-position rotary switch (part No. 05008731), on rear of chassis above L210 (horizontal stabilizing coil).

2. Remove R210 (240k-ohm resistor in r-f agc bus). Connect a 180k-ohm, 1/2-watt, 5% resistor between terminal 1 of S204 and terminal 3 of TB18. This is the -3 volt

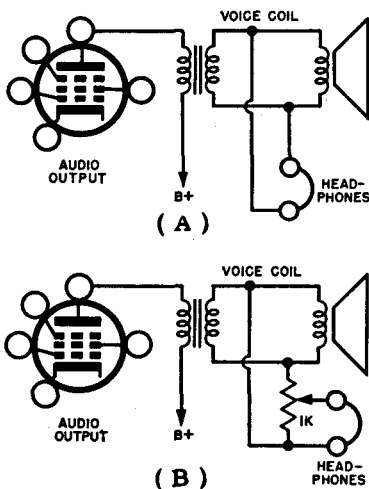
Fig. 61 — Dumont

**Connecting headphones to
receiver (see Fig. 61).**

Occasionally the service technician is called on to connect a set of headphones to a tv receiver for use by a person with defective hearing.

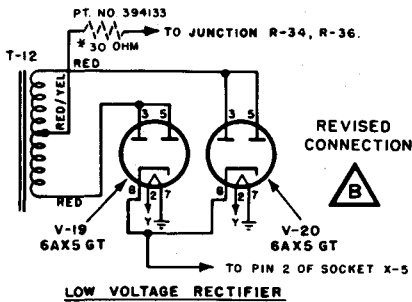
Fig. 63 — Emerson

EMERSON Chassis 120162-A
Reducing excessive horizontal size at high line voltages (see Fig. 63).

On some chassis coded Triangle B, a 30-ohm, 10-watt resistor (part No. 394133) has been placed in series with the red and yellow lead of the power transformer *T12* as shown in the diagram. This was done to reduce the horizontal size which may become excessive under high line voltage conditions. If so desired, this change can be easily made when servicing the chassis.

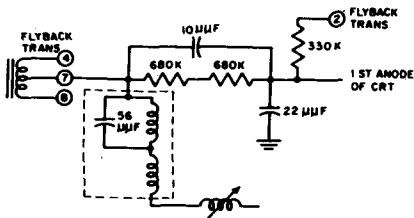
Fig. 74 - Emerson

**Vertical shading and horizontal
ringing (see Fig. 74).**
