Introduction

TV

VOLUME 7

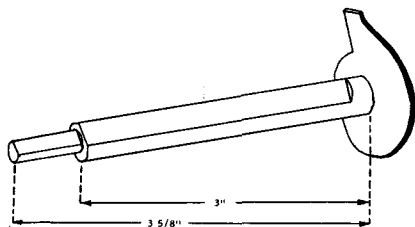
Fig. 8 — Hoffman

HOFFMAN Chassis with
tuners 9684, 9716,
9717 and 99532
Cascode tuner adaptation
(see Fig. 8).

The following information is intended for use with tuner 9788 (Standard Coil 20-mc cascode) when use as replacement for the above tuners. The shaft length must first be modified to match the length of the old tuner. To modify the shaft length, remove the screw that holds the fine tuner in place and remove fine tuning shaft. Cut fine tuning shaft to 3-inch length measured from front of dielectric wafer. Replace fine tuning shaft and cut off main shaft to $3\frac{5}{8}$ -inch length measured from front of dielectric wafer. Main shaft should be $\frac{5}{8}$ -inch longer than the fine tuning shaft when modification is completed. Be sure no metal filings are left between the fine tuning shaft and main tuner shaft.

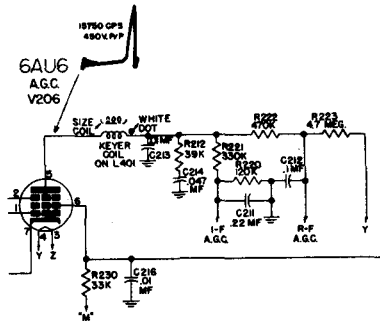
Fig. 11 — Magnavox

MAGNAVOX Chassis 105-, 106-, 107-series
Troubleshooting "sync lockout"
(see Fig. 11).

In servicing the above series television chassis you will occasionally find one which exhibits a condition commonly referred to as "sync lock-out". This condition is recognizable by the complete absence of horizontal

1. Check all tubes, particularly tuner, 1st, 2nd, 3rd i-f, video detector,

sound i-f, noise inverter, sync amplifier, horizontal oscillator output tubes.

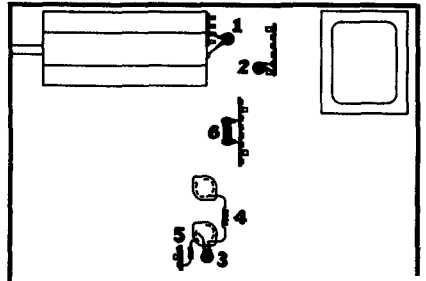
Fig. 31 — Packard-Bell

Preventing regeneration
(see Fig. 31).

part No. 29068 with part No. 29054, resistor $R7$ (82 ohms) should be changed to a 470-ohm, $\frac{1}{2}$ -watt resistor. Also add 22k-ohm, $\frac{1}{2}$ -watt resistor connected from screen of 6CB6 driver ($V2$, pin 6) to 135-volt bus.

In addition, resistor $R1$, 10,000 ohms, $\frac{1}{2}$ watt, is removed from the receiver. This is connected across the sound i-f input coil $L1$.

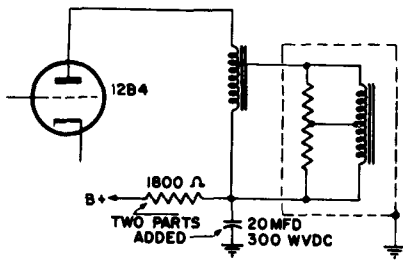
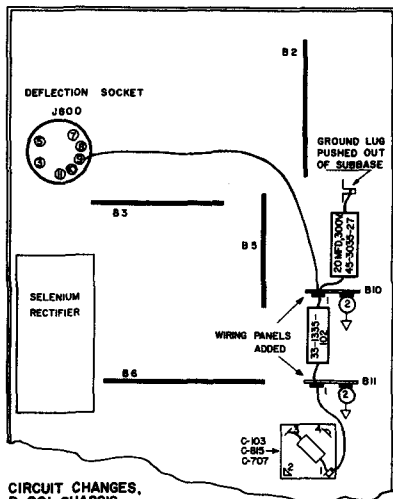
CIRCUIT CHANGES, D-201 CHASSIS, FOR INCREASED LIFE OF 12B4 TUBE

1. Mount two 2-lug wiring panels in the locations shown on the accompanying layout drawing. These panels will be referred to as *B10* and *B11*.

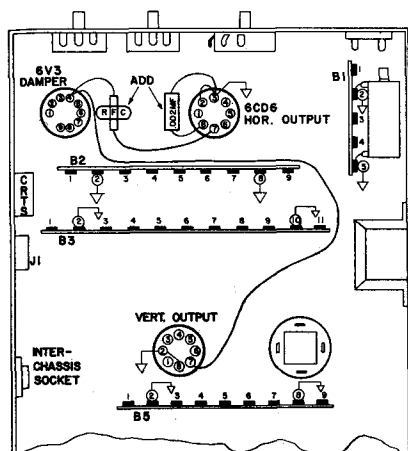
Fig. 34 — Philco

Eliminating Barkhausen oscillations (see Fig. 34).

The following changes should be made to eliminate Barkhausen oscillations in the above chassis:

1. Add a .002- μ f, 400-volt capacitor (part No. 30-1238-8 or 30-4650-

37) between pin 3 and pin 8 of the 6CD6G horizontal output tube. Schematically this capacitor is added from screen grid to cathode of the 6CD6G tube.

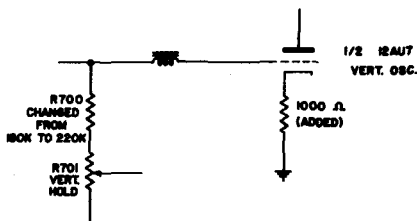
Fig. 35 — Philco

PHILCO Deflection chassis
J-2, J-5
Eliminating Venetian-blind effect (see Fig. 35).

2. Change resistor *R700*, which is wired in series with the vertical hold control, to 220 ohms, 1/2 watt, 10%, part No. 66-4228346.

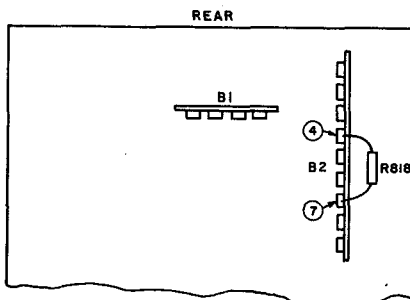
Fig. 36 — Philco

Increasing picture width
(see Fig. 36).

To increase picture width, the following changes, already included in later production run 2, are made:

1. Resistor *R818*, 22k-ohm, 2-watt

resistor connected between lugs 4 and 7 on terminal board *B2*, is changed to a 33k-ohm resistor.

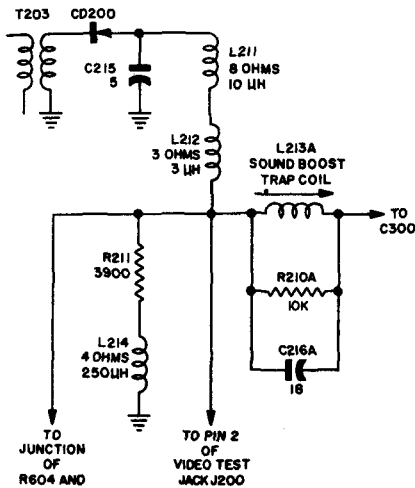
Fig. 39 — Philco

PHILCO R-f chassis R-191
Improving sound gain (see Fig. 39).

The following modifications already made in later production run 5, are incorporated in order to improve sound gain:

1. *L213* and *R210* are replaced by a 4.5-mc sound boost trap coil in the

video detector circuit (new part No. 32-4463-7).

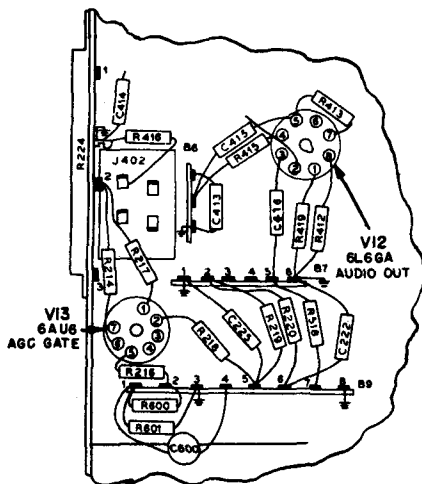
Fig. 41 — Philco

PHILCO R-f chassis 94
Permitting use of uhf tuner (see Fig. 41).

To permit use of the uhf tuner with the above chassis, the following changes, already included in later production are made:

1. Lead of resistor *R518*, 15k ohms, is moved from lug 5 to lug 4 of terminal board *B7*.

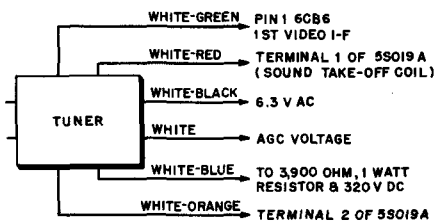
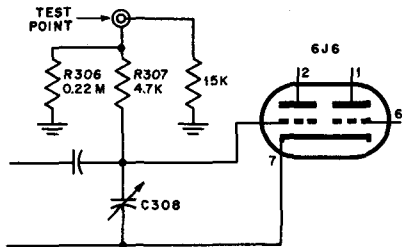
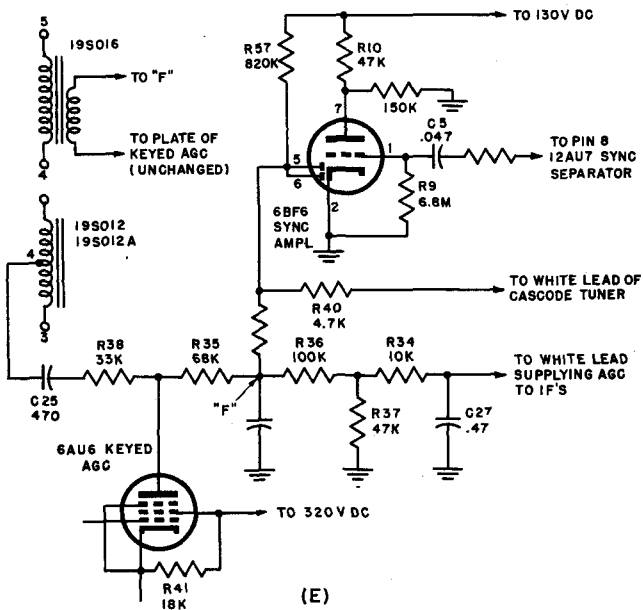
Fig. 42 — Radio Craftsmen

A delayed and graded automatic gain control must be added in order to obtain optimum performance. The new circuit correctly proportions the gains of the r-f and i-f amplifier stages for minimum snow in fringe areas and prevents overload effects in strong signal areas. The new cir-

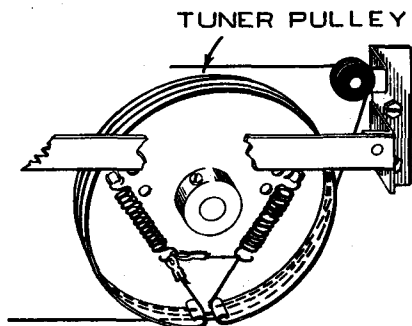
Fig. 44 — Raytheon

RAYTHEON Chassis 21T3
Stiffness in tuning (see Fig. 44).

If stiffness in tuning is noticed, the following is suggested as a means of obtaining a smooth continuous tuning action.

Apply Lubriplate or a similar lubrication to the pulleys, pilot light bar, stop washers, switch lever and arm. Also check that the switch lever

arm does not bind to the tuning shaft and that it does not rub against the escutcheon.
