**BLOCK DIAGRAM  
ADJUSTMENTS  
and  
TROUBLE SHOOTING  
for  
TELESET MODEL  
RA-111A**

**ALLEN B. DU MONT LABORATORIES, INC.  
TELESET SERVICE CONTROL DEPT.  
MARKET STREET, EAST PATERSON, NEW JERSEY**

First Edition April 3, 1950

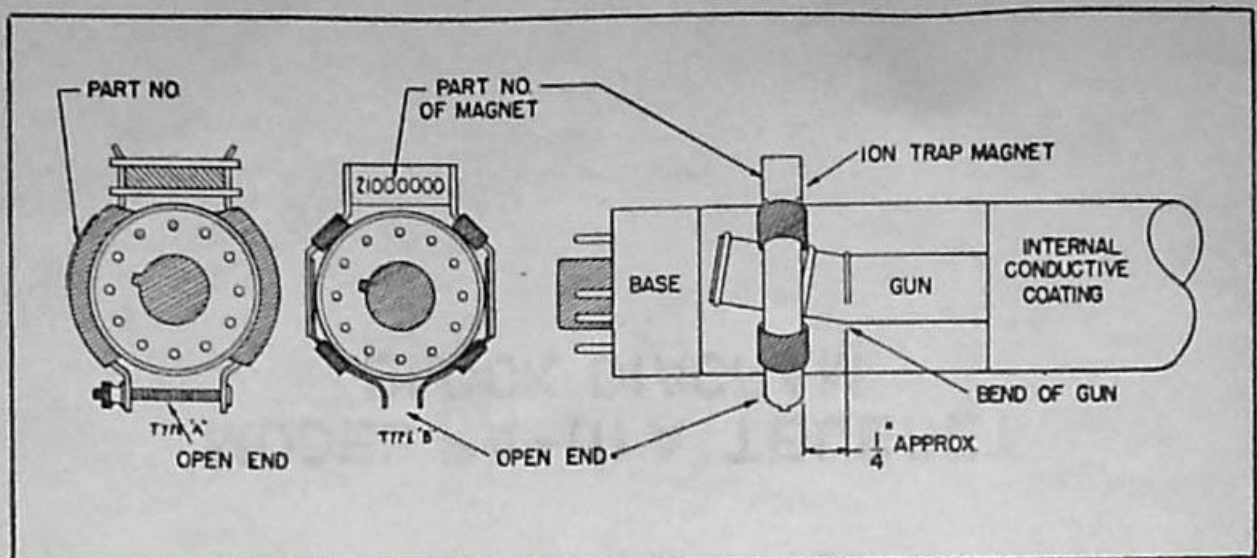
Types of ion-trap magnets used. (Thumbscrew of Type A should be tightened by hand only—do not use tools.)

**NOTE:** Accurate setting of the ion-trap magnet is highly important to insure optimum performance and normal life of the picture tube. The procedure should be carried out as rapidly as possible, to prevent damage to picture tube, and is not to be used as a picture positioning or screen coverage adjustment.

1. Start with the magnet about  $\frac{1}{2}$ " from the base of the tube.
2. Keep the Brightness Control at the lowest possible setting that will allow adjustment of the magnet.
3. Adjust the magnet by rotating it on the neck of the tube and sliding it back and forth for maximum illumination. Correct positioning of the magnet results in a decrease in brightness with movement of the magnet in any direction. (Two positions will be found; use position NEAREST BASE of tube).
4. Make final adjustment of magnet with Brightness Control set just below point where "blooming" (defocus) occurs.
